FINAL REPORT OF MAJOR MINE-EXPLOSION DISASTER  
CANE CREEK MINE, POTASH DIVISION  
TEXAS GULF SULPHUR COMPANY  
GRAND COUNTY, UTAH  
(Mine development under contract with  
HARRISON INTERNATIONAL, INCORPORATED)

August 27, 1963

#### INTRODUCTION

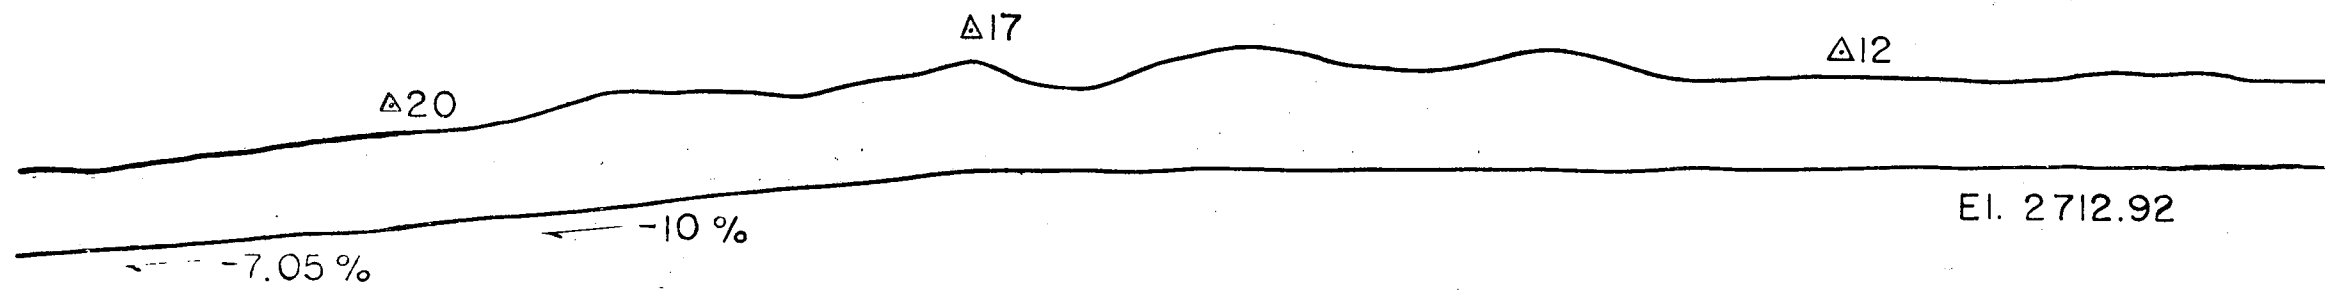
APPENDIX I  
**VERTICAL CROSS SECTION  
SHOP AREA  
3 SOUTH**  
Δ12 - 50' to Δ20 + 40'  
Scale 1" = 20'

room for a steel beam to support a chain block thus making the height in the critical area about 11 feet from sill to back. The high place extended for several feet along the shop drift and created a natural cavity for collection of gases (see Appendix I - profile). Reportedly, tests for combustible gases were made in the shop area by an employee of the Texas Gulf Sulphur Company at 3:00 p.m. on August 27, 1963, using a permissible methane tester, but none was found. These tests were made only at heights that could be reached by the man standing on the floor. Inasmuch as gas tests were made in the shop area as indicated above, it is possible that combustible gas accumulated in the high spot in the shop and was not detected.

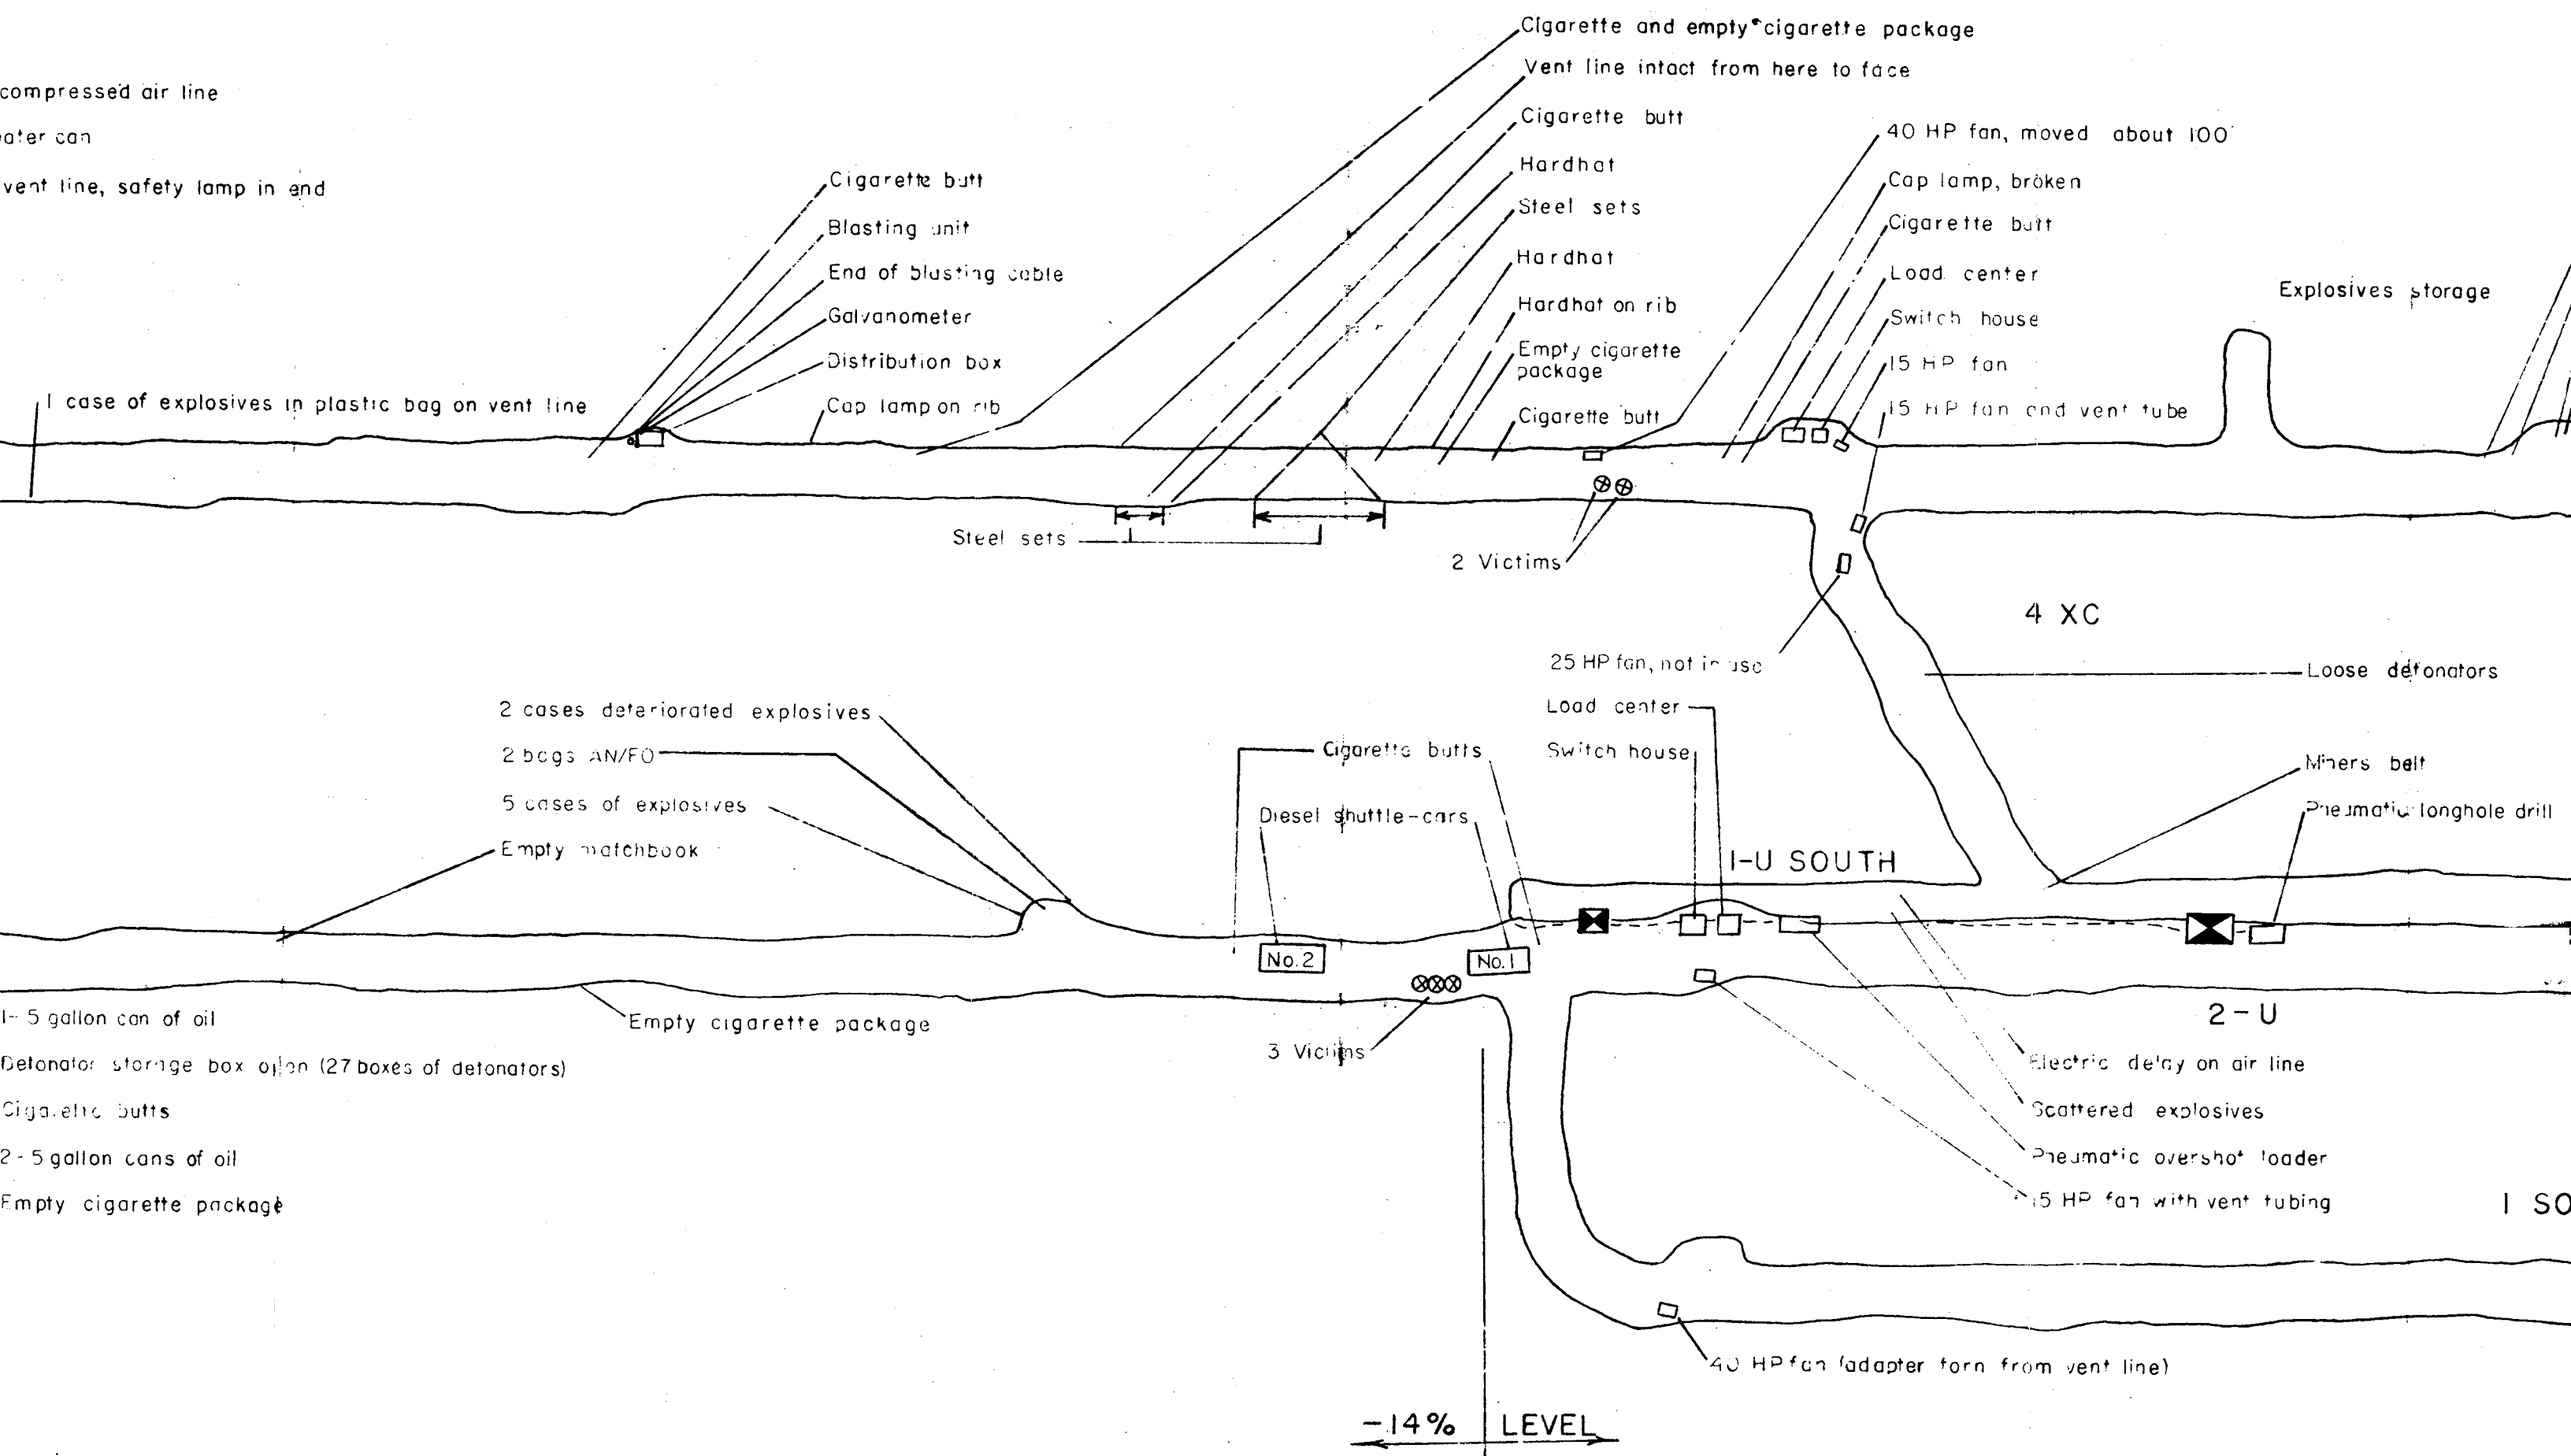
compressed air line  
 water can  
 vent line, safety lamp in end

1 case of explosives in plastic bag on vent line

40 HP fan, moved about 100'  
 Cap lamp, broken  
 Cigarette butt  
 Load center  
 Switch house  
 15 HP fan  
 15 HP fan end vent tube

2 cases deteriorated explosives  
 2 bags AN/FO  
 5 cases of explosives  
 Empty matchbook

Round shot at 4:20 PM  
August 27, 1963
