REPORT OF MULTIPLE FATAL COAL-MINE ~~ACCIDENT~~ ACCIDENT

NO. 4 MINE, WEST SECTION (ABANDONED)
STEARNS COAL AND LUMBER COMPANY
WORLEY, McCREARY COUNTY, KENTUCKY
(Post Office: Stearns, McCreary County, Kentucky)

August 5, 1961

C. E. Hyde
Federal Coal-Mine Inspector

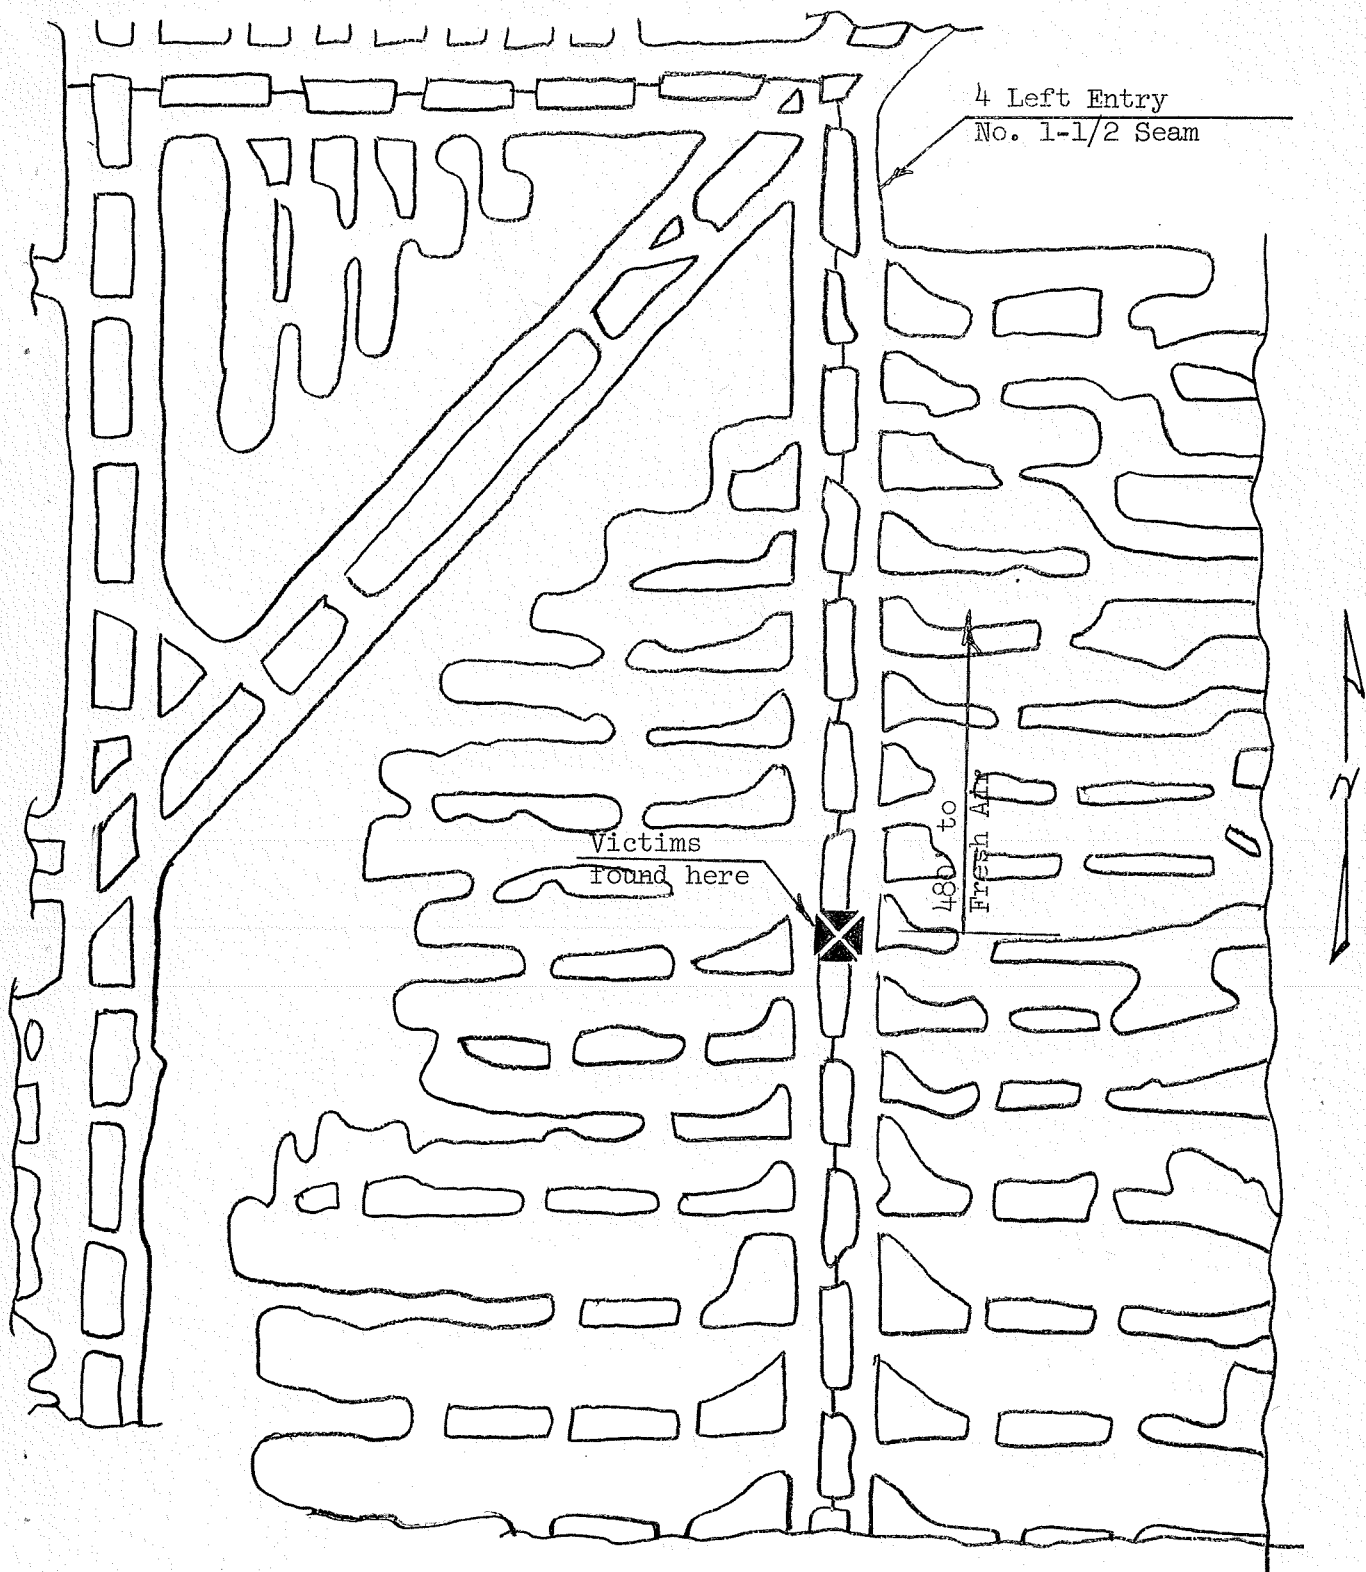
APPENDIX B
 MULTIPLE FATAL COAL-MINE FIRE ACCIDENT
 NO. 4 MINE, WEST SECTION (ABANDONED)
 STEARNS COAL AND LUMBER COMPANY
 WORLEY, McCREARY COUNTY, KENTUCKY

On Saturday morning, August 5, 1961, Maurice Blevins, General Superintendent, T. E. Lafferty, Superintendent, No. 16 mine, No. 2 seam, and Ottis Tucker, Section Foreman, No. 18 mine, entered the abandoned No. 4 mine, West Section, at the 4 west portal; see Appendix B. It was their

It could not be ascertained which areas were traveled or how extensive the explorations of the party were before entering 4 left entry off 4 west, but according to statements made by Mr. Lafferty (survivor who later died) the party had covered many areas. They entered 4 left entry about 12:30 p.m., and traveled toward the Bit Hole panel (fire area), a distance of 23 crosscuts or 1,380 feet from 4 west main, and for some reason decided to return to 4 west main. They retreated one crosscut length, 60 feet, and at 12:50 p.m., removed a portion of a double-wall wooden stopping in No. 22 crosscut attempting to increase the volume of air in 4 left by short-circuiting the air from the area enclosed by the stoppings. They were immediately engulfed by carbon monoxide and oxygen-deficient air. Their flame safety lamp, the only protective device in their possession, was extinguished. The party then retreated a distance of 840 feet to No. 8 crosscut where they each attempted to open a hole in the wooden stopping in No. 8 crosscut; see Appendix B. By this time the men were too weak to open the stopping effectively, but a small opening was made in the wooden wall nearest the entry, the clay was removed from between the walls, and a crack between the boards of the other wall was exposed. This small hole evidently permitted sufficient air to enter to keep two of the men alive for some time. Mr. Tucker died at 1:15 p.m.; Mr. Blevins became unconscious shortly thereafter; Mr. Lafferty's last conscious act, before being rescued, was looking at his watch at 3:15 p.m.

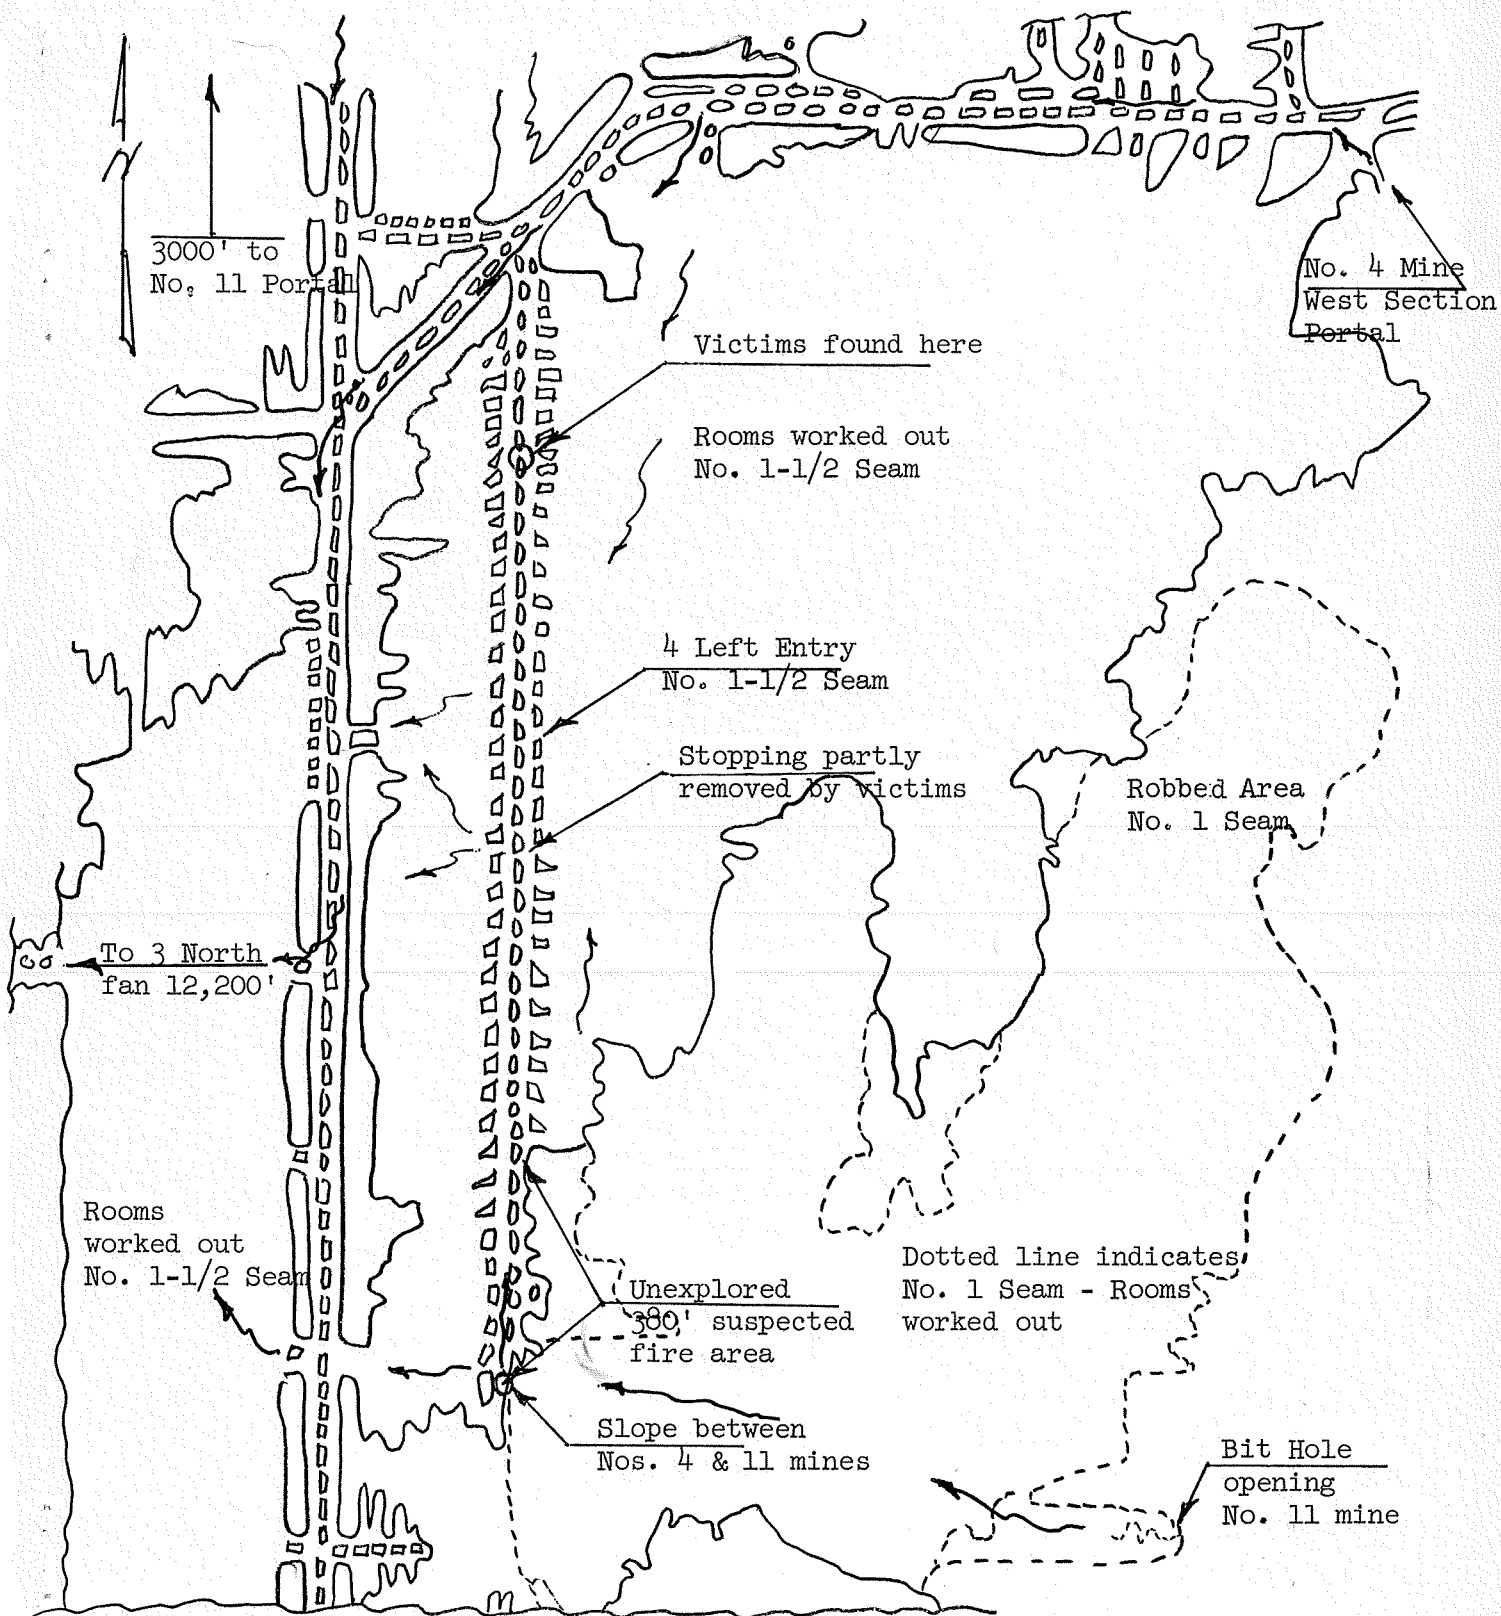
APPENDIX C
 MULTIPLE FATAL COAL-MINE FIRE ACCIDENT
 NO. 4 MINE, WEST SECTION (ABANDONED)
 STEARNS COAL AND LUMBER COMPANY
 WORLEY, McCREARY COUNTY, KENTUCKY

About 2 weeks prior to the accident, a seal at the Bit Hole opening was removed, and some additional air entering this opening undoubtedly passed over the fire area; see Appendix C. This recent change in ventilation probably permitted fresh air to pass over the smoldering fire and caused it to rekindle to the extent that carbon monoxide was given off and entered the air current. Following the accident, a slight trace of carbon monoxide was detected at the 3 north fan portal of the abandoned No. 11 mine.
