UNITED STATES
DEPARTMENT OF THE INTERIOR
BUREAU OF MINES

FINAL REPORT OF MAJOR MINE-EXPLOSION DISASTER
MINE NO. 2
BLUE BLAZE COAL COMPANY
HERRIN, WILLIAMSON COUNTY, ILLINOIS

January 10, 1962

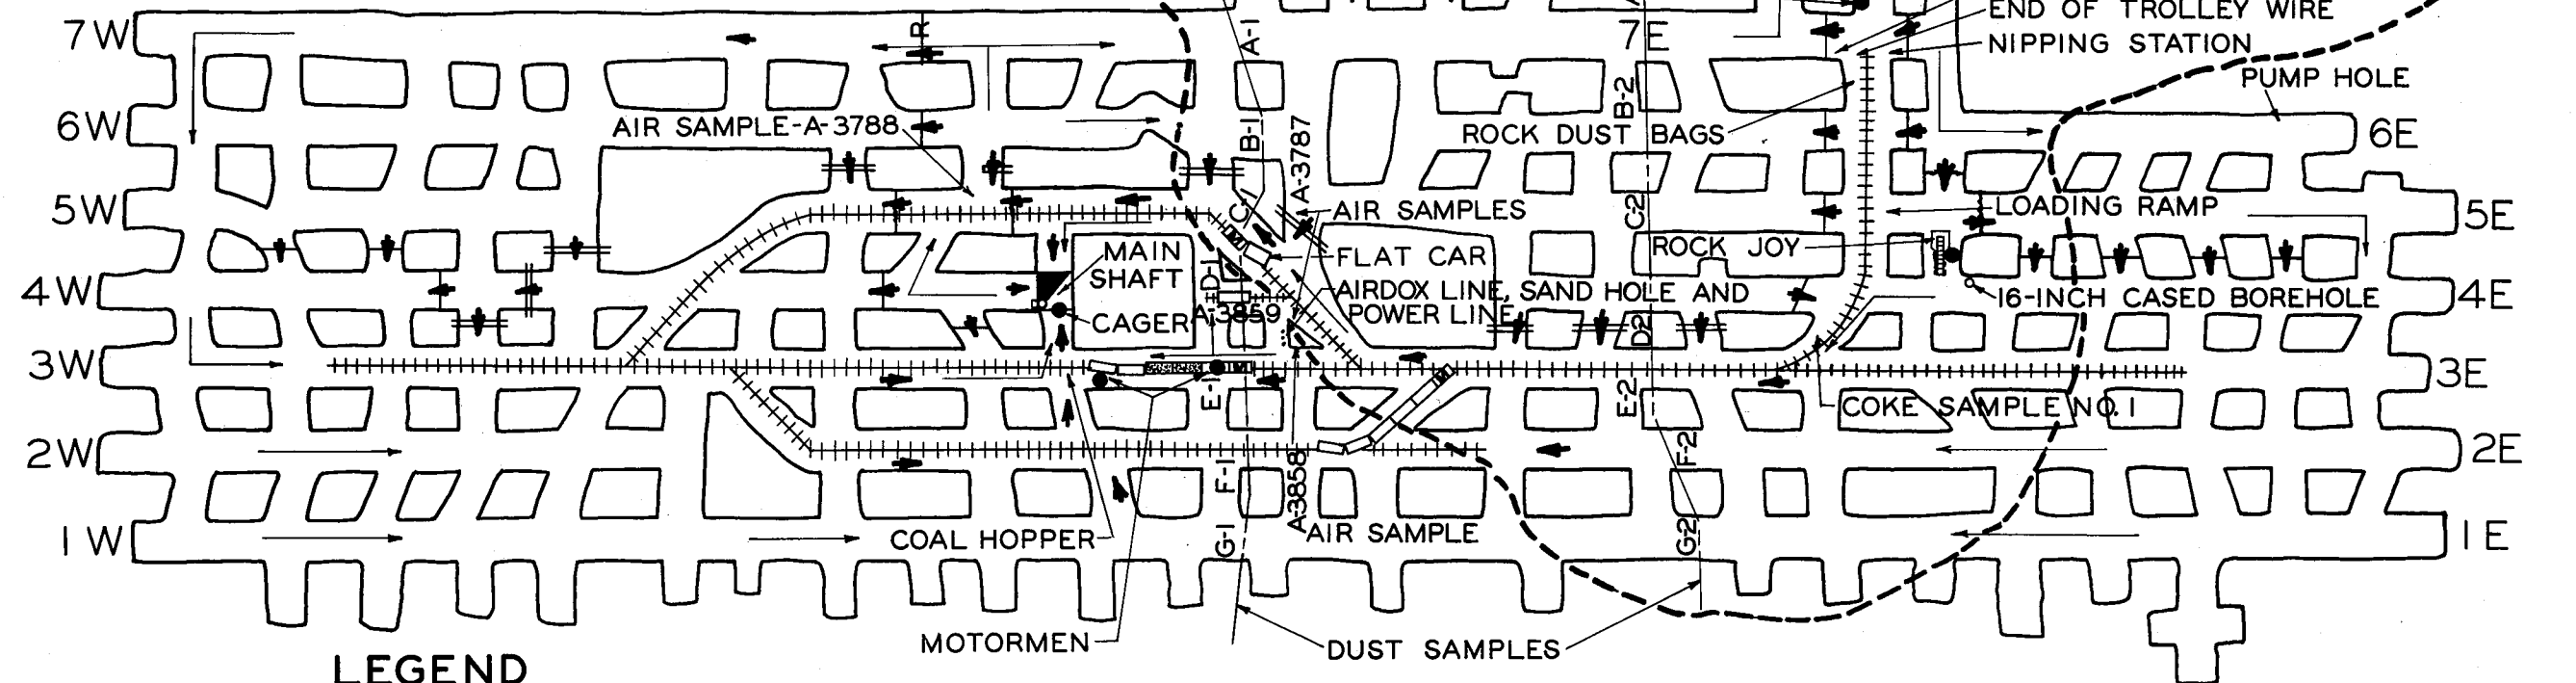
MINE EXPLOSION-JANUARY 10, 1962

Flame: Evidence of heat and flame, in the form of coke, soot or partly burned paper, canvas and wood, was observed in the north working section, in the abandoned north entry panel, in the main east entries about 100 feet inby and about 350 feet outby the north working section. (See Appendix B).

Probable Point of Origin: The consensus of the Bureau of Mines investigators is that the explosion originated at the last crosscut turned north off No. 2 room off 3 north where the shuttle car was being repaired.

room 2 off 3 north entry at the entrance to the second north crosscut. Methane apparently entered the ventilating current from the abandoned north panel that had been penetrated. The gas was ignited by an arc or spark from the open control panel while repairs were being made on the shuttle car. Coal dust in the immediate area entered into the explosion, which then picked up all the fuel necessary for propagation from the accumulations of coal throughout the north working section.

NOTE:
FORCES EXTENDED THROUGHOUT THE ENTIRE MINE.
THE GREATEST FORCES WERE NEAR AND AT THE
BOTTOM OF THE MAIN SHAFT.
