**Accident Investigation Report
Surface Nonmetal Mine**

Fatal Falling/Sliding Material Accident

**Bullitt County Stone Company
Rogers Group, Incorporated-Bullitt County Stone Company
Shepherdsville, Bullitt County, Kentucky
I.D. No. 15-00008**

July 17, 1996

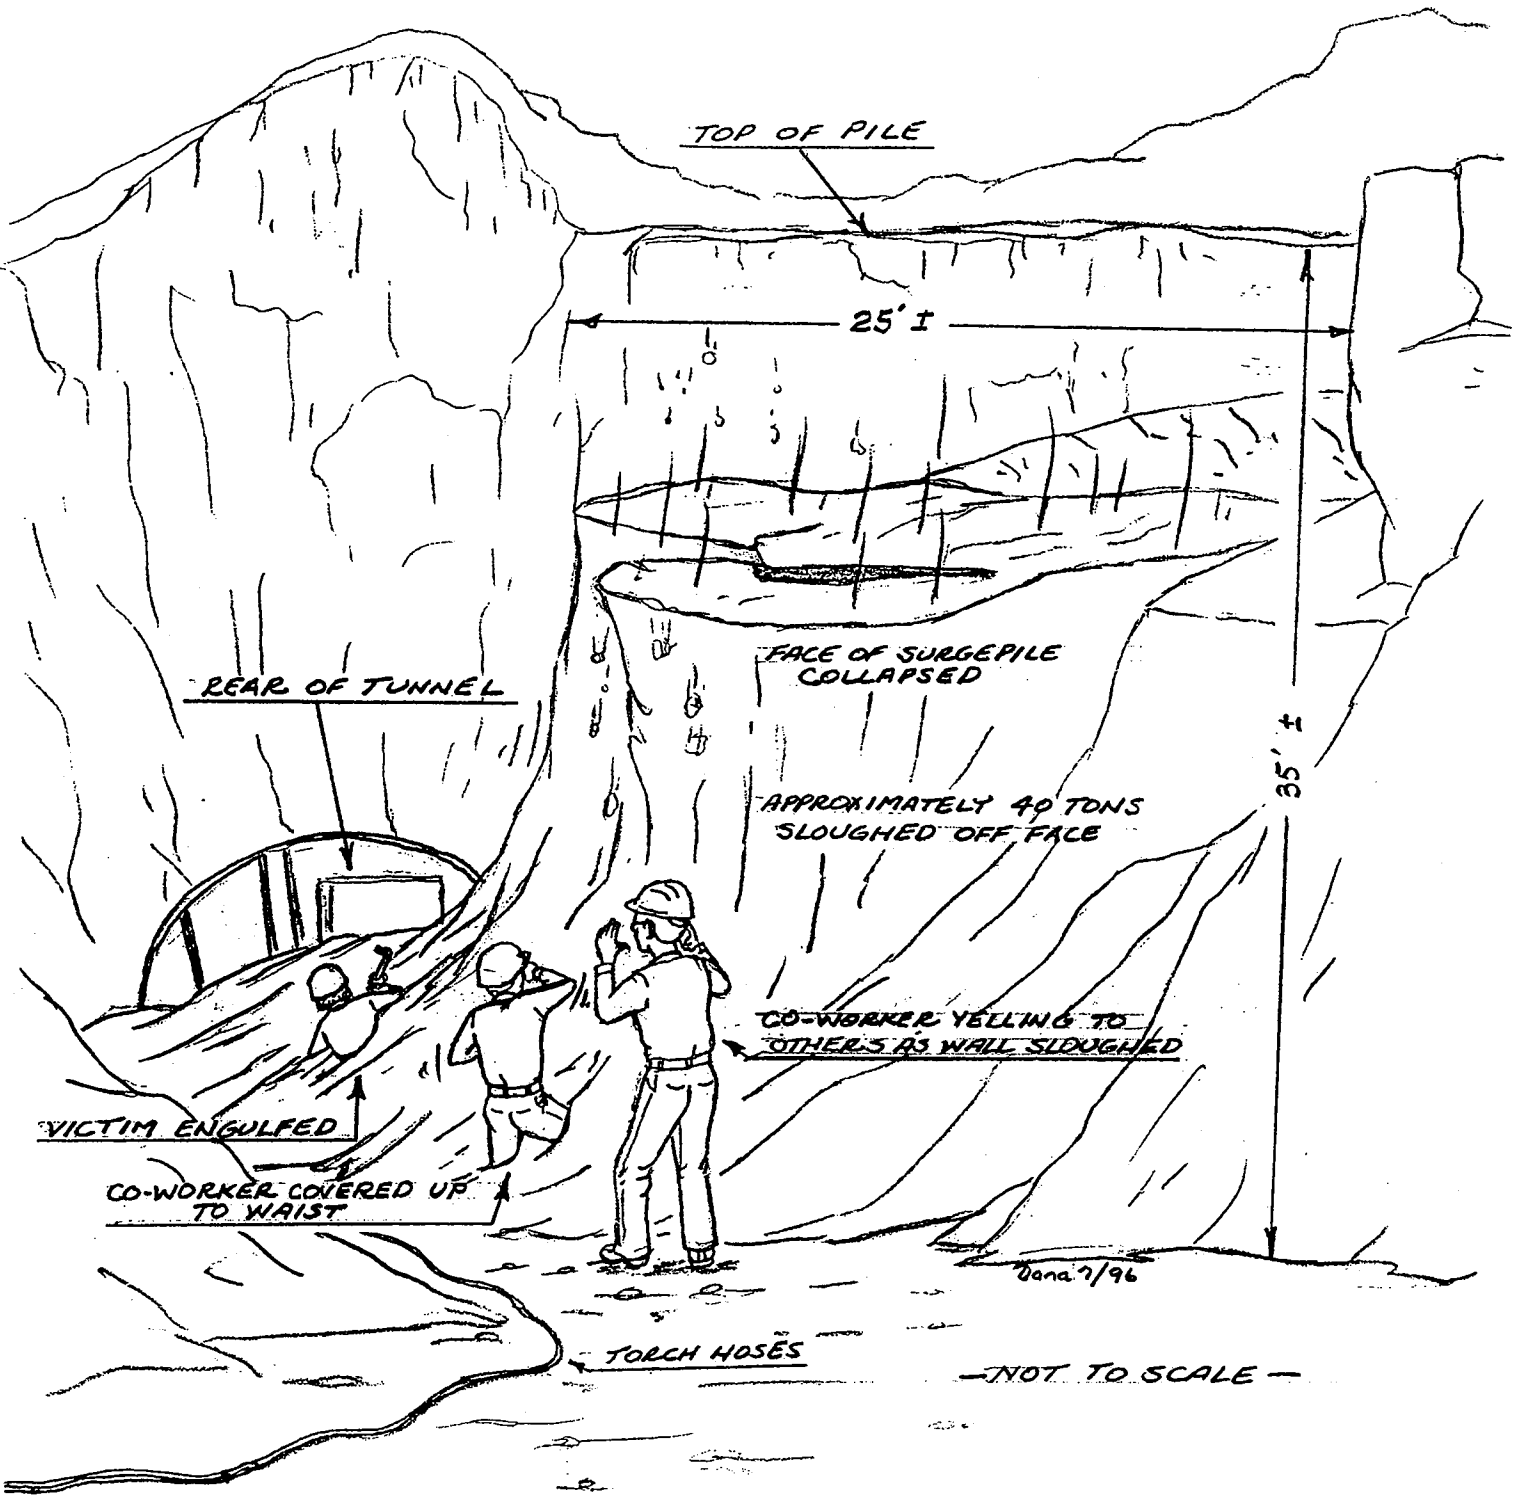
FACE OF SURGE PILE COLLAPSED

APPROXIMATELY 40 TONS SLOUGHED OFF FACE

CO-WORKER YELLING TO OTHERS AS WALL SLOUGHED

VICTIM ENGULFED

CO-WORKER COVERED UP TO WAIST

The surge pile where the accident occurred consisted of approximately 15,000 tons of dense graded aggregate material. A reclaim tunnel which was constructed of steel, measured 9 feet in diameter, 50 feet long and was under the surge pile. The tunnel declined at an approximate 10-12 degree angle, with the lower end enclosed and housed a conveyor belt which transported material from the surge pile to the pug mill.

Two Michigan front-end loaders, a L270 and a L320, were used to excavate an approximate 25 foot wide cut in the surge pile at the rear of the tunnel to expose the enclosed end of the tunnel. This excavation left vertical banks above and around the tunnel end which were approximately 35 feet high.

Gerwitz had knelt down and began cutting when the right side of the bank sloughed. Smolenski yelled for Gerwitz to get out, but she was unable to escape and was covered by an estimated 40 tons of material. Weber was buried to his waist. Smolenski attempted to uncover him with his hands, but realized that he could not get Weber out. Smolenski ran to the area overlooking the shop and yelled to George Newlin, who immediately radioed for help. A front-end loader was used to free Weber. Approximately 30 minutes later, Gerwitz's body was recovered. She was pronounced dead at the scene by the county coroner. Cause of death was attributed to suffocation.

The cause of the accident was the failure to properly slope or support the stockpile banks that surrounded the pug mill tunnel before entering the area.

A welder was fatally injured when she was buried under a slough of material estimated at 40 tons of dense graded aggregate. The pug mill operator was partially buried but not seriously injured. The welder was in the process of cutting out the metal plate at the end of the surge tunnel when the slide of material occurred. The back wall had not been sloped or supported in any manner.

This citation was terminated on July 19, 1996. The area was barricaded and filled in.
