United States
Department of Labor
Mine Safety and Health Administration
Office of the Administrator
Coal Mine Safety and Health

Report of Investigation
Underground Coal Mine Explosion
McClure No. 1 Mine - I.D. No. 44-04251
Clinchfield Coal Company
McClure, Dickenson County, Virginia
June 21, 1983

Originating Office
Mine Safety and Health Administration
4015 Wilson Boulevard
Arlington, Virginia 22203
Joseph A. Lamonica - Administrator

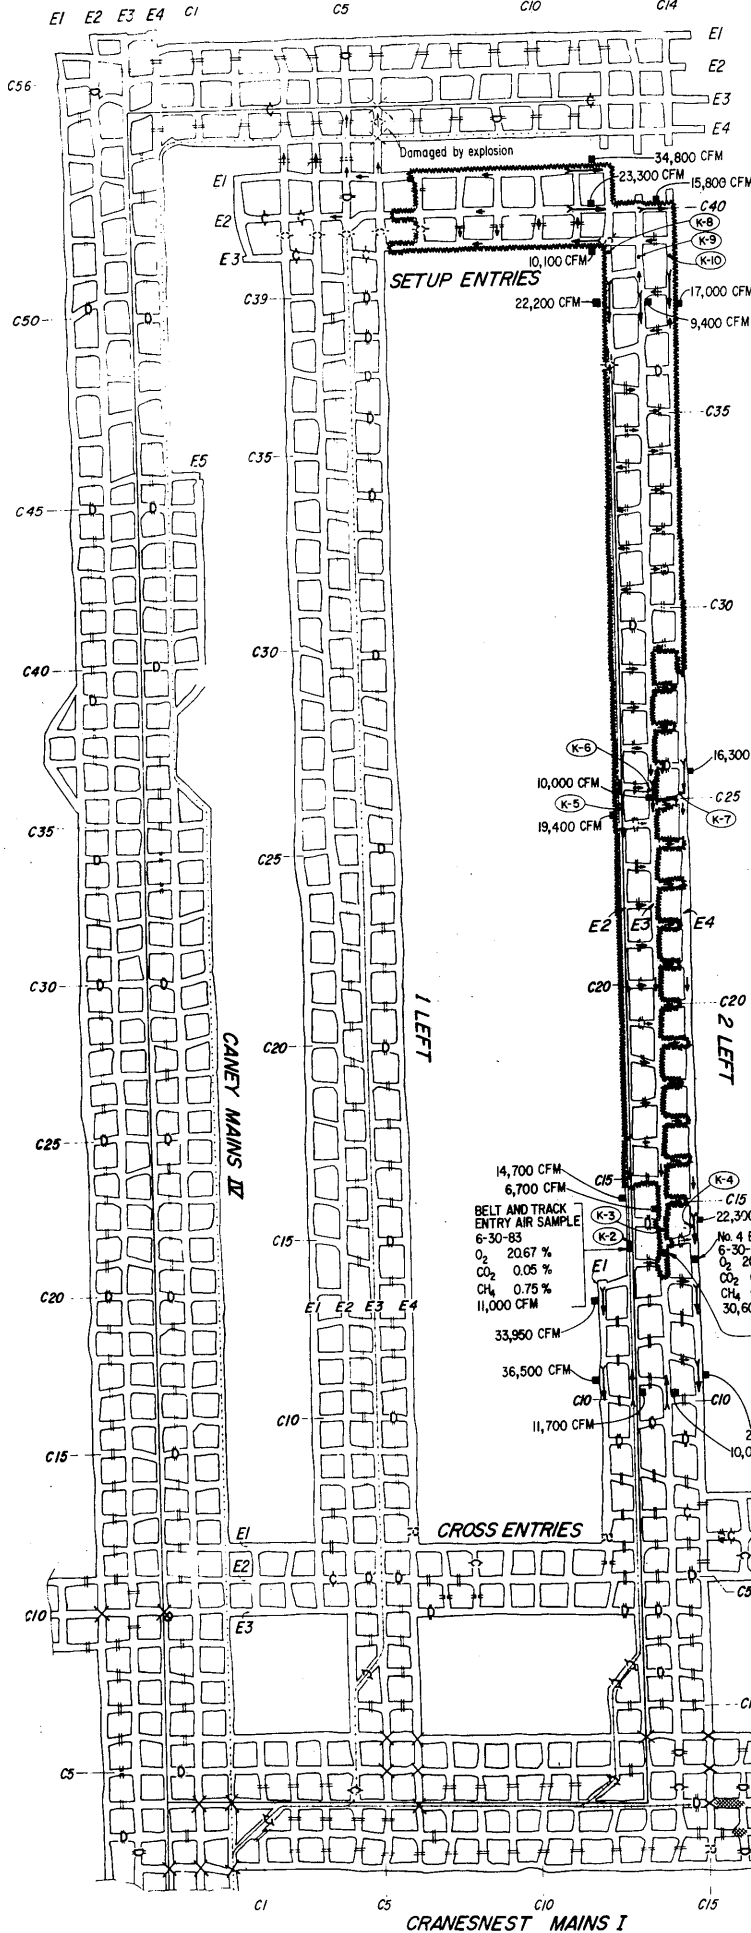
APPENDIX S
McCLURE NO. 1 MINE, ID 44-04251
CLINCHFIELD COAL COMPANY

Map showing direction and extent of major forces, extent of flame, airflow directions and air quantities after explosion.

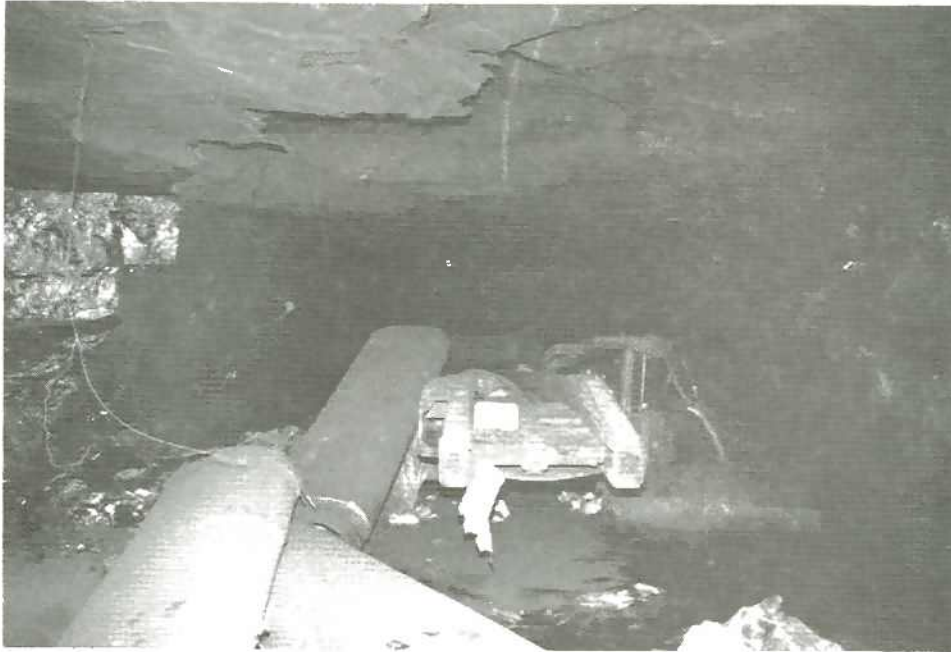
View of continuous mining machine located at the face of the No. 4 entry.

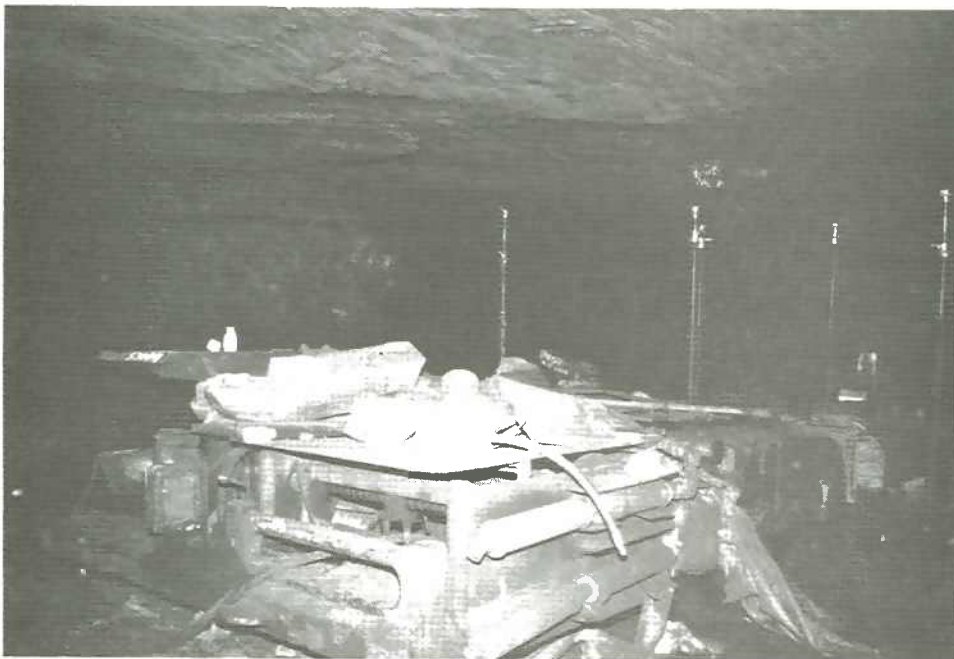
View of roof bolting machine located at the face of the No. 3 entry.

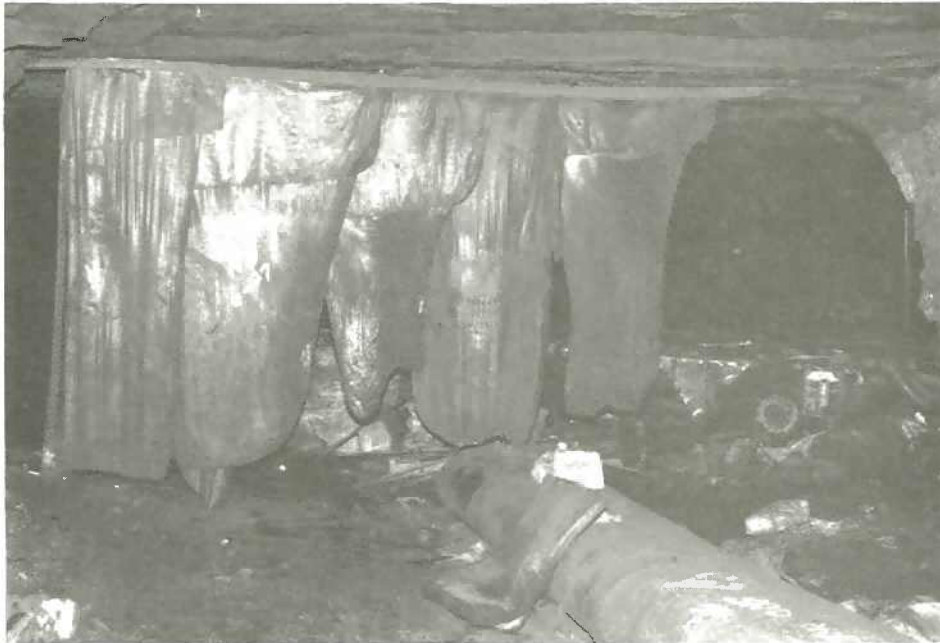
Fly curtain located in the No. 40 crosscut between the Nos. 3 and 4 entries.

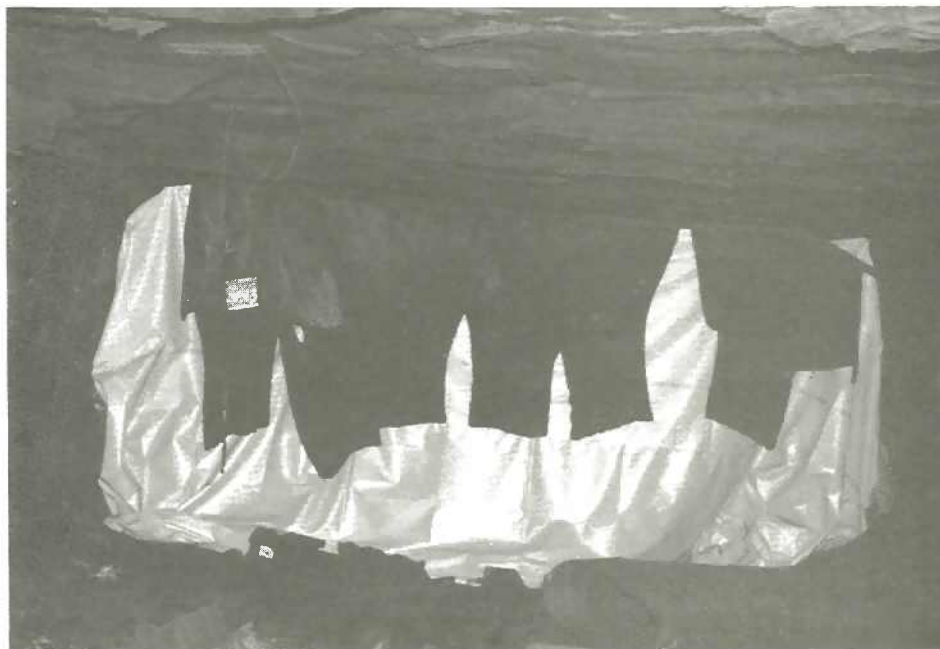
View of the No. 38 crosscut between the Nos. 3 and 4 entries.

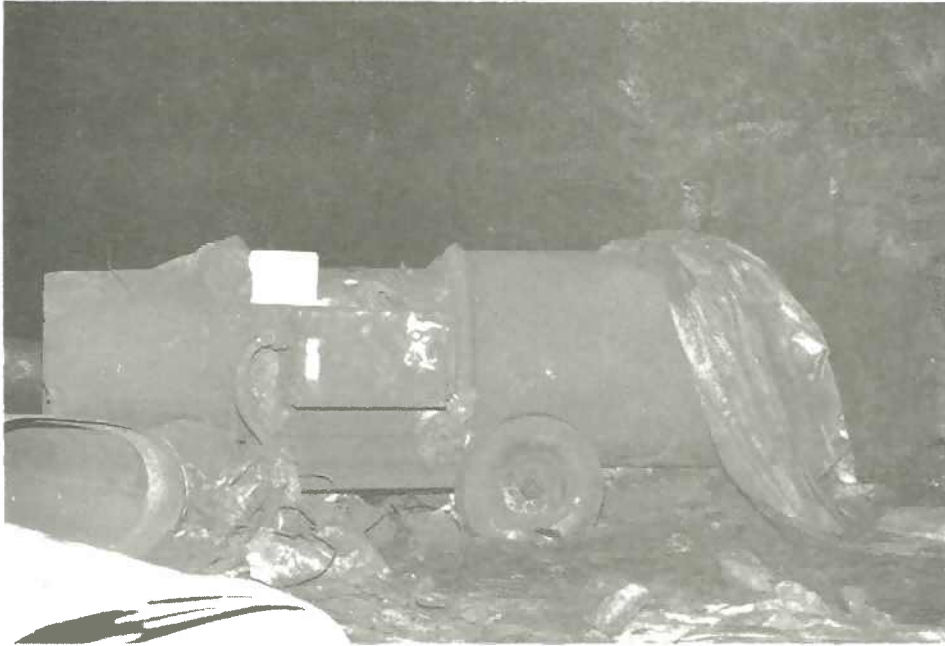
Outby side of auxiliary fan located in the No. 4 entry.

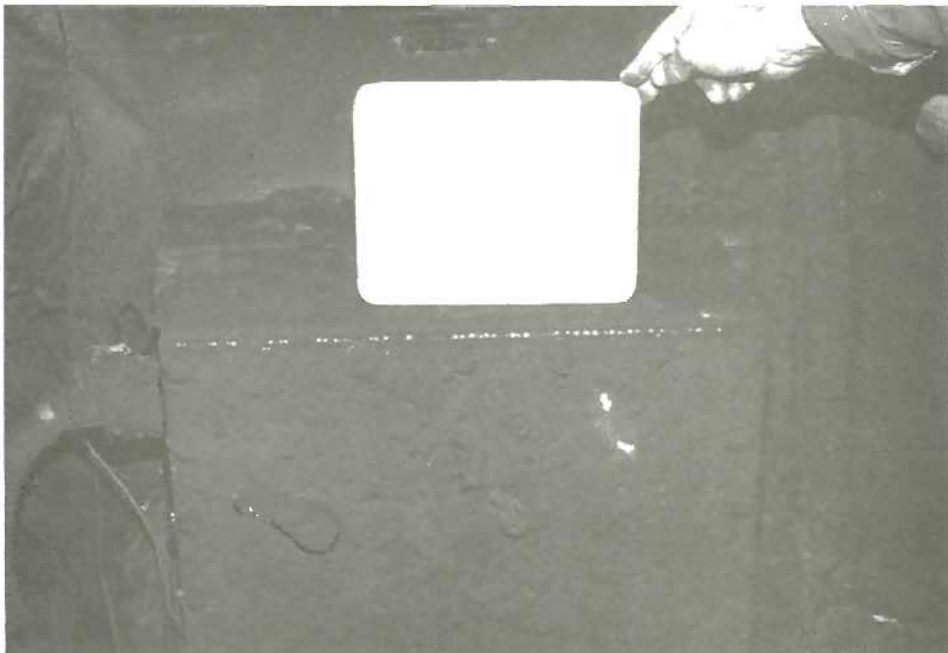
Auxiliary fan controller enclosure located on outby side of fan

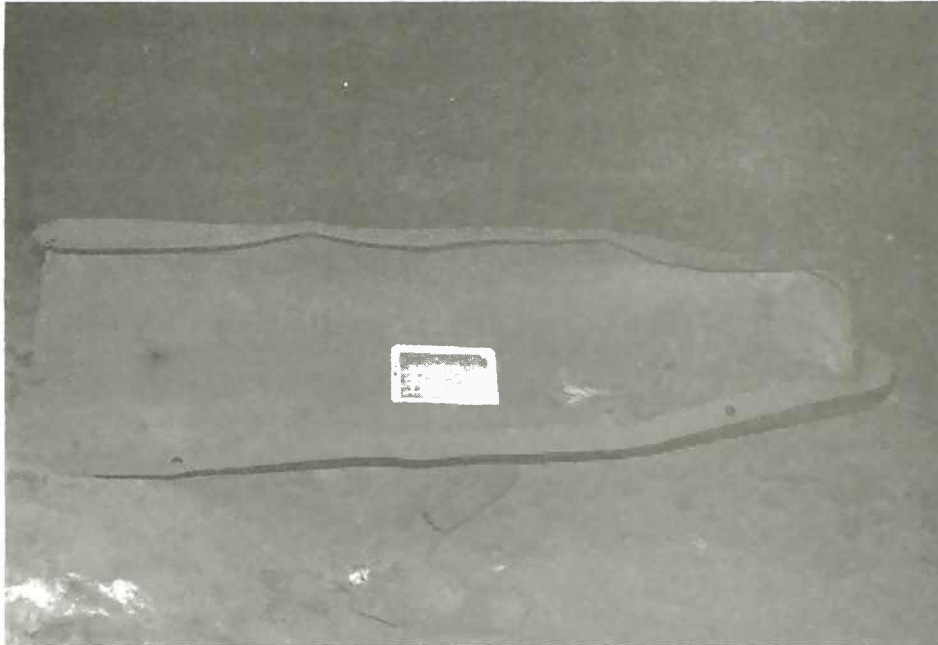
Power center lid found in the No. 3 entry
35 feet inby the power center.

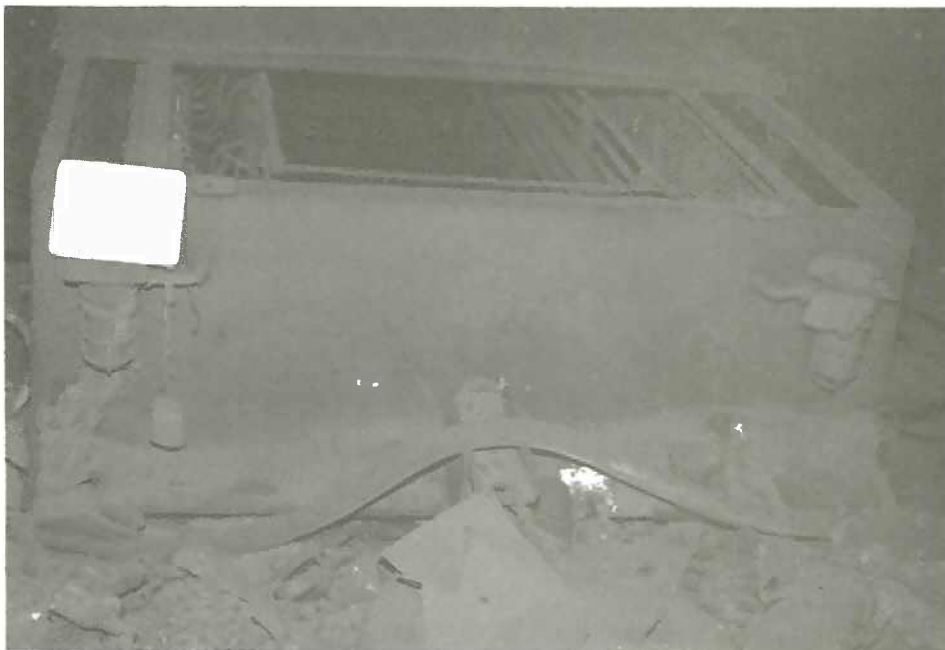
View of the inby end of power center.

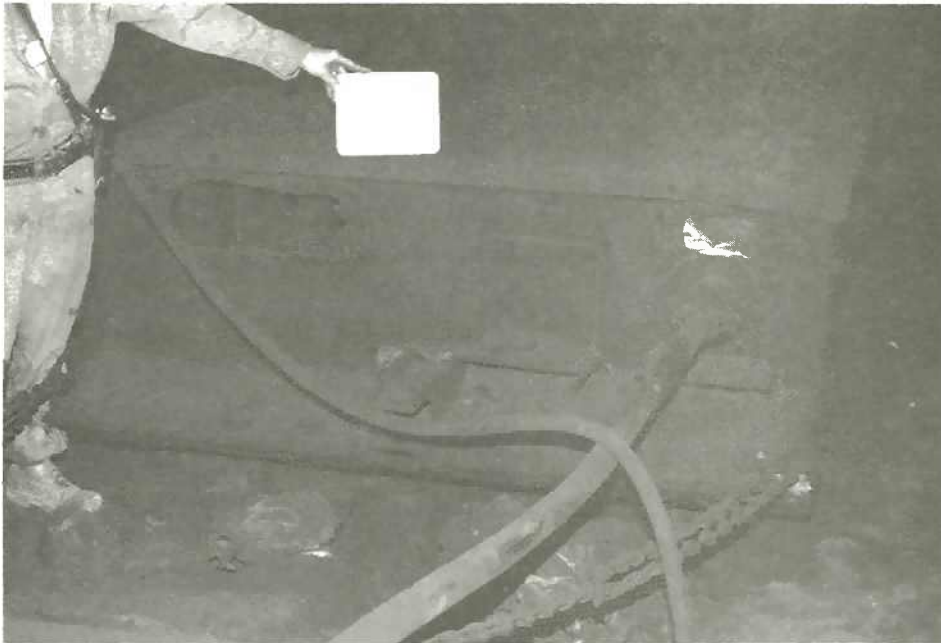
View of the outby end of power center.

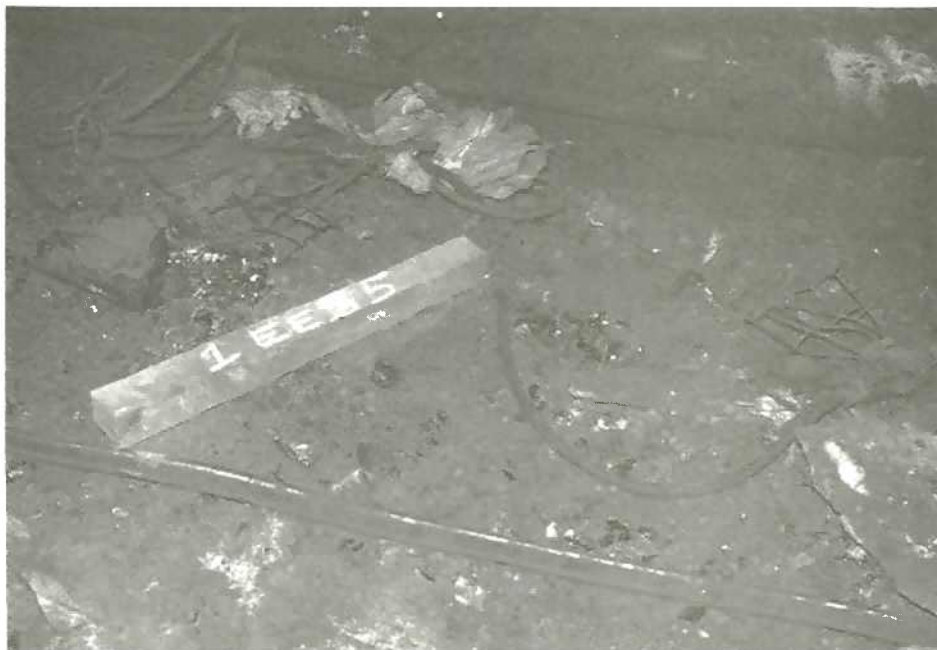
Portion of the power center lighting circuit and supply cable marked "Dinner Hole Lights" found 150 feet inby the power center.

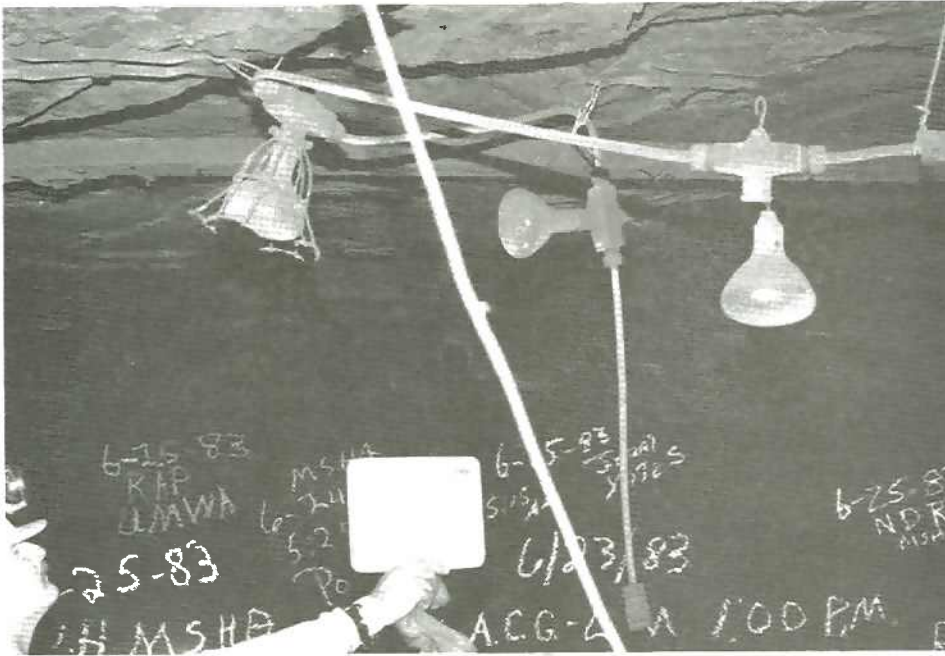
Incandescent lights hanging in dinner hole.

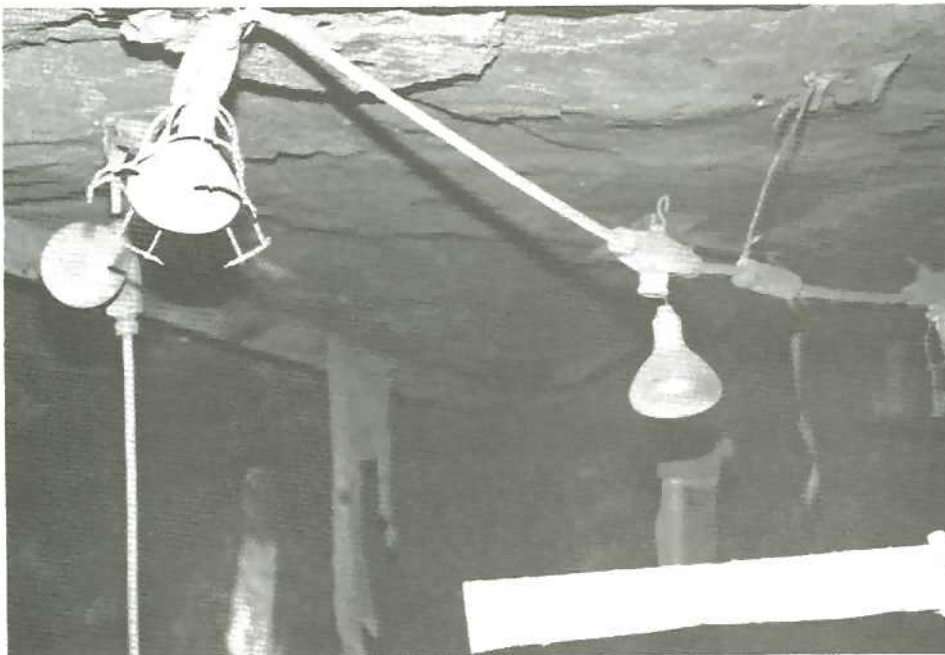
Incandescent lights hanging in dinner hole.

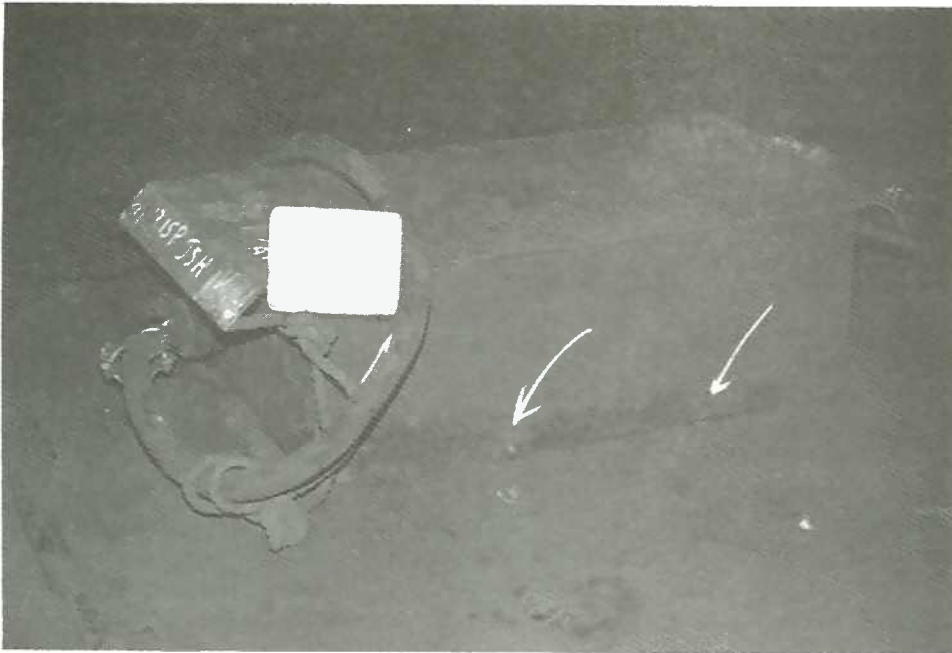
High-voltage splice box found in the No. 3 entry approximately 140 feet outby it's original location.

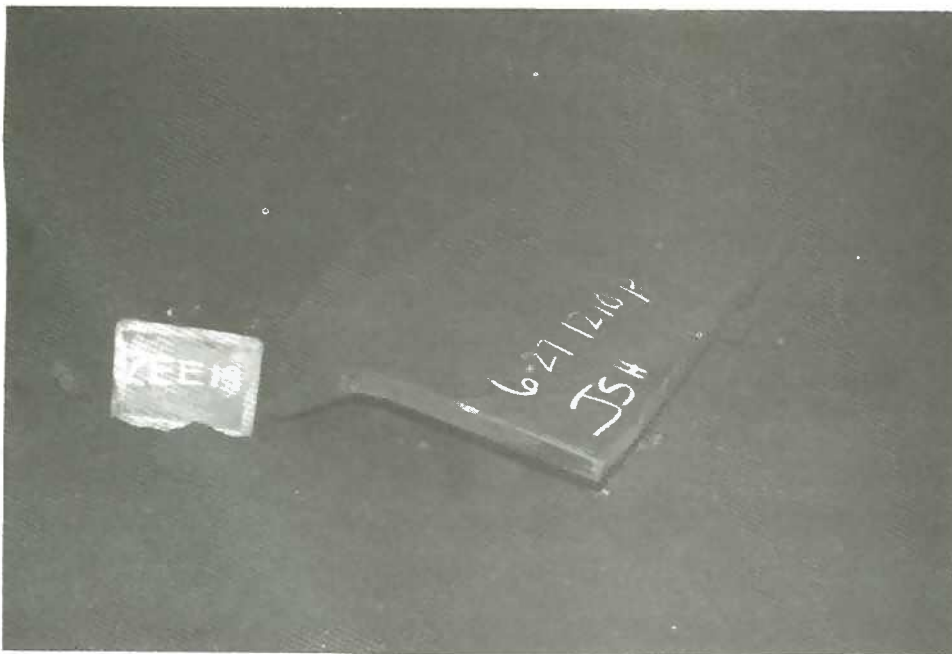
Lid to high-voltage splice box found in the intersection of the No. 3 entry and the No. 24 Left crosscut, 200 feet outby it's original location.

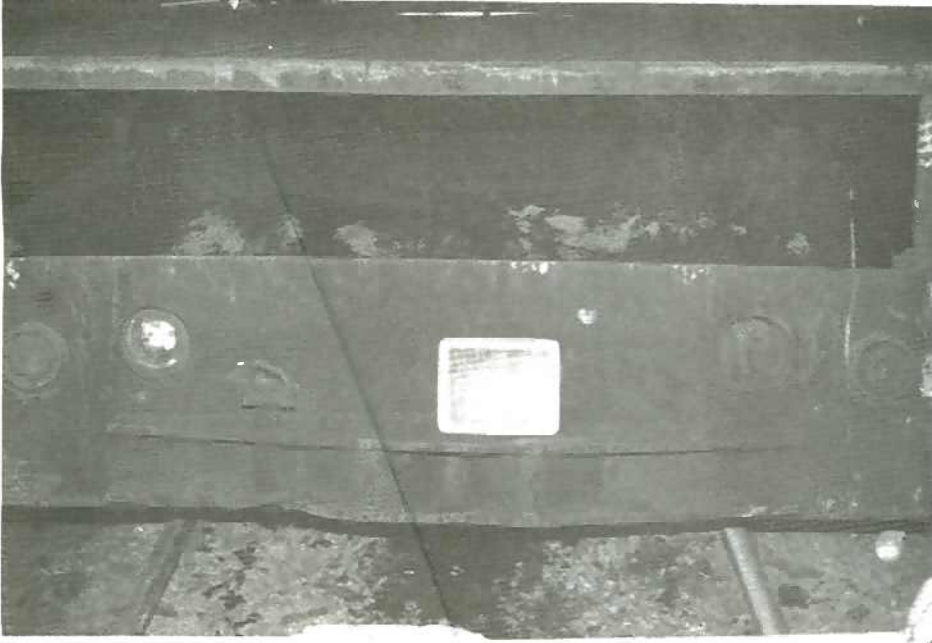
Outby end of the 2 Left section personnel carrier.

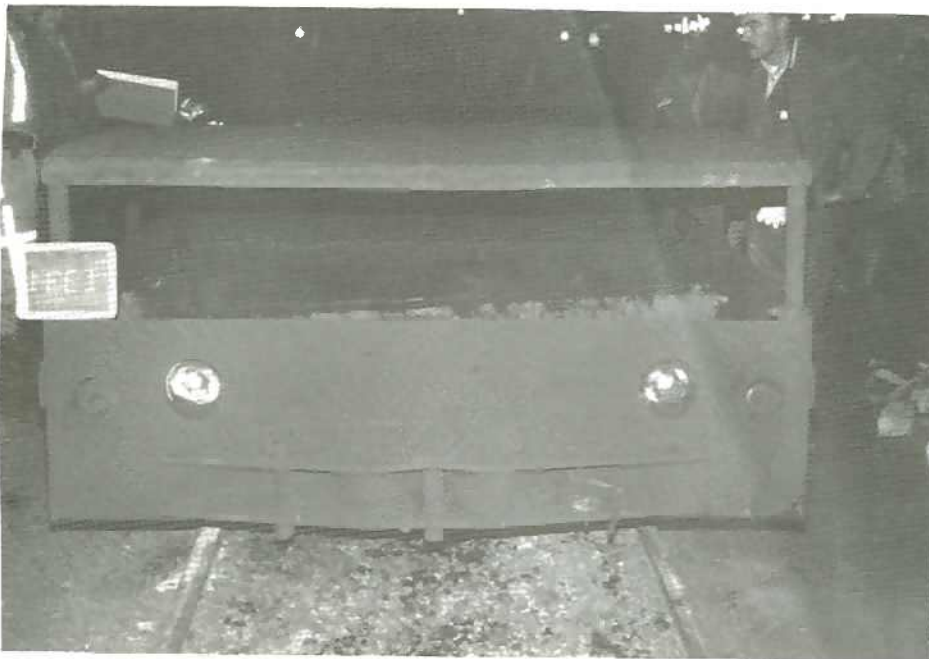
Inby end of the 2 Left section personnel carrier.
