Accident Investigation Report

**REPORT OF FATAL HAULAGE (TRUCK) ACCIDENT
NEVADA MOLY
BROWN AND ROOT, INC.
TONOPAH, NYE COUNTY, NEVADA**

March 29, 1981

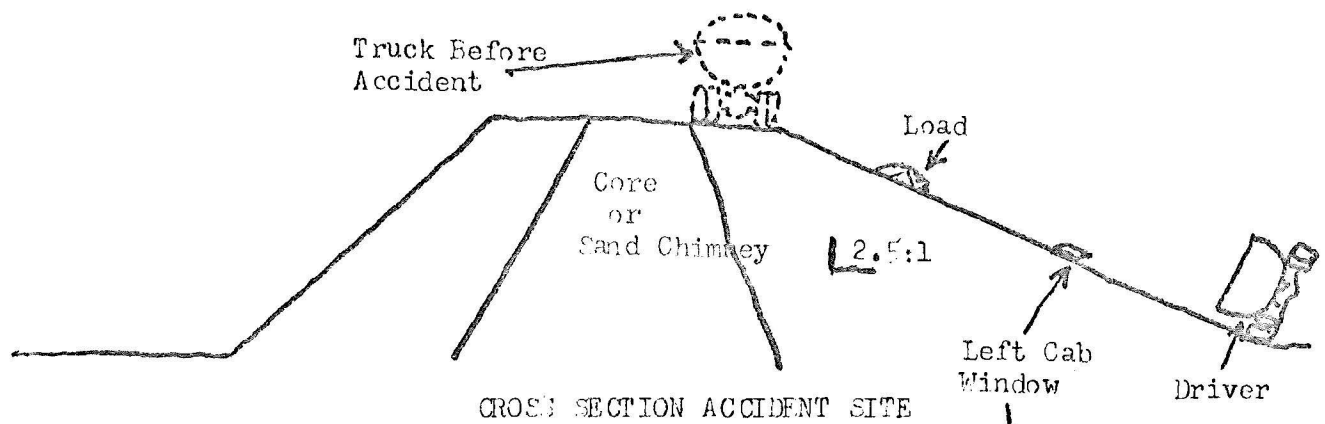
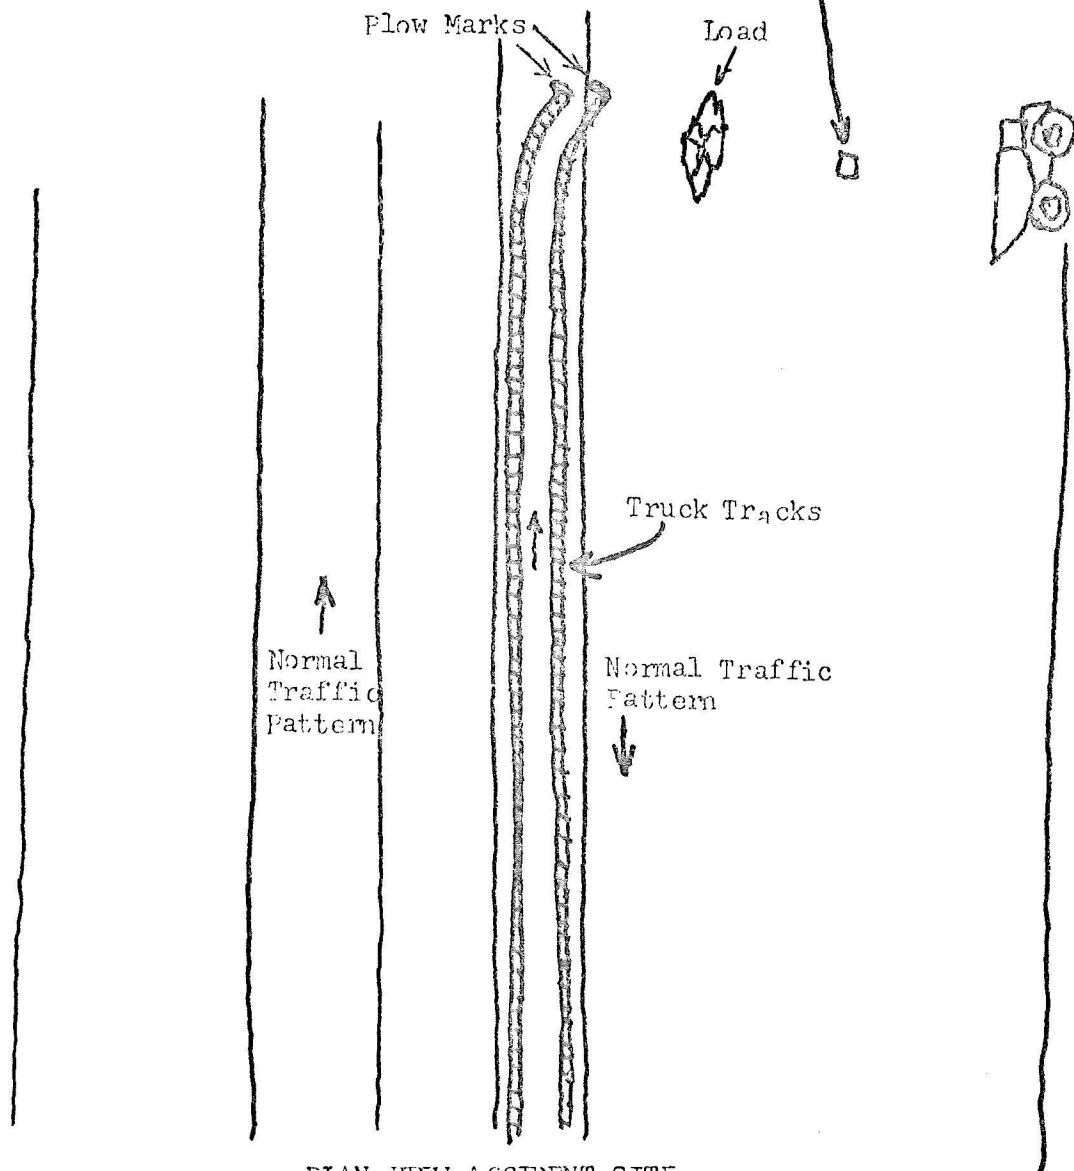
PLAN VIEW ACCIDENT SITE
Not to Scale

Robbins' truck was loaded in the pit, and she drove down the road to the fill, up the approach ramp, made a left turn, and then along the fill on the downstream side of the fill. She was not only on the wrong side of the dam, but driving in a backward traffic pattern. She was in the right-hand pattern or normal highway pattern.

Robbins' truck followed a small berm/ditch for some 250 feet. It gradually drifted to the right catching the berm. The right front wheel dropped off the compacted edge. From the tracks, it appeared Robbins realized she was in trouble and attempted to steer the truck back on the road. Plow marks were evident at the end of the tracks. The truck rolled over, lost the load, rolled again, lost the cab window, rolled a third time, coming to rest at the toe of the dam on its left side. Robbins' head was pinned between the cab and rock guard portion of the bed. She was under the truck. Two eyewitnesses saw the truck go over the edge.
