UNITED STATES DEPARTMENT OF LABOR MINE SAFETY AND HEALTH ADMINISTRATION Metal and Nonmetal Safety and Health

REPORT OF INVESTIGATION

Fatal Powered Haulage Accident November 3, 2018

O-N Minerals (Michigan) Company O-N Minerals, Cedarville Operation Cedarville, Mackinac County, Michigan Mine I.D. 20-00061

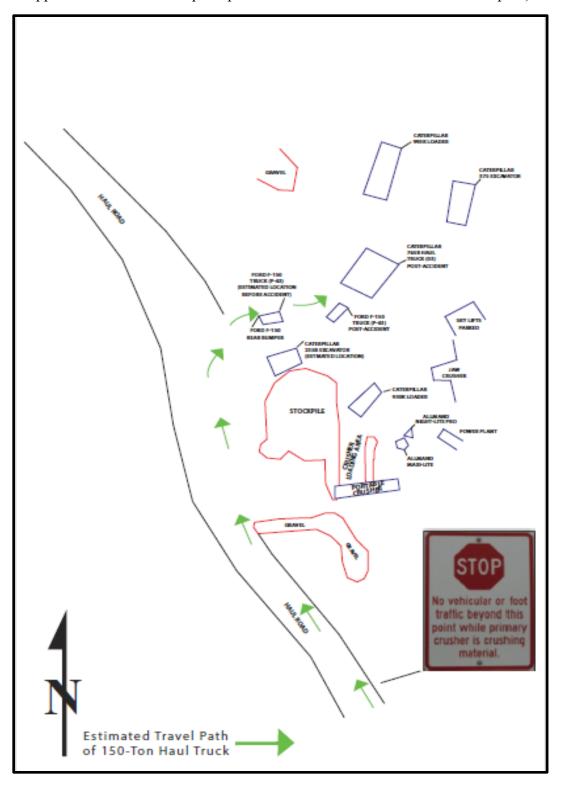
APPENDIX B Map of the Accident Site

The accident occurred in a stockpile area, north of the portable crushing plant and west of the primary jaw crusher. The terrain at the accident scene was relatively level. (See Appendix B)

(The map provided in the investigation was enhanced so as to provide more details in the approximate location the pickup truck was struck and 150-ton haul truck path)
