UNITED STATES
DEPARTMENT OF THE INTERIOR
BUREAU OF MINES

FINAL REPORT OF MAJOR MINE
INRUSH OF HOT GASES AND STEAM
DISASTER

SHERWOOD MINE
INLAND STEEL COMPANY
IRON RIVER, IRON COUNTY, MICHIGAN

June 1, 1959

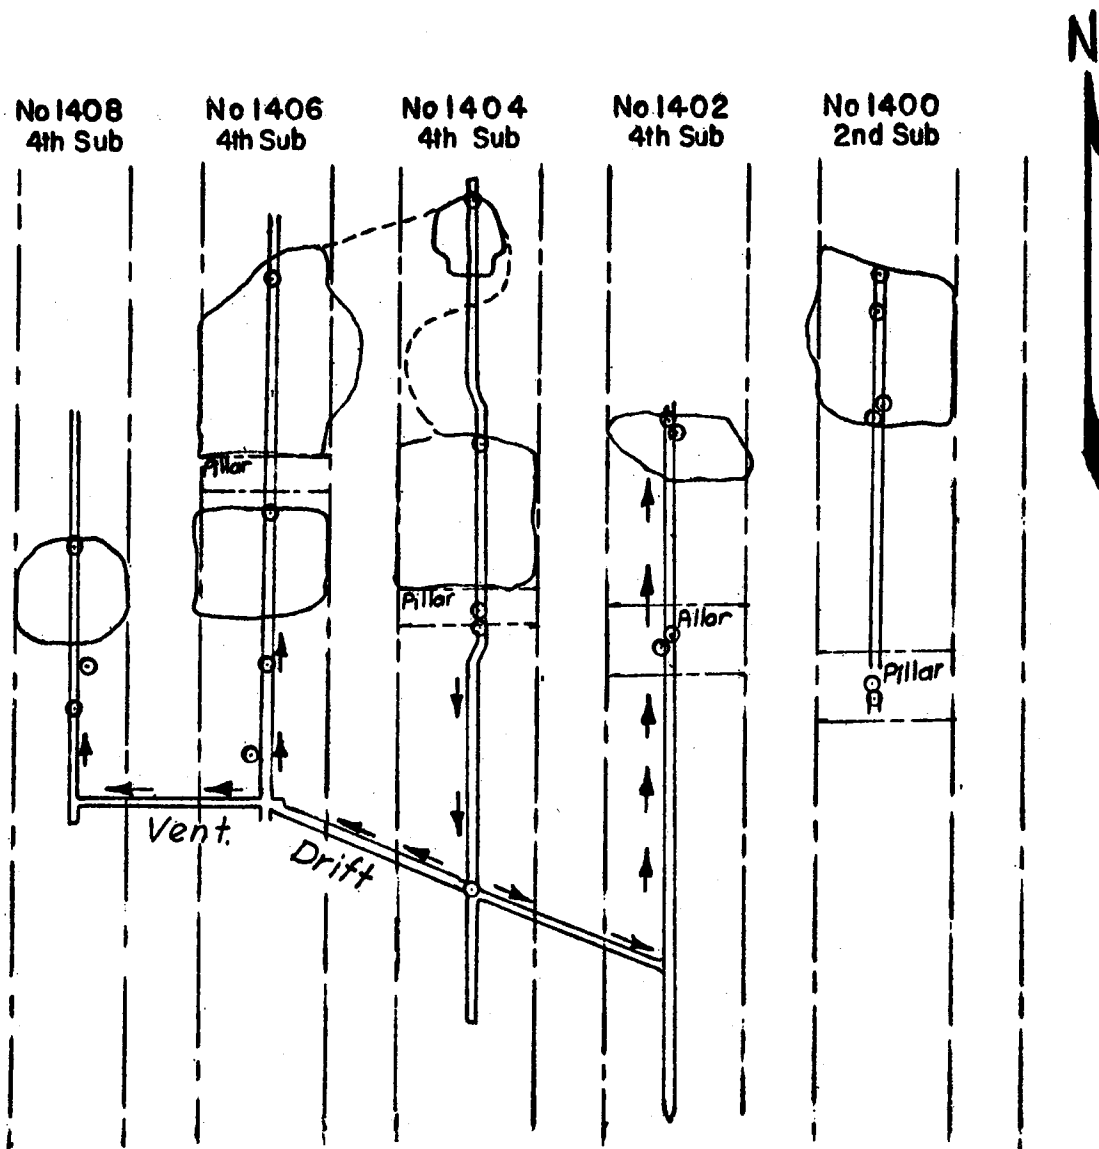
Evidence of mild forces were found 20 feet below the 1200 level in a ventilation drift connecting the top mining sublevels to Nos. 1402, 1404, 1406, and 1408 stopes. Streamlining of fine black dust on the floor of the drift and the bent ends of wire used to support piping, indicated forces entered this area from No. 1404 stope and travelled south to the ventilation drift. Forces travelled both east and west on the ventilation drift and north on each of the dog drifts to Nos. 1402, 1406, and 1408 stopes, (see figure 2). A sample of the fine dust that covered all surfaces in the sublevel was taken from a 4-inch thick layer on the floor in No. 1402 stope dog drift.

Figure 2. — Plan view of 1220 sublevel (ventilation drift) showing direction of forces.

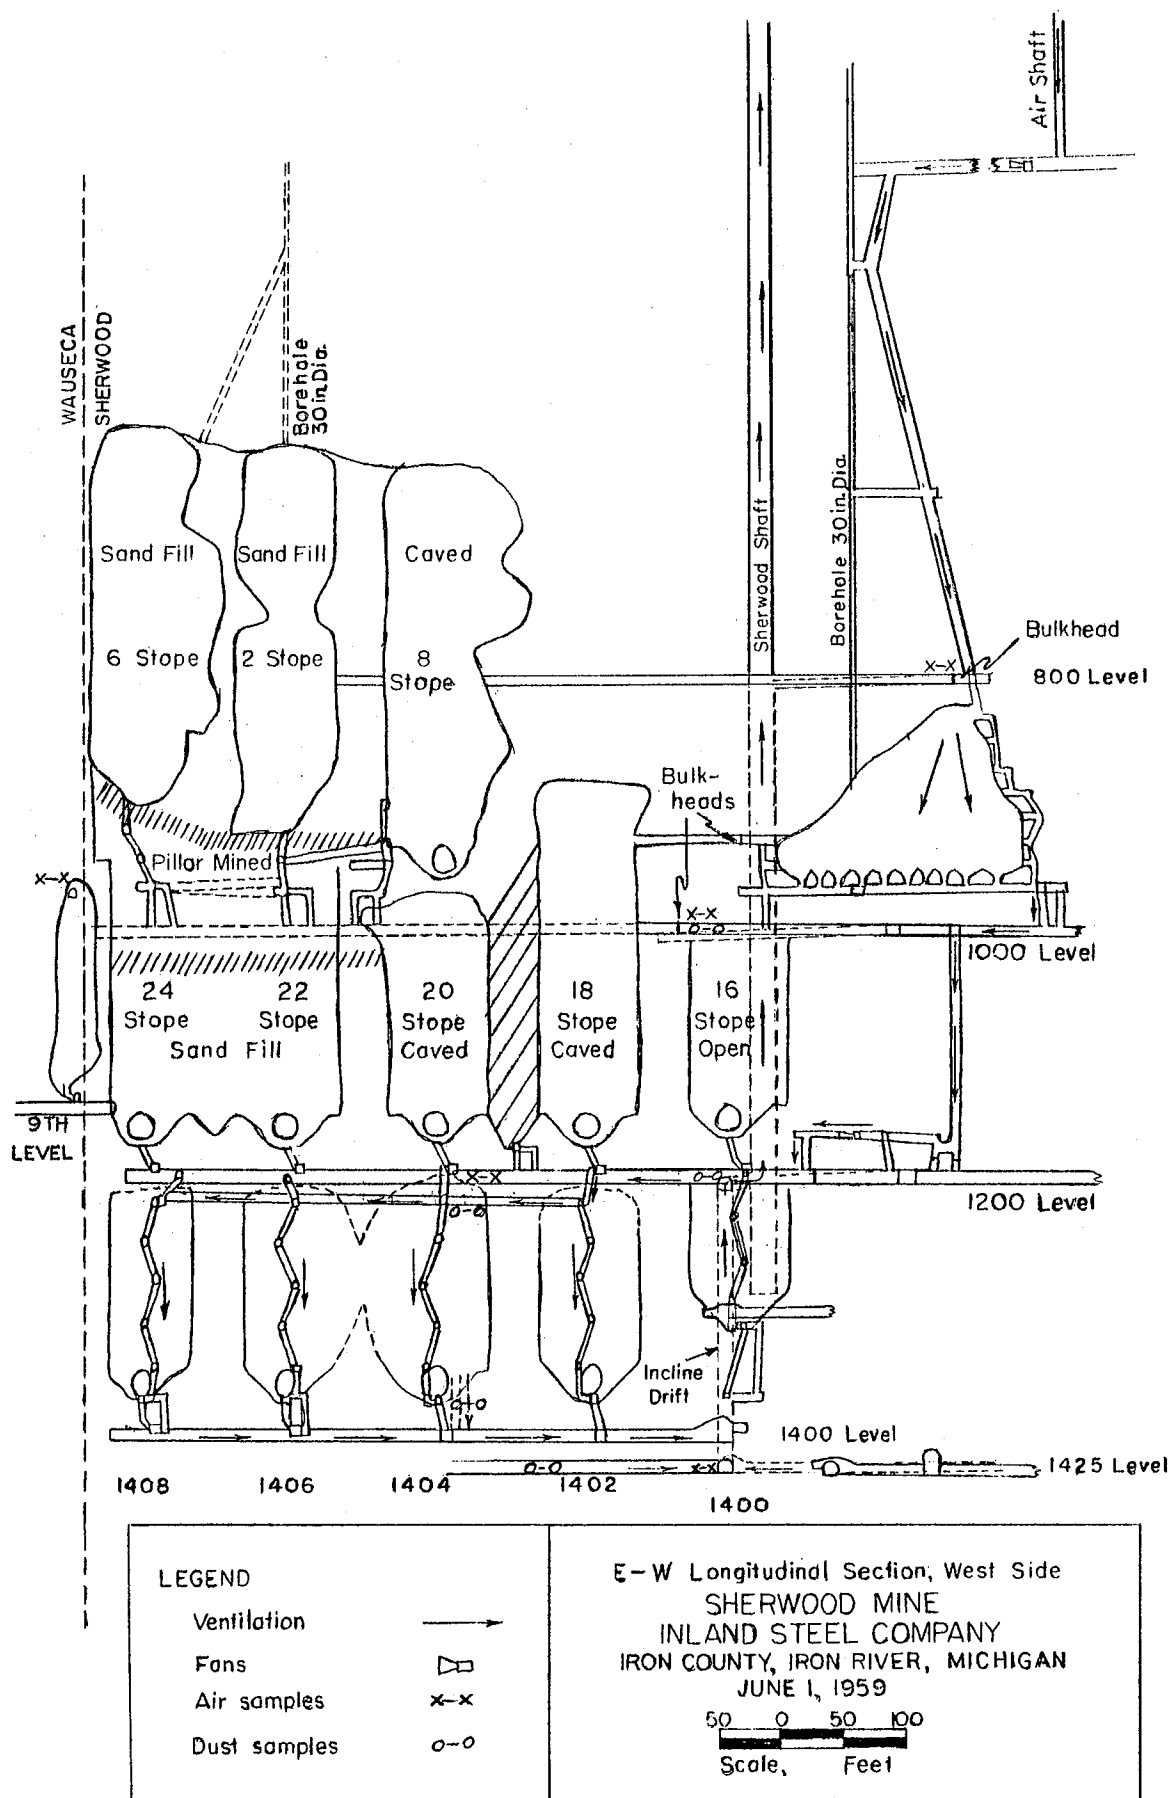
Figure 3

Bureau of Mines' records show that a fire occurred in No. 2 stope on August 4, 1947. Company officials reported that a fire also occurred in the adjacent No. 8 stope (See figure 3), at a later date. This fire area was sealed by erecting

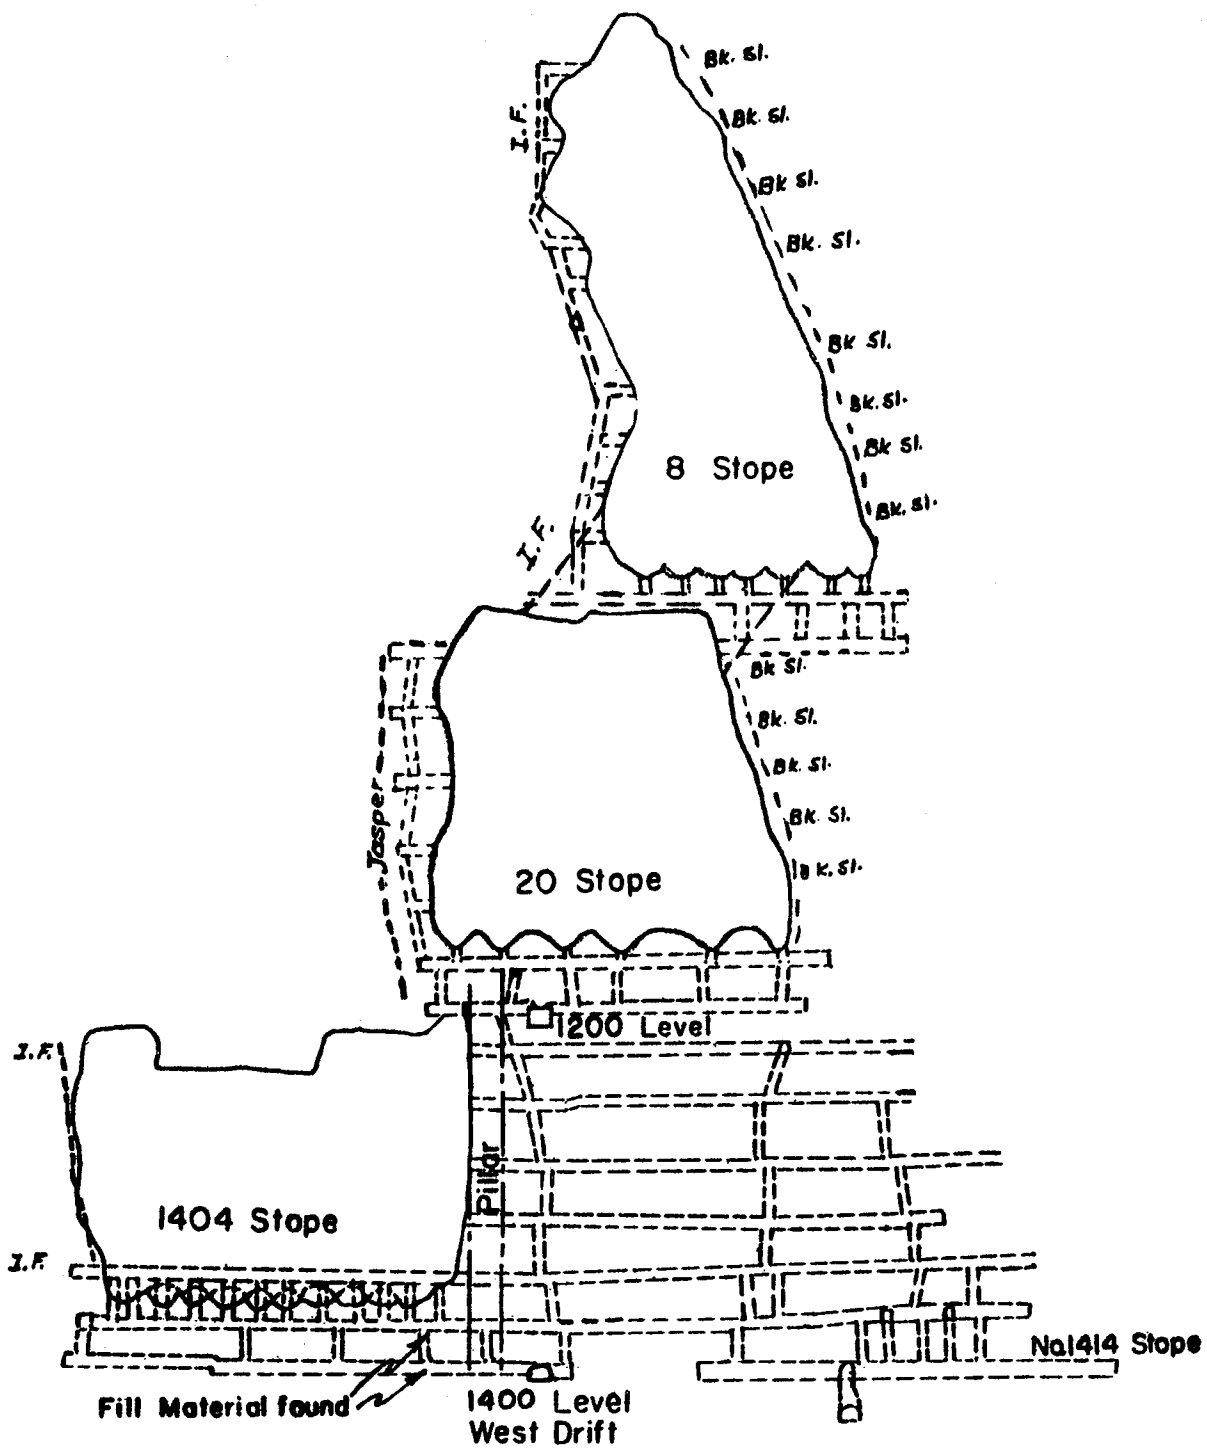
Figure 4.- N-S CROSS SECTION THROUGH 1404 STOPE
LOOKING EAST

Some fill material, which included sand and rounded boulders, was found on the belt and in a chute in the transfer drift and scraping sublevel below No. 1404 stope; however, the back of the stope was examined from the top mining sublevel, and except for a breakthrough into a small drift above the stope, the floor pillar appeared intact. The amount of fill material found was insufficient to account for any great pressures.

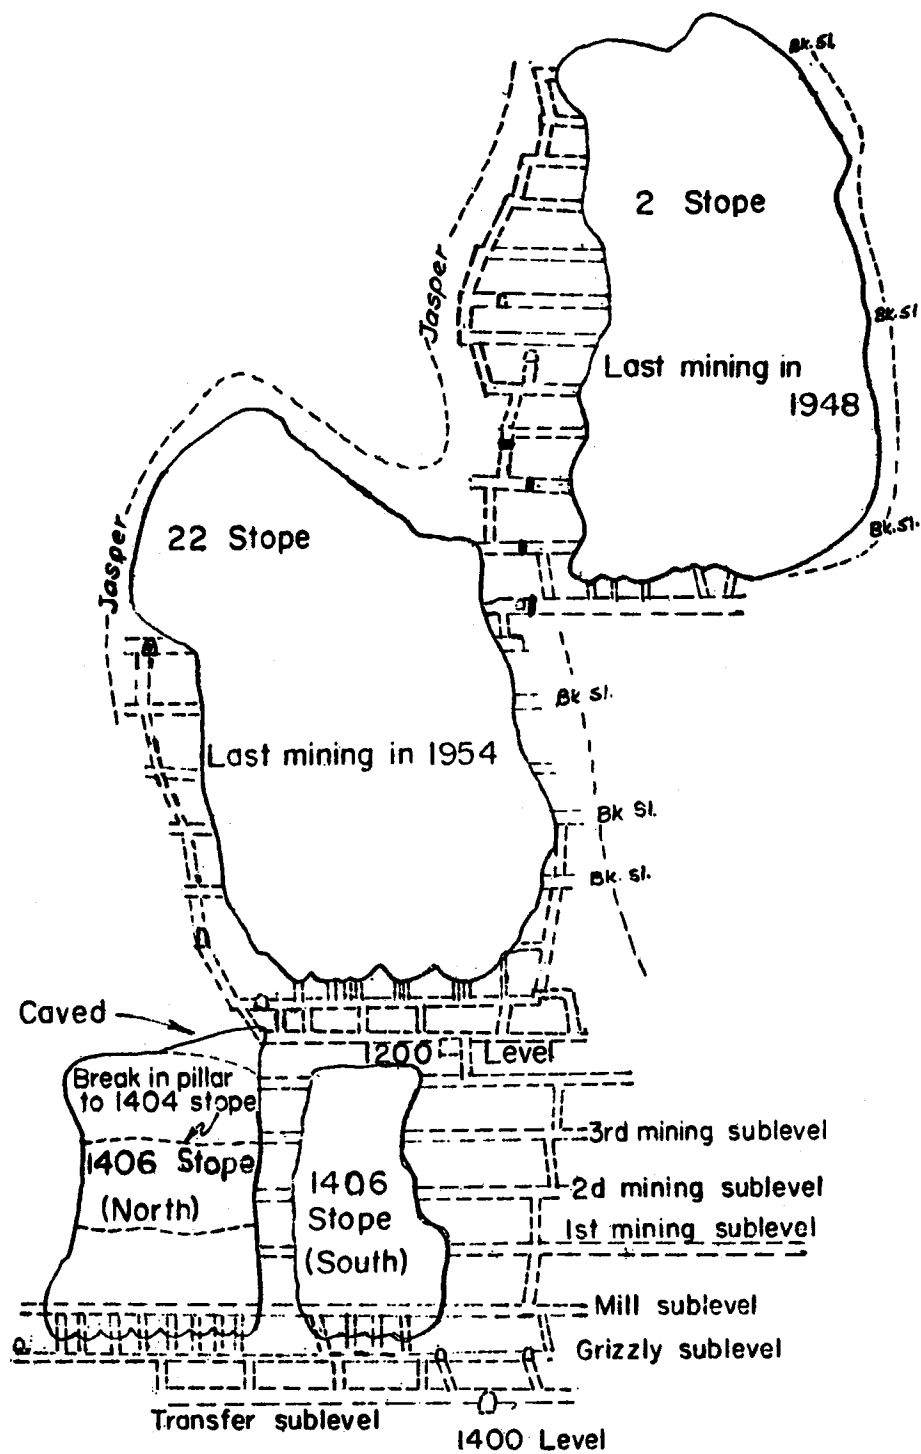
Figure 5.- N-S CROSS SECTION THROUGH I406 STOPE
LOOKING EAST

Company officials reported that, previous to the disaster, caving had occurred from the back of No. 1406 stope north which was the floor pillar under No. 22 stope (see figure 5). It is believed that, at the time of the disaster, this caving broke into No. 22 stope, fill material entered No. 1406 stope north and rolled down the pile and through the break in the pillar into No. 1404 stope and down the mill to the transfer drift where fill material was found. It is further believed that the amount of fill material in these two stopes was sufficient to account for the sound of running material noted by the miners on the 1400 level and cause the initial rush of air.
