FINAL REPORT ON MAJOR EXPLOSION DISASTER
BUNKER MINE
TROTTER COAL COMPANY
CASSVILLE, MONONGALIA COUNTY, WEST VIRGINIA

October 15, 1951

REPORT ON FINDINGS OF INSPECTION
OF ELECTRICAL EQUIPMENT IN EXPLOSION AREA
BUNKER MINE
TROTTER COAL COMPANY
CASSVILLE, MONONGALIA COUNTY, WEST VIRGINIA

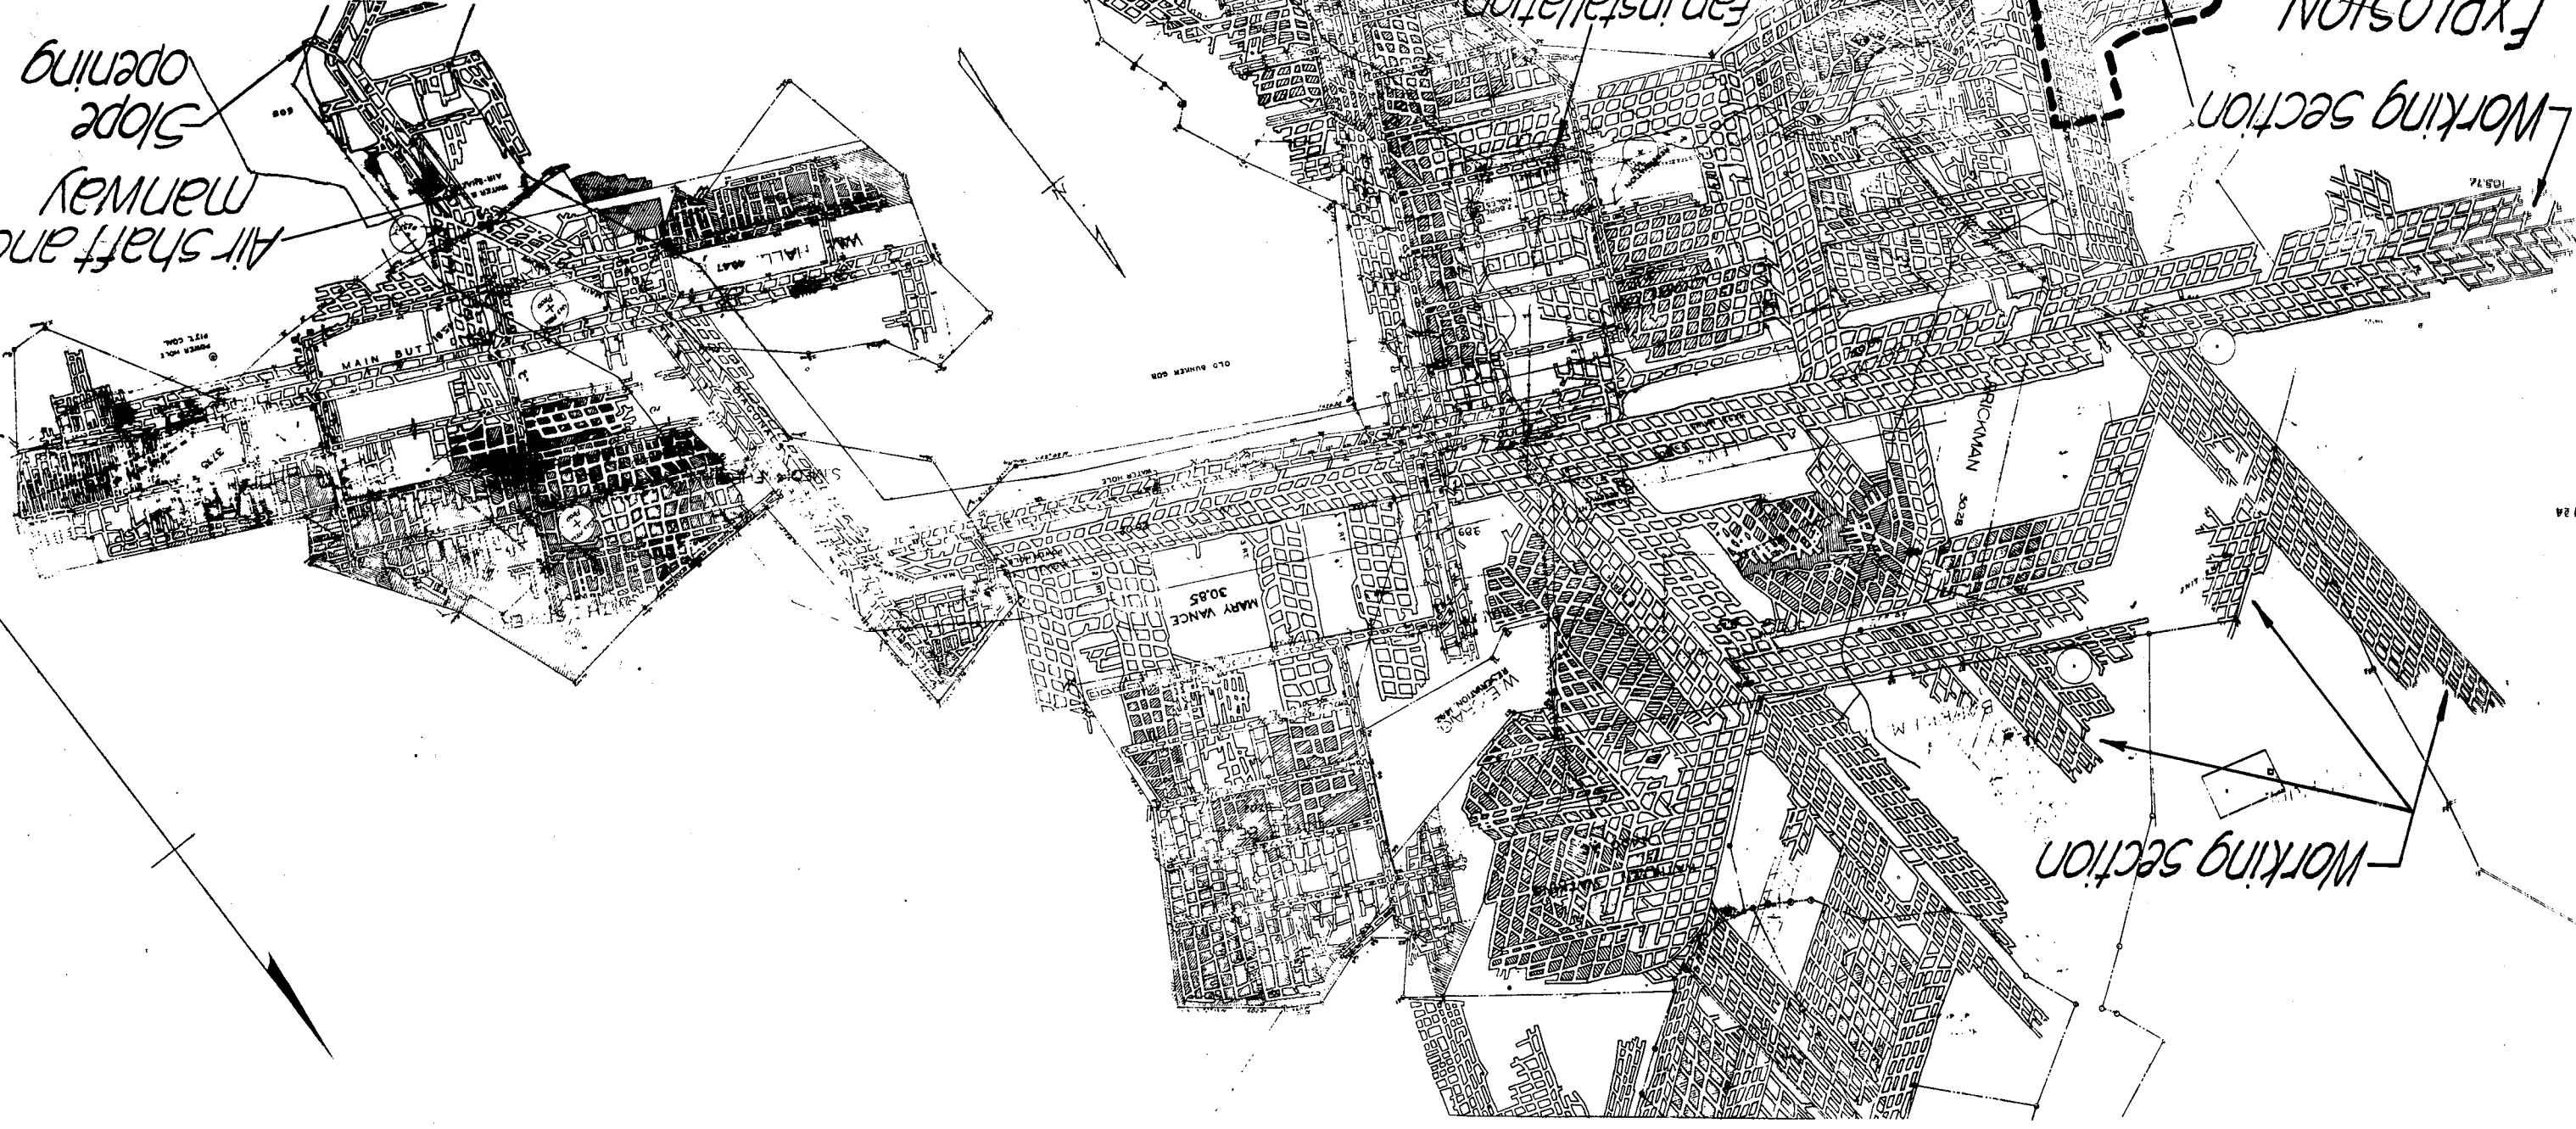
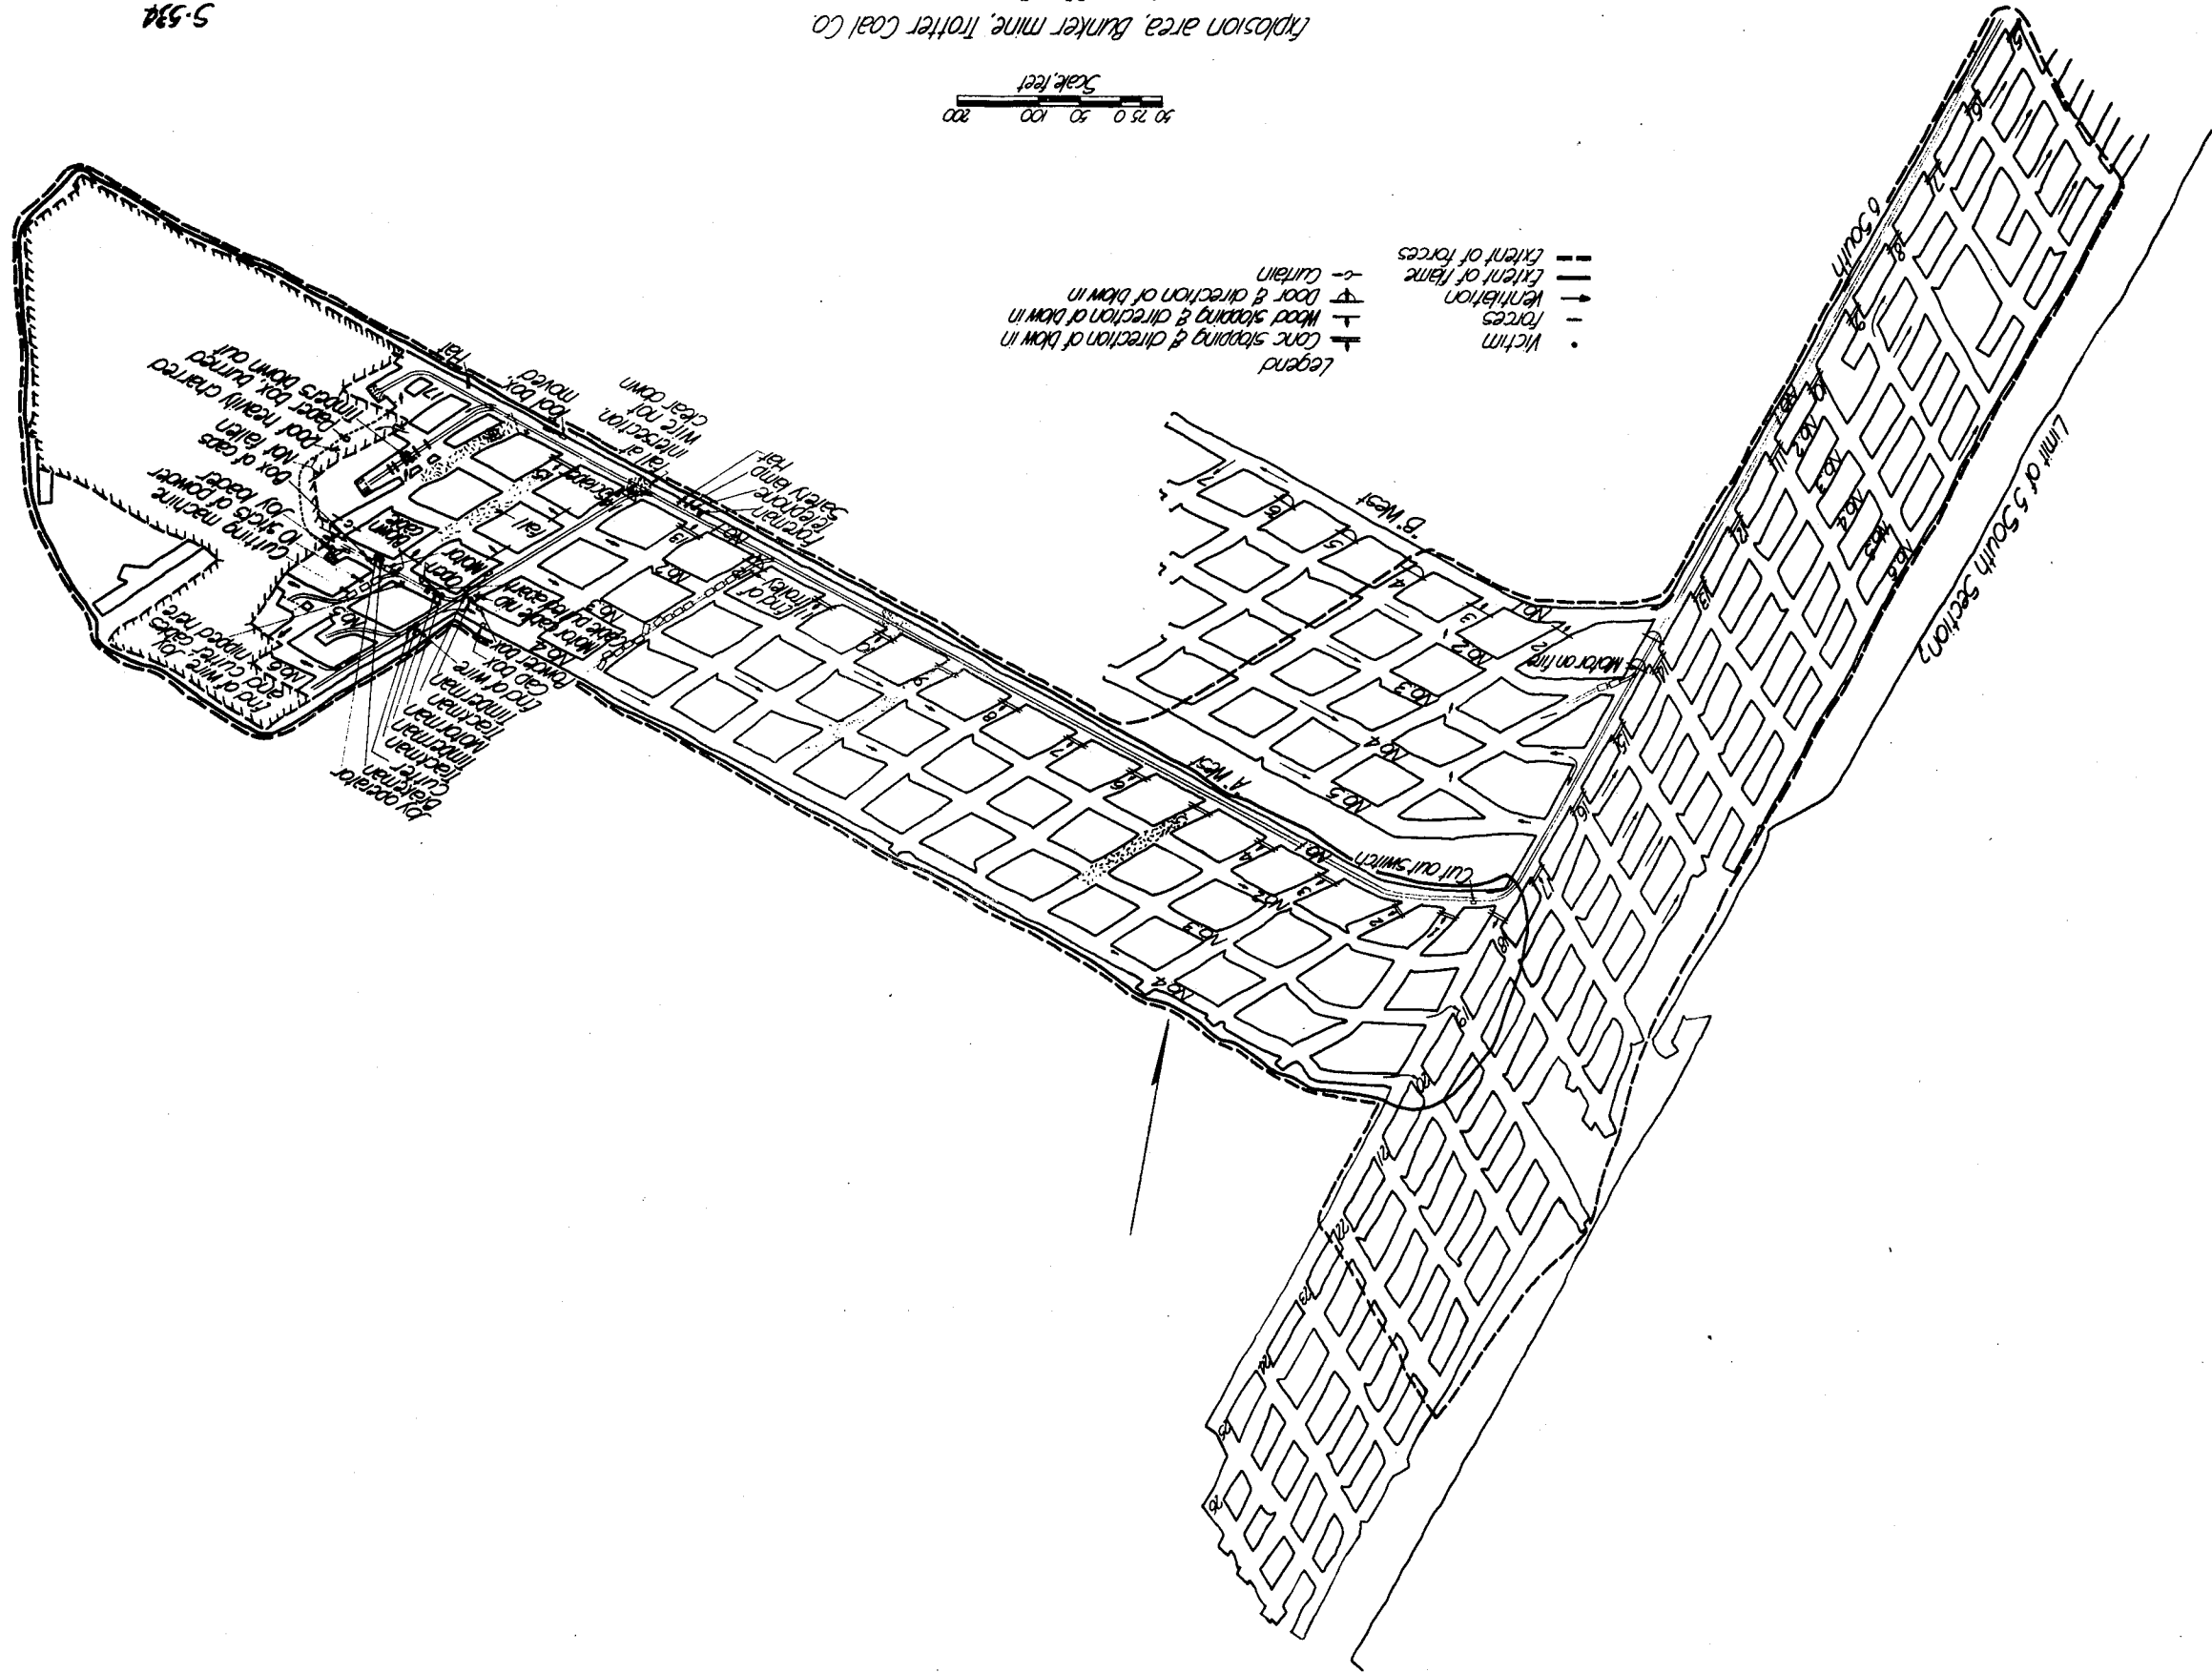
A study of the movement of materials in the affected area indicated that the forces radiated from the vicinity of the loading machine and locomotive in A entry A west. The details of the direction of forces are shown on the map referred to as Appendix C.

Ten men were in the area where the explosion occurred, and it was very evident from the locations of the bodies after the explosion (see Appendix C) that the men were in the act of moving outby from where they would be stationed during normal operations. This, very likely, was due to the roof "working" where a pillar fall was expected. The mining machine had cut the pillar split between Nos. 15 and 16 crosscuts and was parked in No. 15 crosscut. The loading machine was in a pillar split off 4 entry, as shown on the map. The tramming controls were in the reverse position, and the cable power tap was on the trolley wire. The locomotive was found coupled to a mine car which was partly loaded about 30 feet outby the loaded machine. The main controller was in the off position with the reverse lever in the position for outby travel. The switch in the control circuit to the reel motor was in the on position. The trolley pole was hooked in the down position, the brake was set, the battery-powered headlight was burning, and the cable power tap was on the trolley wire. The trackmen and timbermen had completed preparations for a cut in a pillar split between Nos. 14 and 15 crosscuts off No. 5 entry.
