FINAL REPORT
GAS AND DUST EXPLOSION, DOCENA MINE,
TENNESSEE COAL, IRON AND RAILROAD COMPANY
ADAMSVILLE, JEFFERSON COUNTY, ALA.
June 4, 1941

E. A. Anundsen
Acting District Engineer
And
M. J. Ankeny
Mining Engineer

UNITED STATES
DEPARTMENT OF THE INTERIOR
BUREAU OF MINES

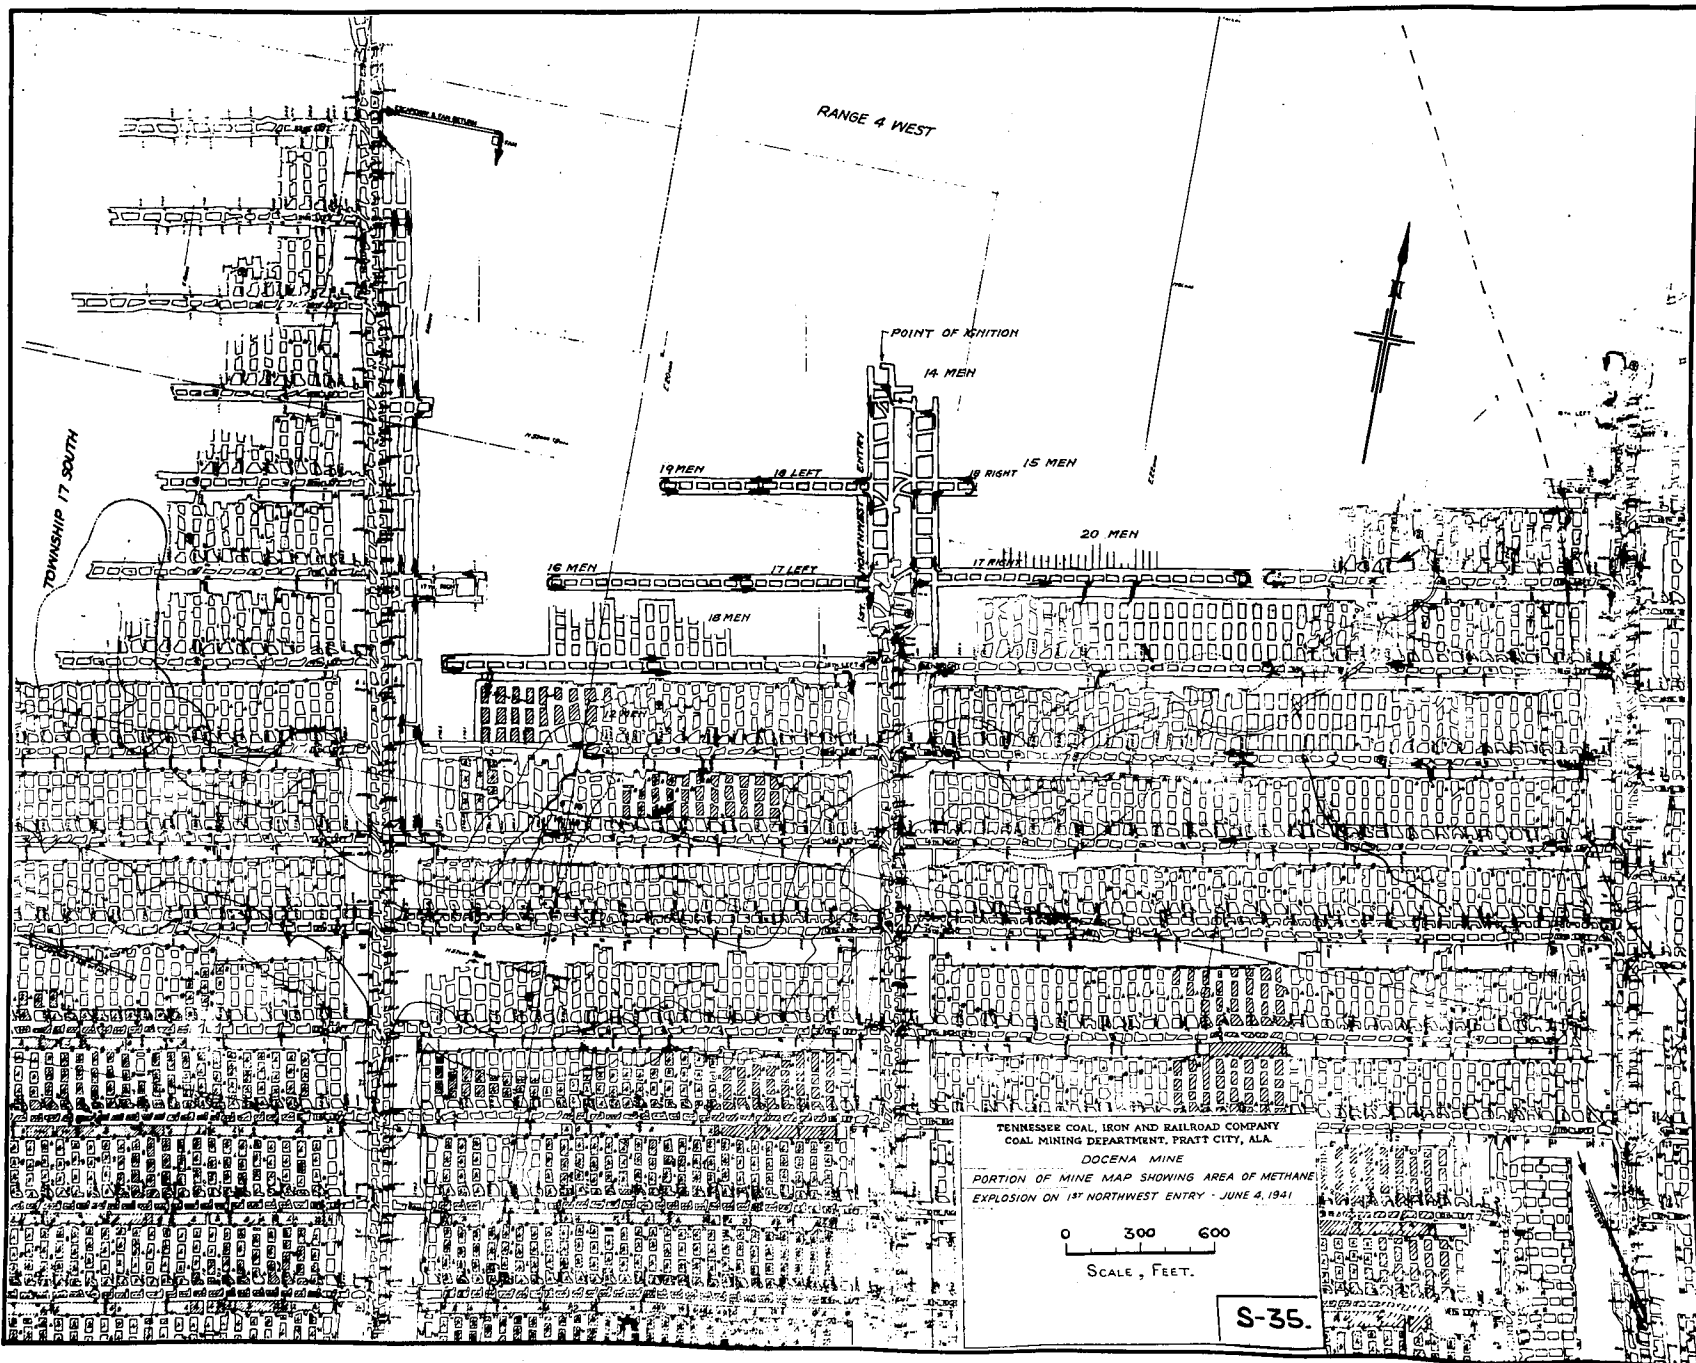
TENNESSEE COAL, IRON AND RAILROAD COMPANY
 COAL MINING DEPARTMENT, PRATT CITY, ALA.
 OCCENA MINE
 PORTION OF MINE MAP SHOWING AREA OF METHANE
 EXPLOSION ON 1ST NORTHWEST ENTRY - JUNE 4, 1941

Help continued to arrive and the rescue work proceeded with the remainder of the injured found as indicated on the attached map. These men were placed in the 19th right aircourse where they received first aid before they were moved further.

permissible explosive, lying along the left rib of this crosscut, was undisturbed. However, new fuel appeared to have been picked up from the roadway at the discharge point of the conveyors and from the loaded cars. Somewhat increased heat or flame and violence appeared to radiate outby from this point and the two most seriously burned survivors (brattice man and electrical inspector) were outby this point. The explosion entered both right and left aircourses through 19th right and 19th left, traveling out to the 18th right and left entries. At the same time, it continued to the 18th right in the main entry. Lack of fuel due to rock dusting apparently caused it to die out without passing the 18th right and left entries. The explosion apparently did not enter the extreme right or "barrier" aircourse due to the pools of water which are indicated on Appendix III.
