UNITED STATES
DEPARTMENT OF THE INTERIOR
BUREAU OF MINES

FINAL REPORT OF MAJOR MINE FIRE AND EXPLOSION DISASTER
MARS NO. 2 MINE 46-01313
CLINCHFIELD COAL COMPANY
(DIVISION OF THE PITTSBURGH COMPANY)
WILSONBURG, HARRISON COUNTY, WEST VIRGINIA

October 16, 1965

Originating Office - Bureau of Mines
Morgantown, West Virginia 26504
John J. Dougherty, Acting Subdistrict Manager
Morgantown, West Virginia, Subdistrict, Health and Safety District B

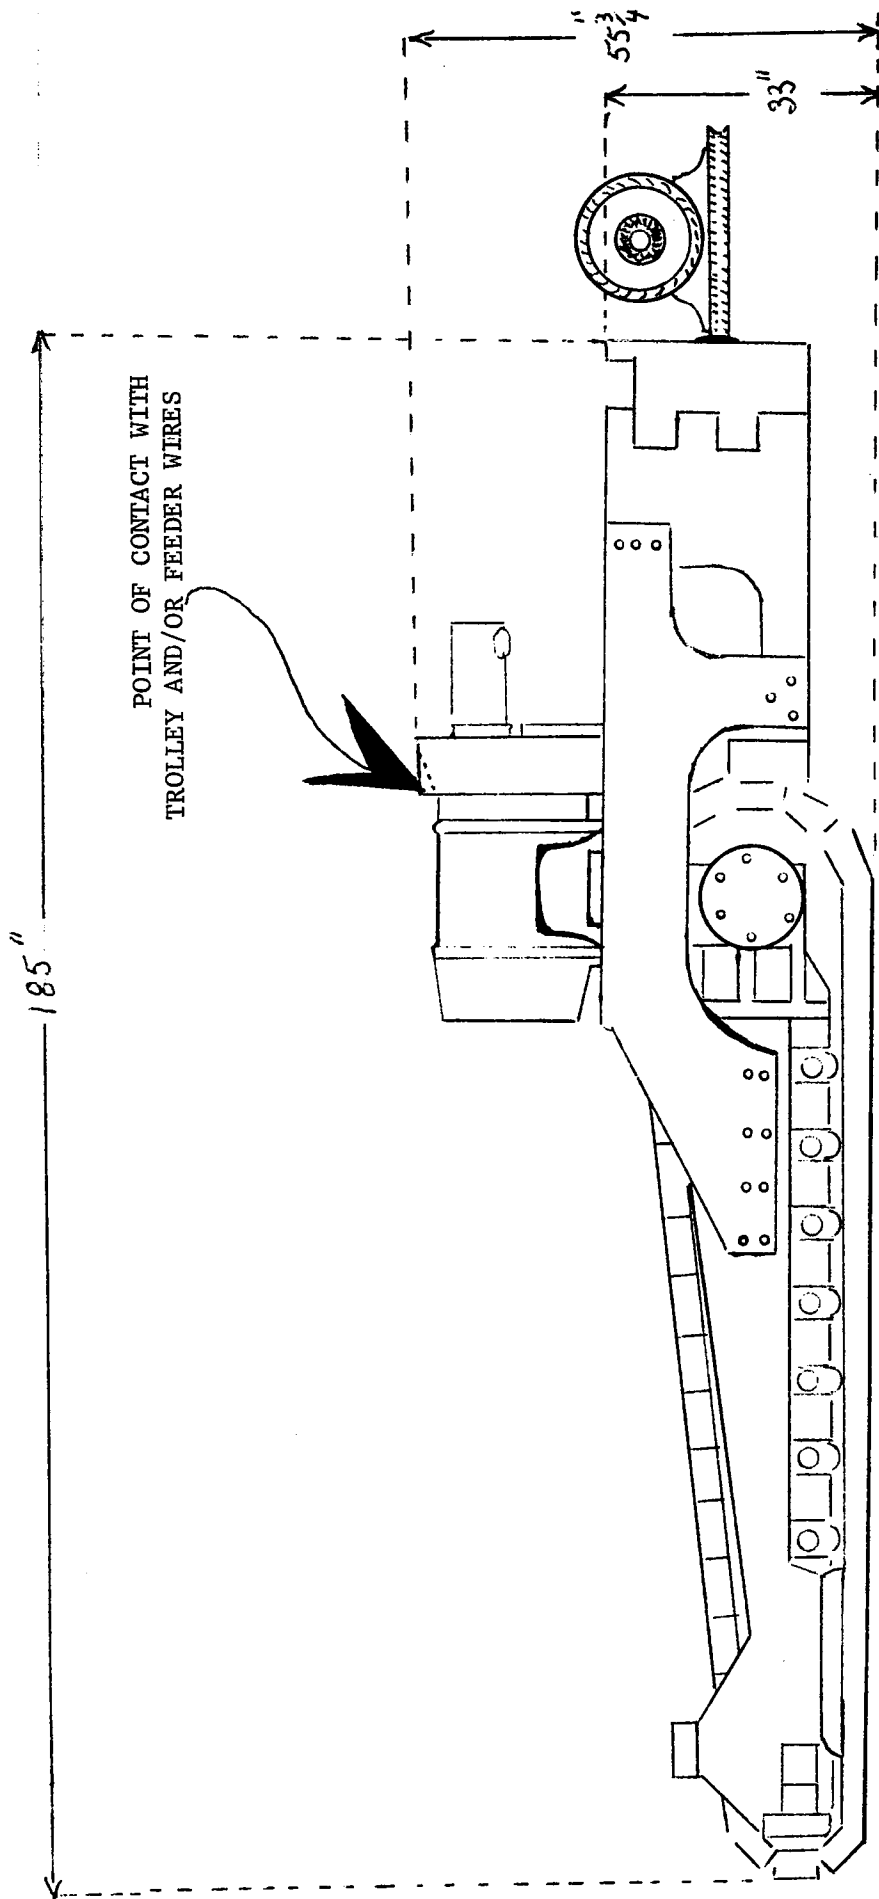
PARTLY DISMANTLED 557AW MARIETTA MINER

The fire was initiated by a short circuit when the top of the traction pump drive on a stripped-down continuous mining machine being trammed on the north mains track haulageway contacted the energized trolley and/or trolley feeder wires.

5. About 10:50 p.m., while the continuous miner was being trammed, the top of the traction pump drive on the machine contacted the trolley and/or trolley feeder wires at the west mains junction; the resultant short circuit caused intense arcing and flame that ignited the coal roof and ribs, rubber belting used as insulation, and later hydraulic oil.

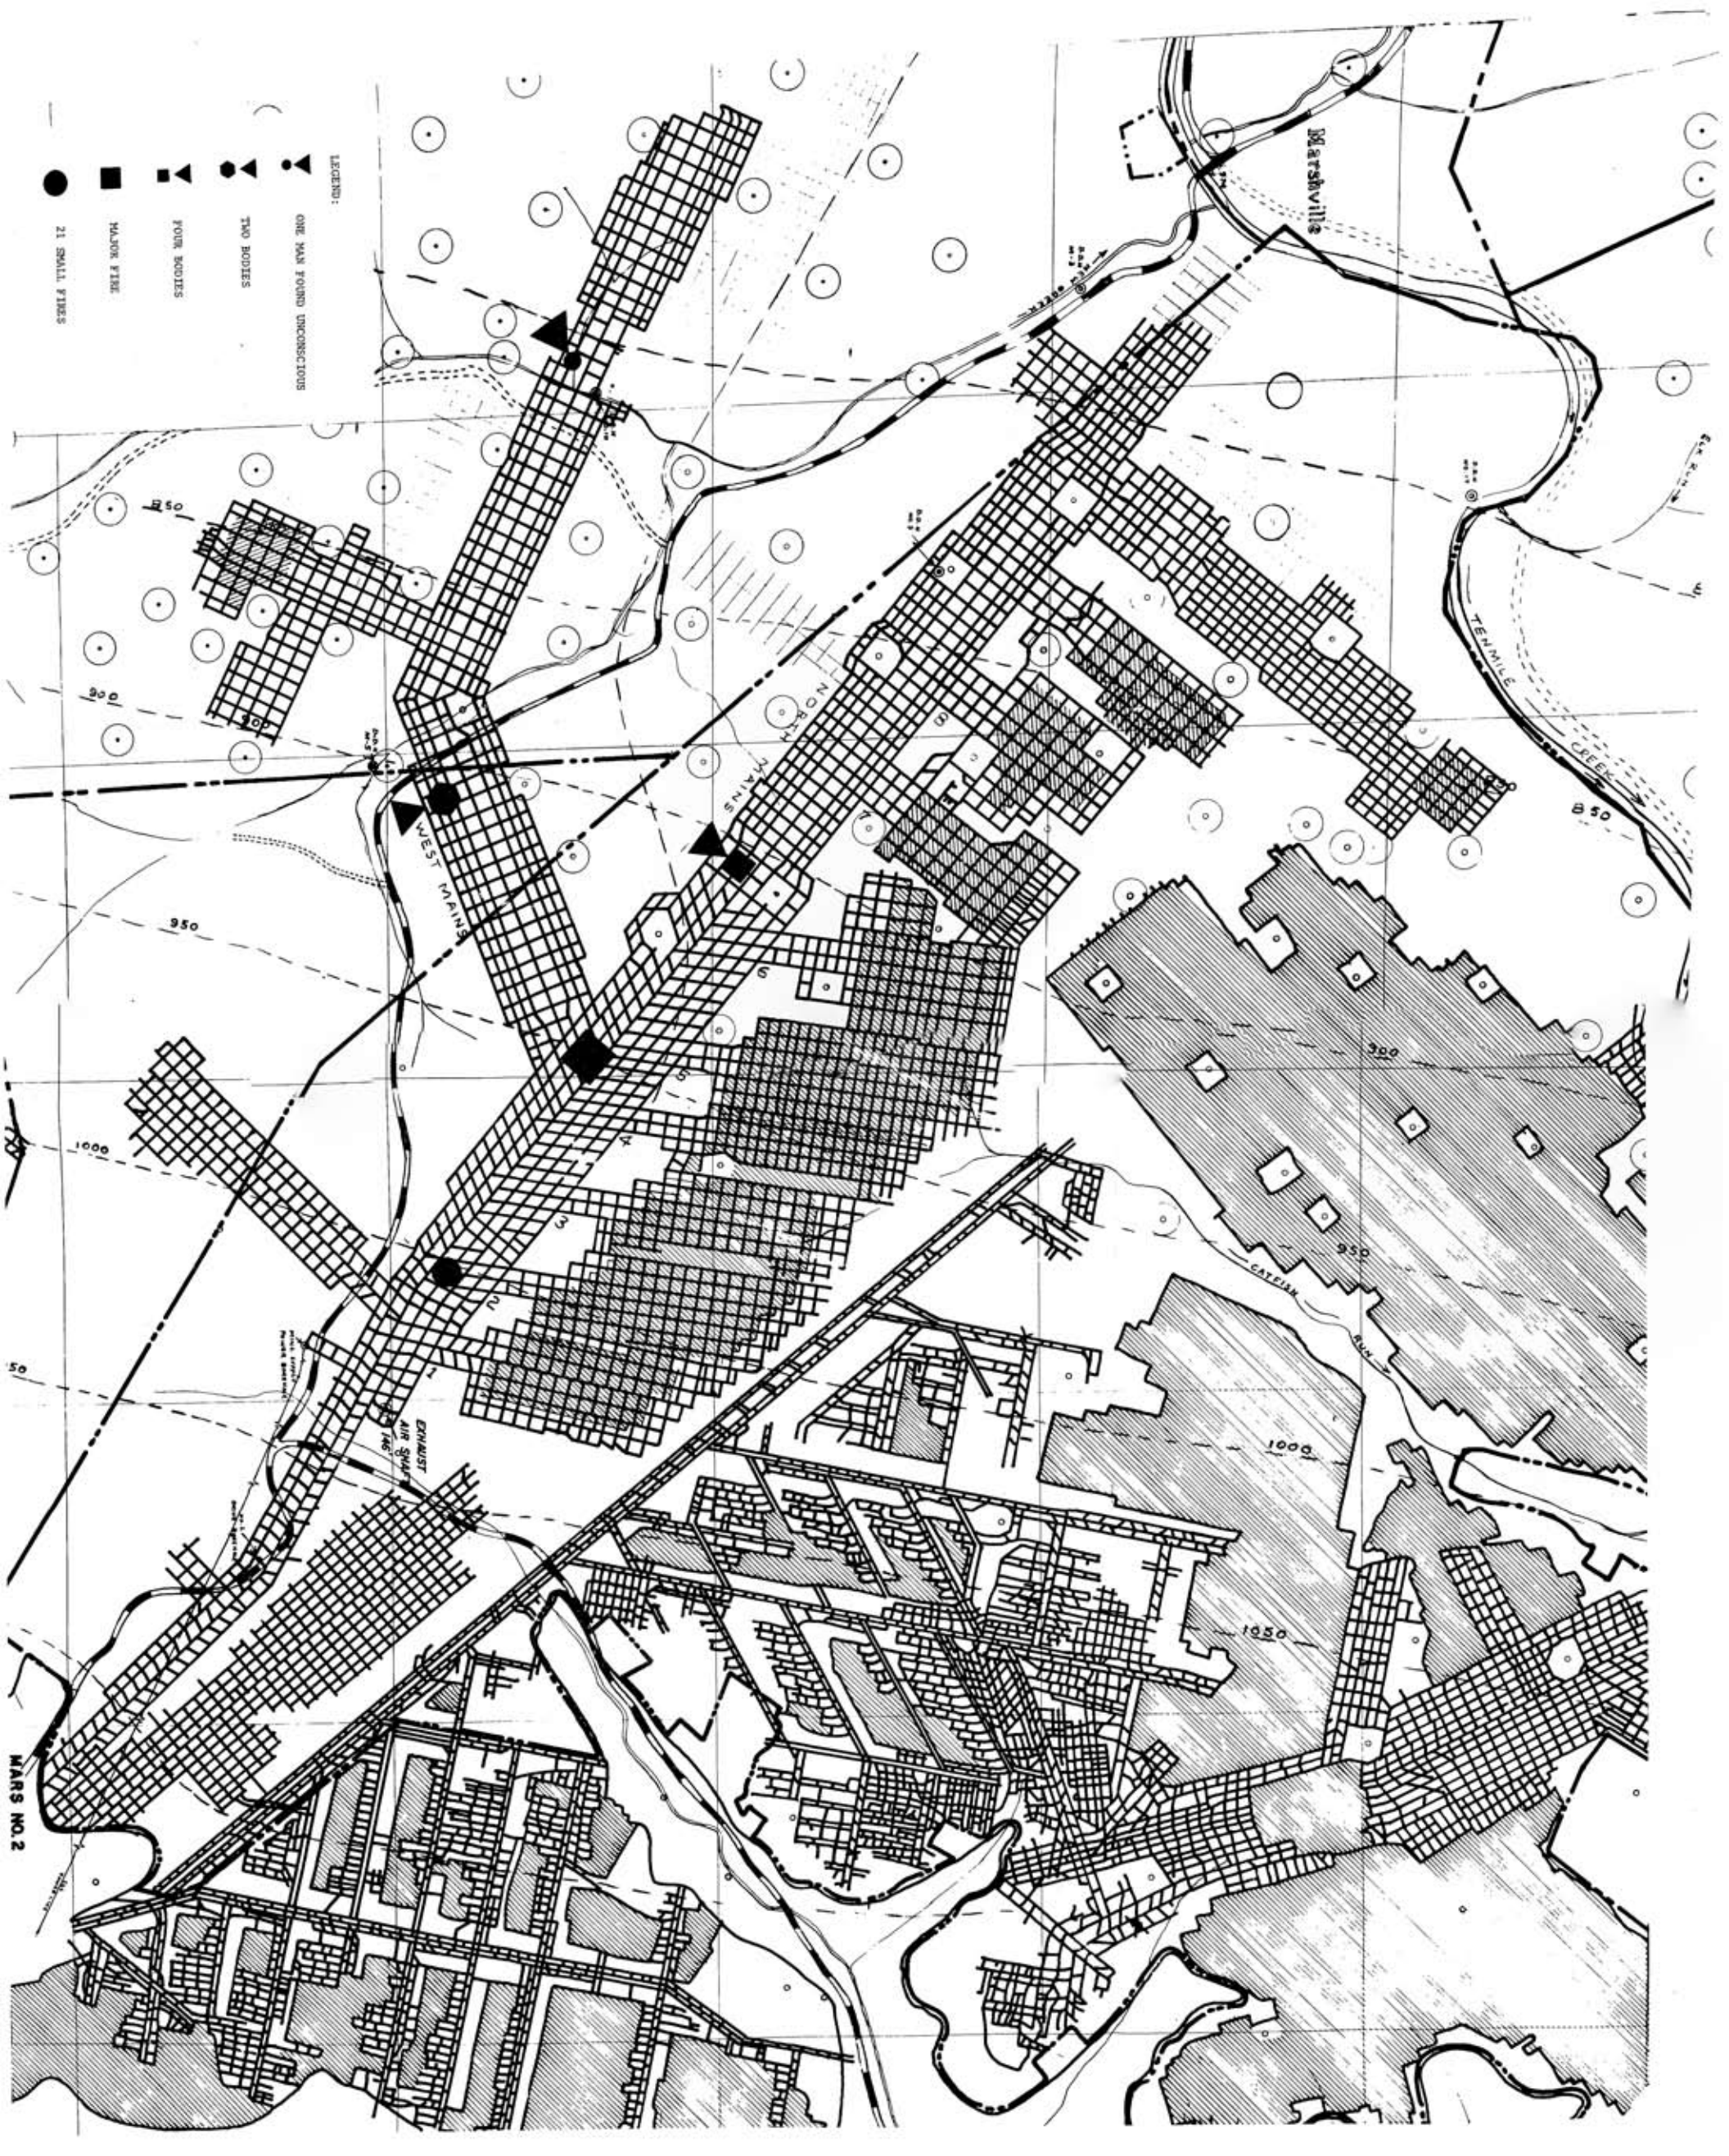
Evidence of heat or flame, in the form of soot and coke, was observed in all eight of the north mains entries for distances of approximately 2,350 feet outby the junction of west mains and 600 feet inby this junction. Twenty-one smoldering fires were found and extinguished on the floor between No. 4 belt entry and No. 6 entry about 1,350 feet outby the origin of the explosion. A total of 177 dust samples was collected in the north mains entries inby and outby the fire area, and in the west mains entries inby the fire area. The results of analyses for incombustible content and tests for coke in the mine dust samples are shown in table 1. The presence of coke in the mine dust samples is one of the criteria by which extent of flame was fixed; 52 of the 151 dust samples collected in north mains inby and outby the fire and explosion area contained coke ranging in quantities from traces to large.

Forces of the explosion radiated from the fire area and traversed all but Nos. 1 and 8 entries in north mains for distances of about 1,800 feet outby and 600 feet inby. Twelve of the 13 concrete block stoppings destroyed between Nos. 6 and 7 entries in north mains were blown toward the No. 5 entry and the other one toward No. 7 entry. Four stoppings between Nos. 2 and 3 entries in north mains were displaced toward No. 2 entry. Man doors in stoppings not damaged were either blown off or blown open toward the No. 1 entry. Five overcasts inby 2 right were destroyed and one was damaged. Portions of the No. 3 north mains conveyor belt and structure in No. 4 entry were blown toward No. 3 entry and an empty steel mine car parked in the 2 right track switch was blown onto the north mains haulageway. Forces of the explosion also reached the surface as one of the explosion doors at the fan was blown open. Forces of the explosion dissipated rapidly after reaching the 1 right junction and traveled toward the drift openings (see Appendix E).
