FINAL REPORT ON A GAS AND DUST EXPLOSION,
JANUARY 10, 1940, IN MINE NO. 1 OF THE
POND CREEK POCAHONTAS COMPANY,
BARTLEY, McDOWELL COUNTY,
WEST VIRGINIA

UNITED STATES
DEPARTMENT OF THE INTERIOR
BUREAU OF MINES

By M. J. Ankeny, E. J. Gleim, M. C. McCall, and C. W. Owings

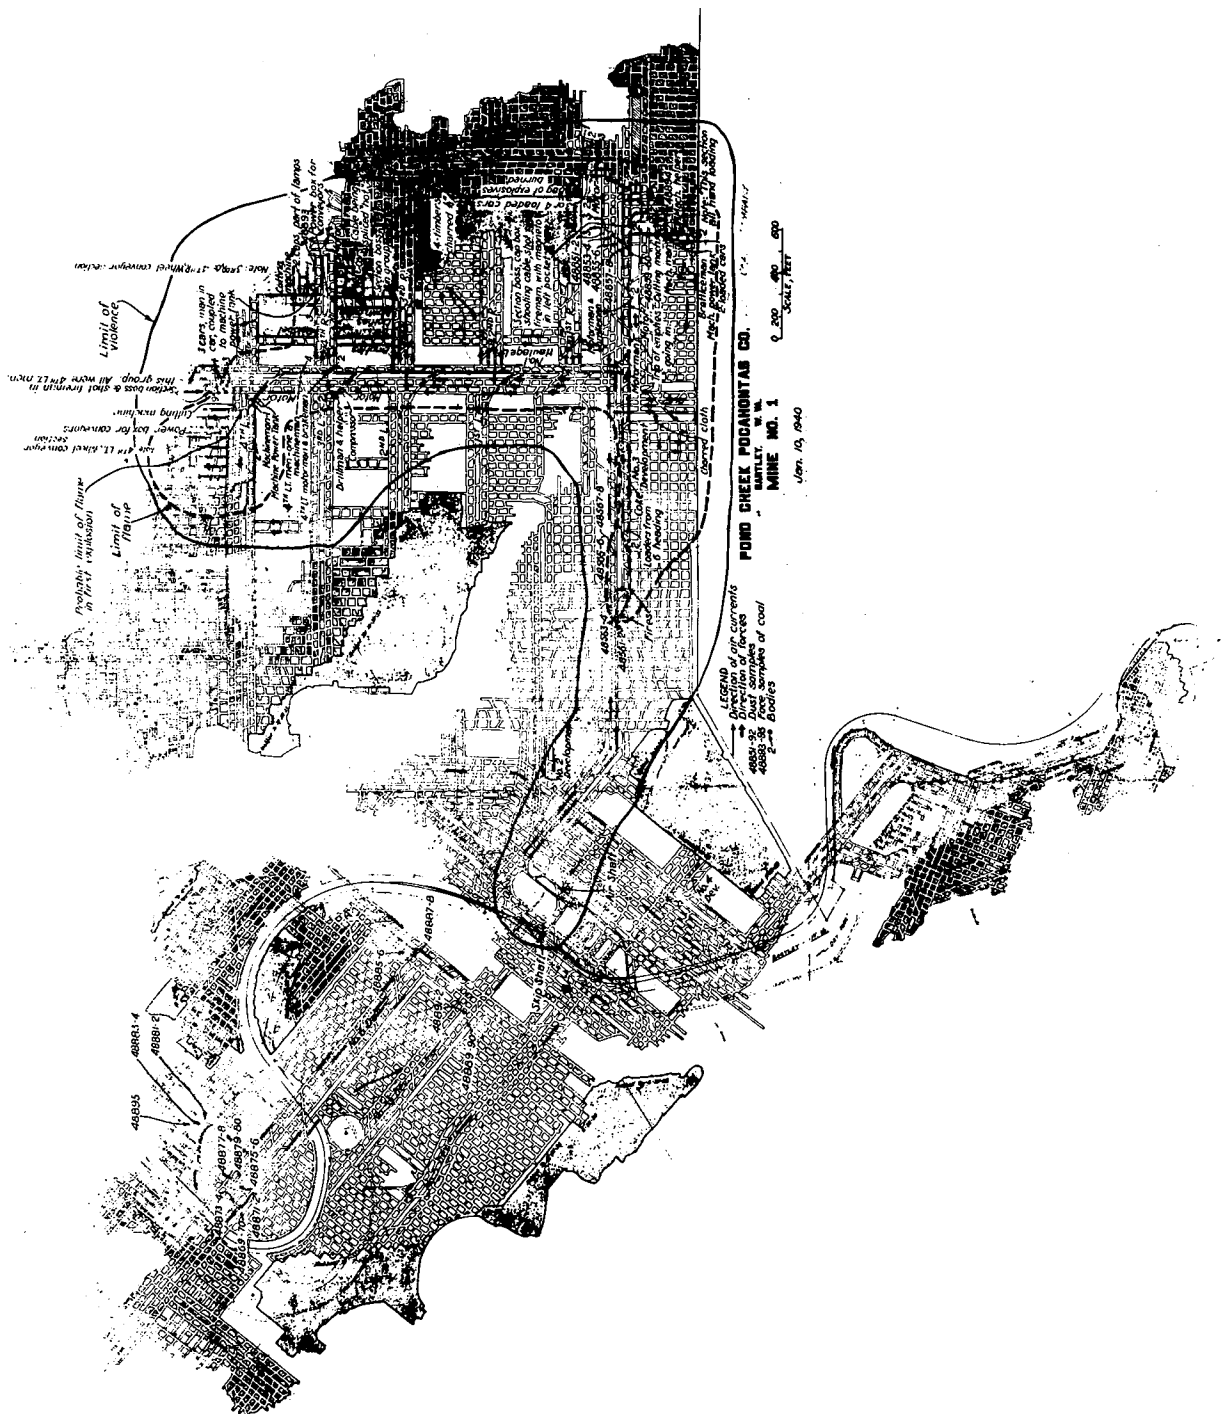
The direction of major forces is shown on the map of the mine. In many places positive evidence of forces in opposite directions was found, indicating that probably more than one explosion occurred.

Limit of violence

Limit of fire
