REPORT OF INVESTIGATION  
(SURFACE AREA OF UNDERGROUND COAL MINE)

MULTIPLE FATAL FALL OF MATERIAL ACCIDENT

Virginia Pocahontas No. 1 Mine (ID No. 44-00246)  
Island Creek Coal Company  
Oakwood, Buchanan County, Virginia

August 24, 1982

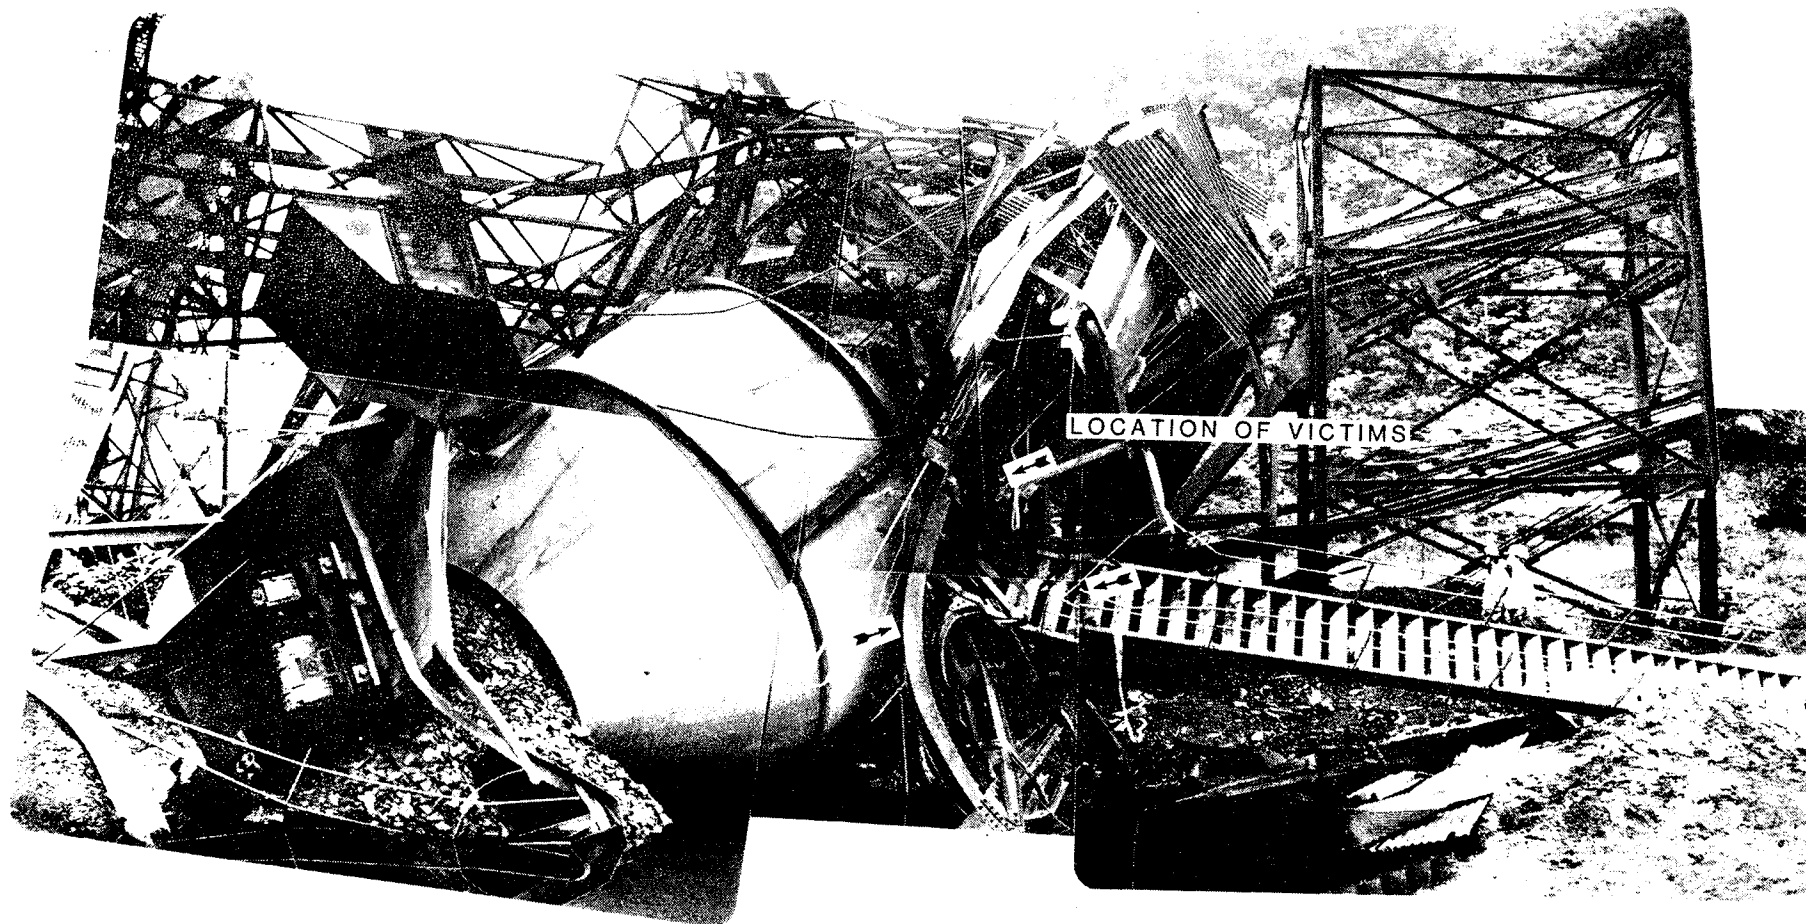
Photographic Composite of  
Collapsed Structure

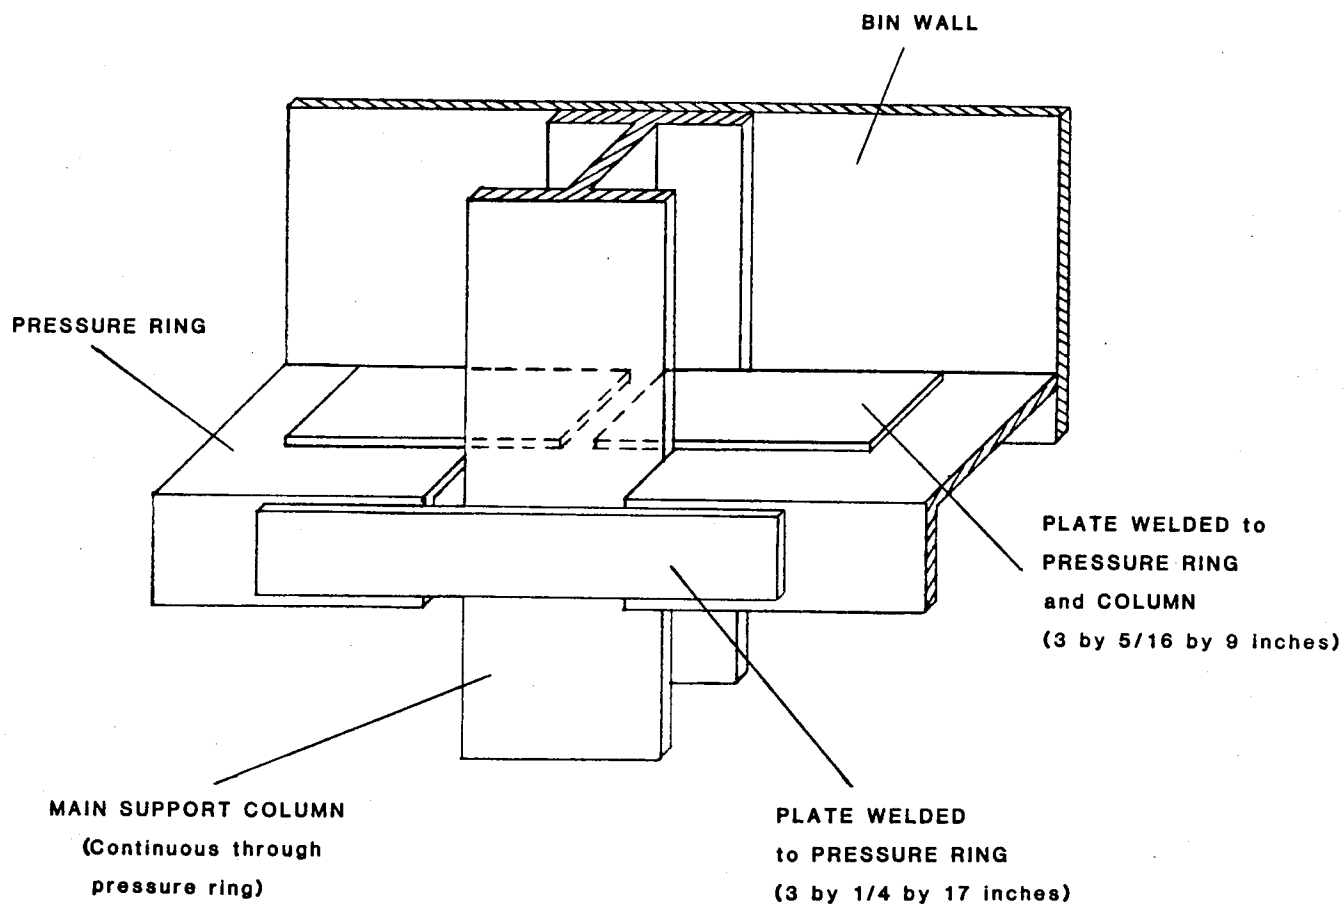
### DRAWING NO. 2

Connection of Main & Stub Columns, Pressure Ring, & Bin Wall Before Repairs

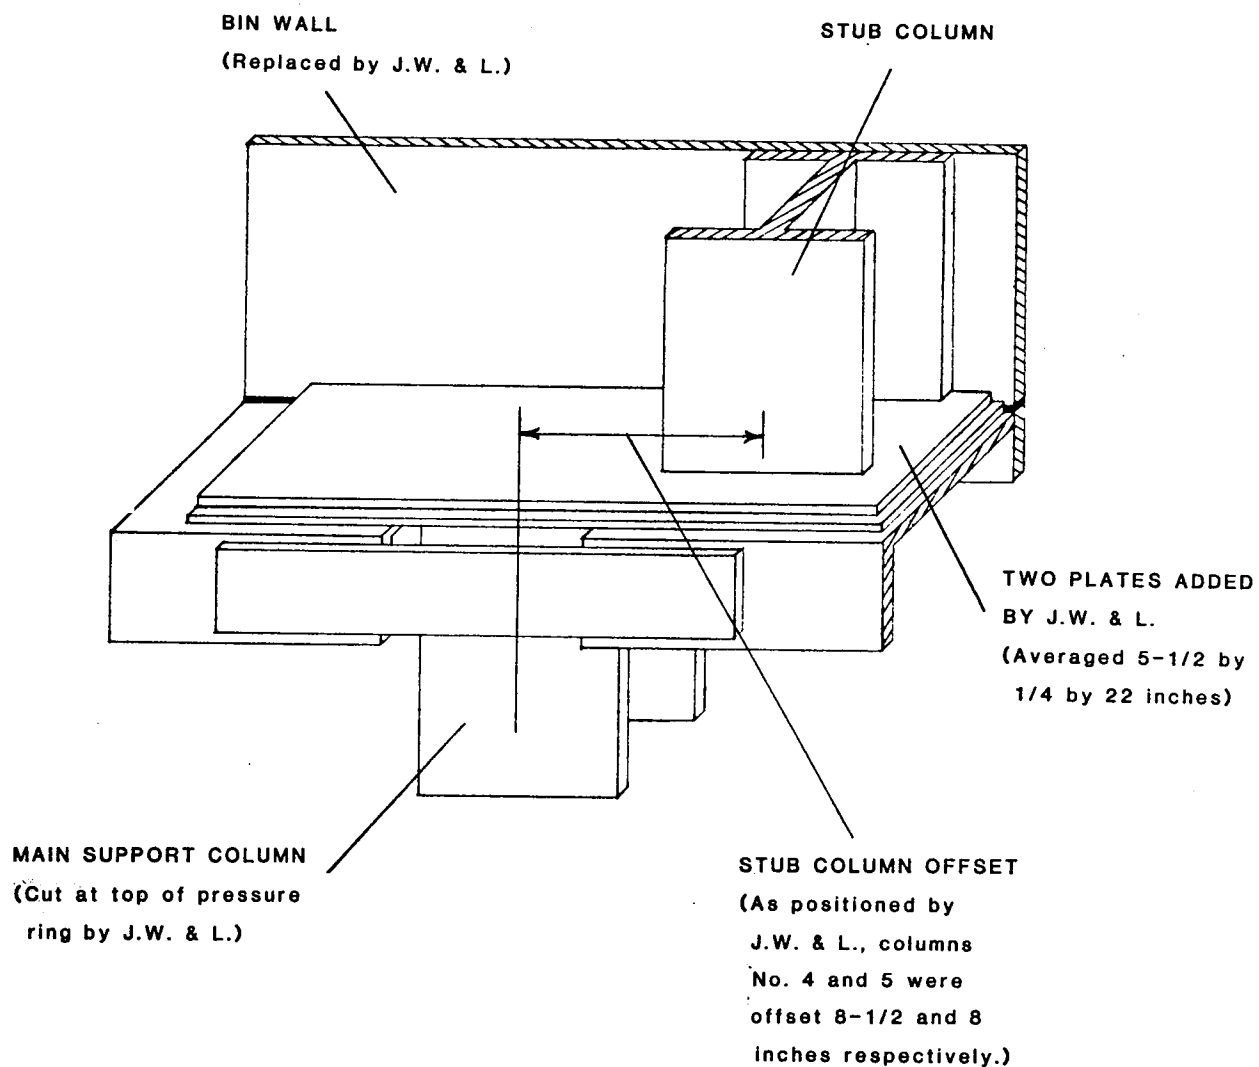
## DRAWING NO. 3

12. During fabrication of the new bin, two of the six stub columns were misaligned at least eight inches from the main columns. (See drawing No. 3.)
13. The circumference of the new bin was slightly larger than the circumference of the cone top resulting in a bulge in the side of the bin between columns 3 and 4 which extended out to within one inch of the outer edge of the compression ring. This left a small ledge on the inside of the bin.

The accident occurred because repair work performed by the independent contractor on the refuse bin resulted in the facility being structurally unsound. Two of the six bin upper support columns (stub columns) were not aligned with the main support columns, significantly reducing the load supporting capability of the structure.

Connection of Main & Stub Columns, Pressure Ring, & Bin Wall After Repairs

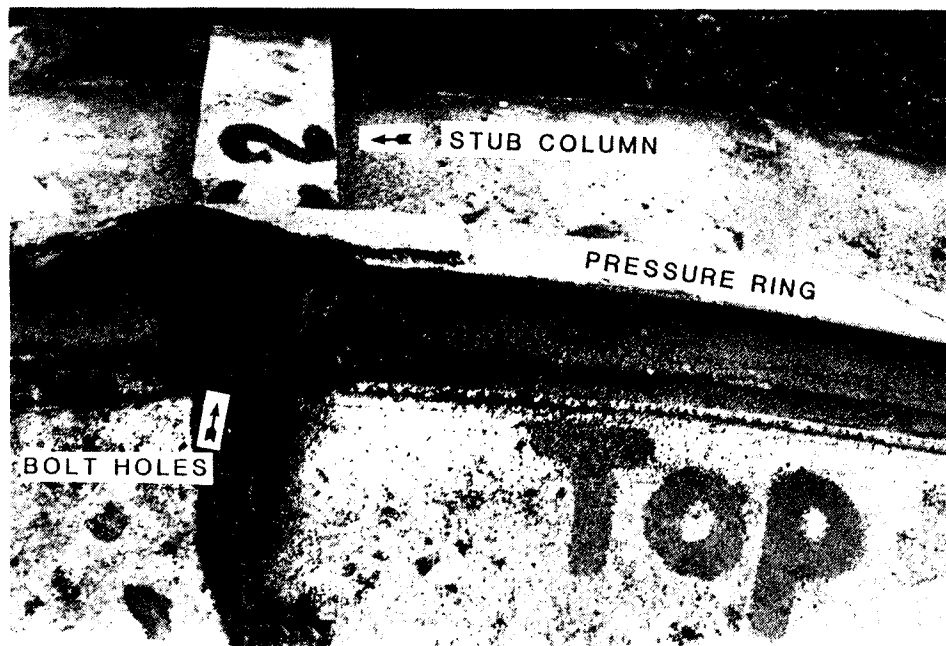
### Typical: Aligned Stub Column

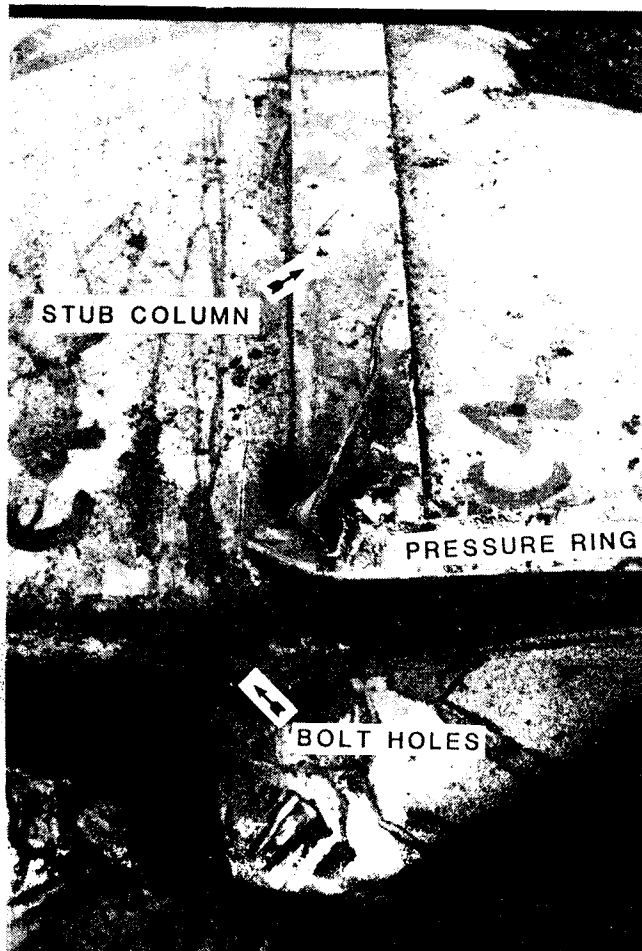
### Two Misaligned Stub Columns
