REPORT OF FATAL COAL MINE ROOF-FALL ACCIDENT  
CLYDE MINE  
REPUBLIC STEEL CORPORATION  
NORTHERN COAL MINES DISTRICT  
FREDERICKTOWN, WASHINGTON COUNTY, PENNSYLVANIA

May 22, 1968

J. D. Breedon  
Federal Coal Mine Inspector

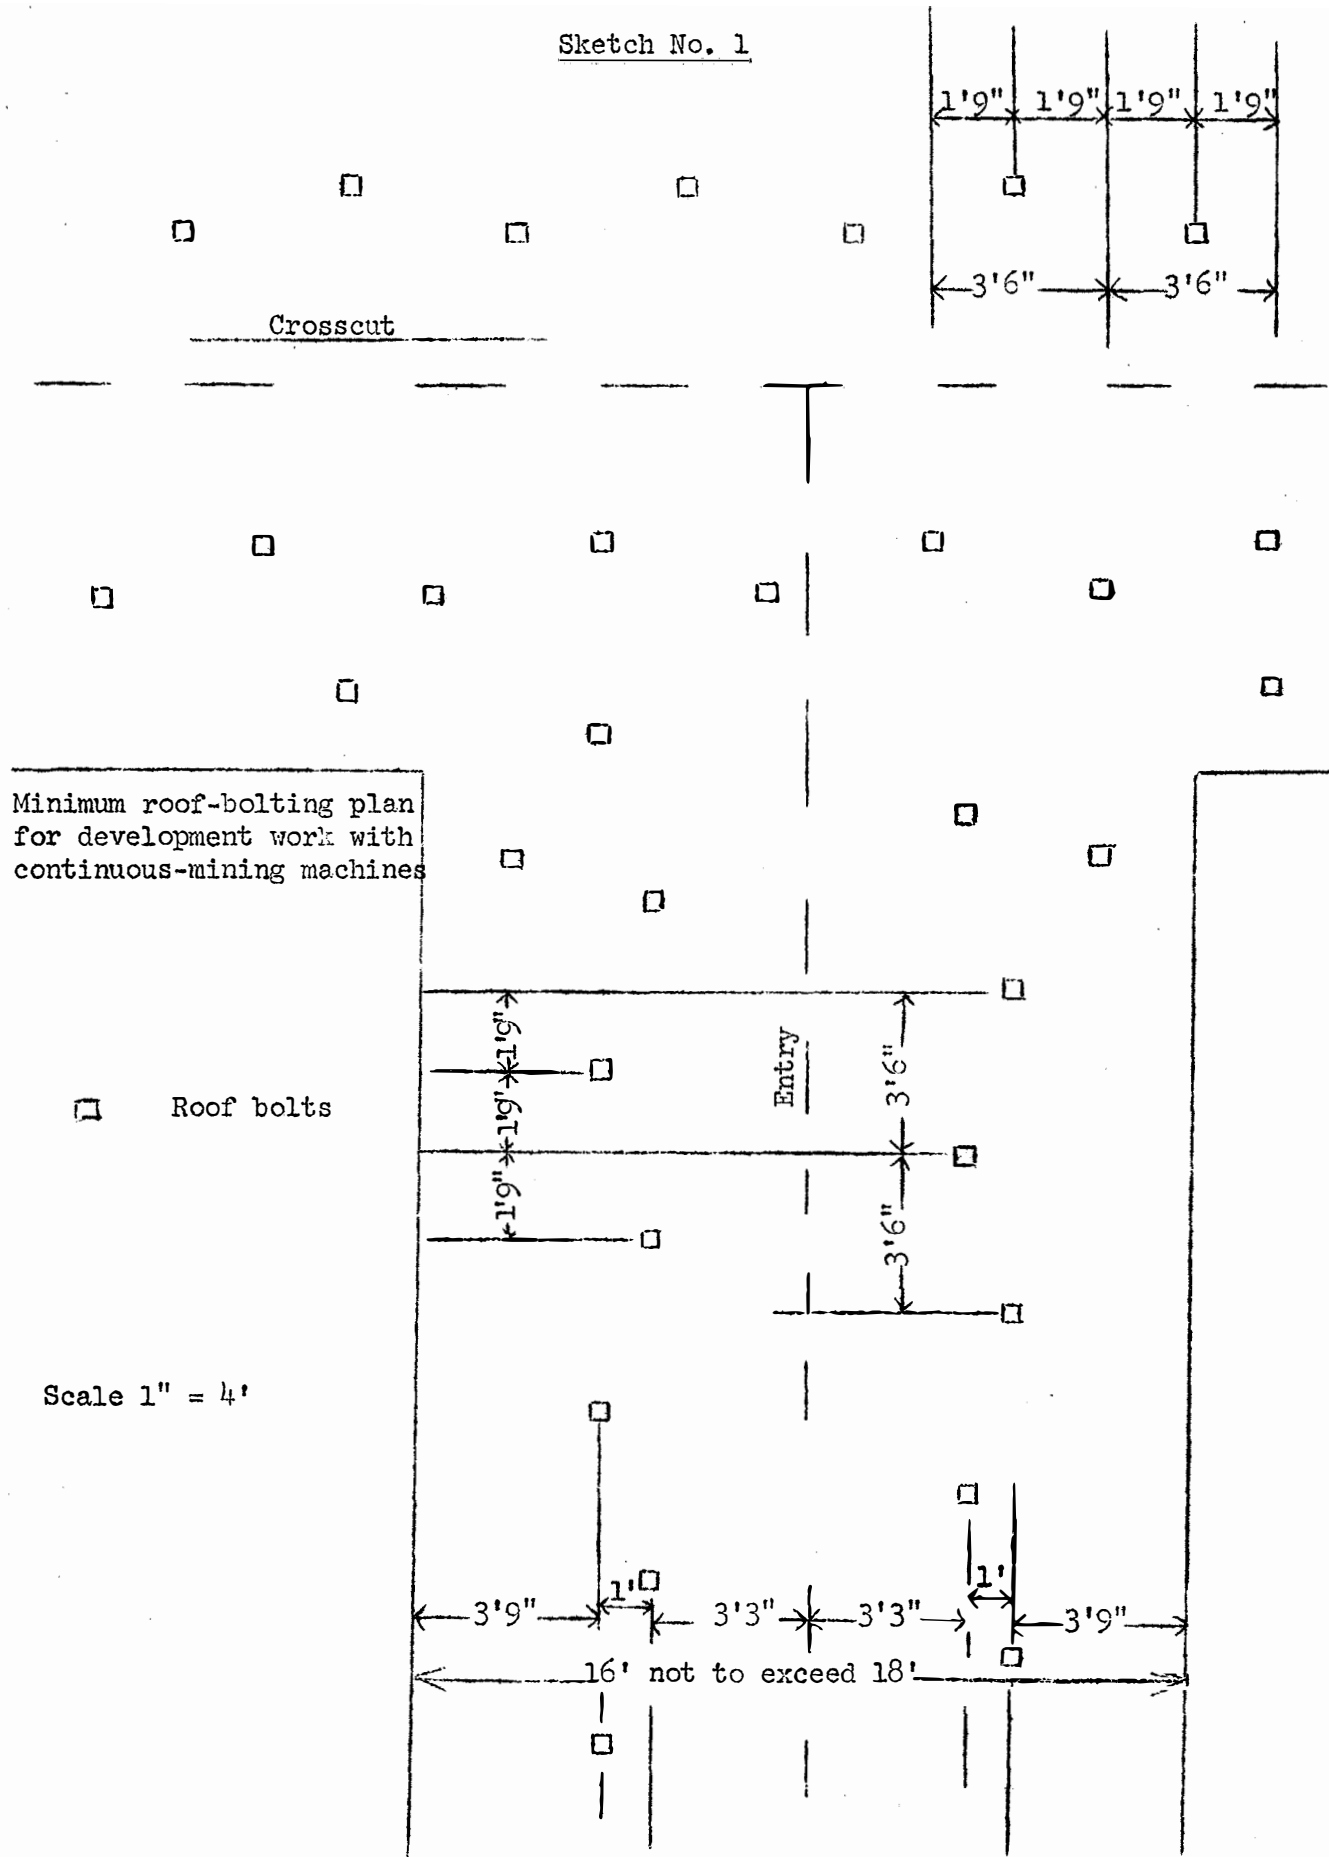
Sketch No. 1

A Bureau-approved plan for roof support was adopted. The plan required roof bolts to be installed in staggered rows of two. The bolts were offset 21 inches lengthwise and 8-1/2 feet crosswise with one bolt in each cross section (see sketch No. 1). During development roof bolts had not been installed in accordance with the adopted plan in the immediate area where the accident occurred, but a supplemental row of roof bolts had been installed later on 2- to 5-foot centers between the required rows of bolts (see sketch No. 2). Due to the clay vein encountered in No. 2 entry, wooden crossbars had been bolted to the roof inby the clay vein, but outby (accident area) crossbars were not used. Although the number of roof supports installed in No. 2 entry was in excess of the minimum required by the plan, it is apparent that the installed roof supports were inadequate for the abnormal roof condition encountered.

Minimum roof-bolting plan  
for development work with  
continuous-mining machines

3. The adopted plan for roof control (bolting) should be complied with at all times.

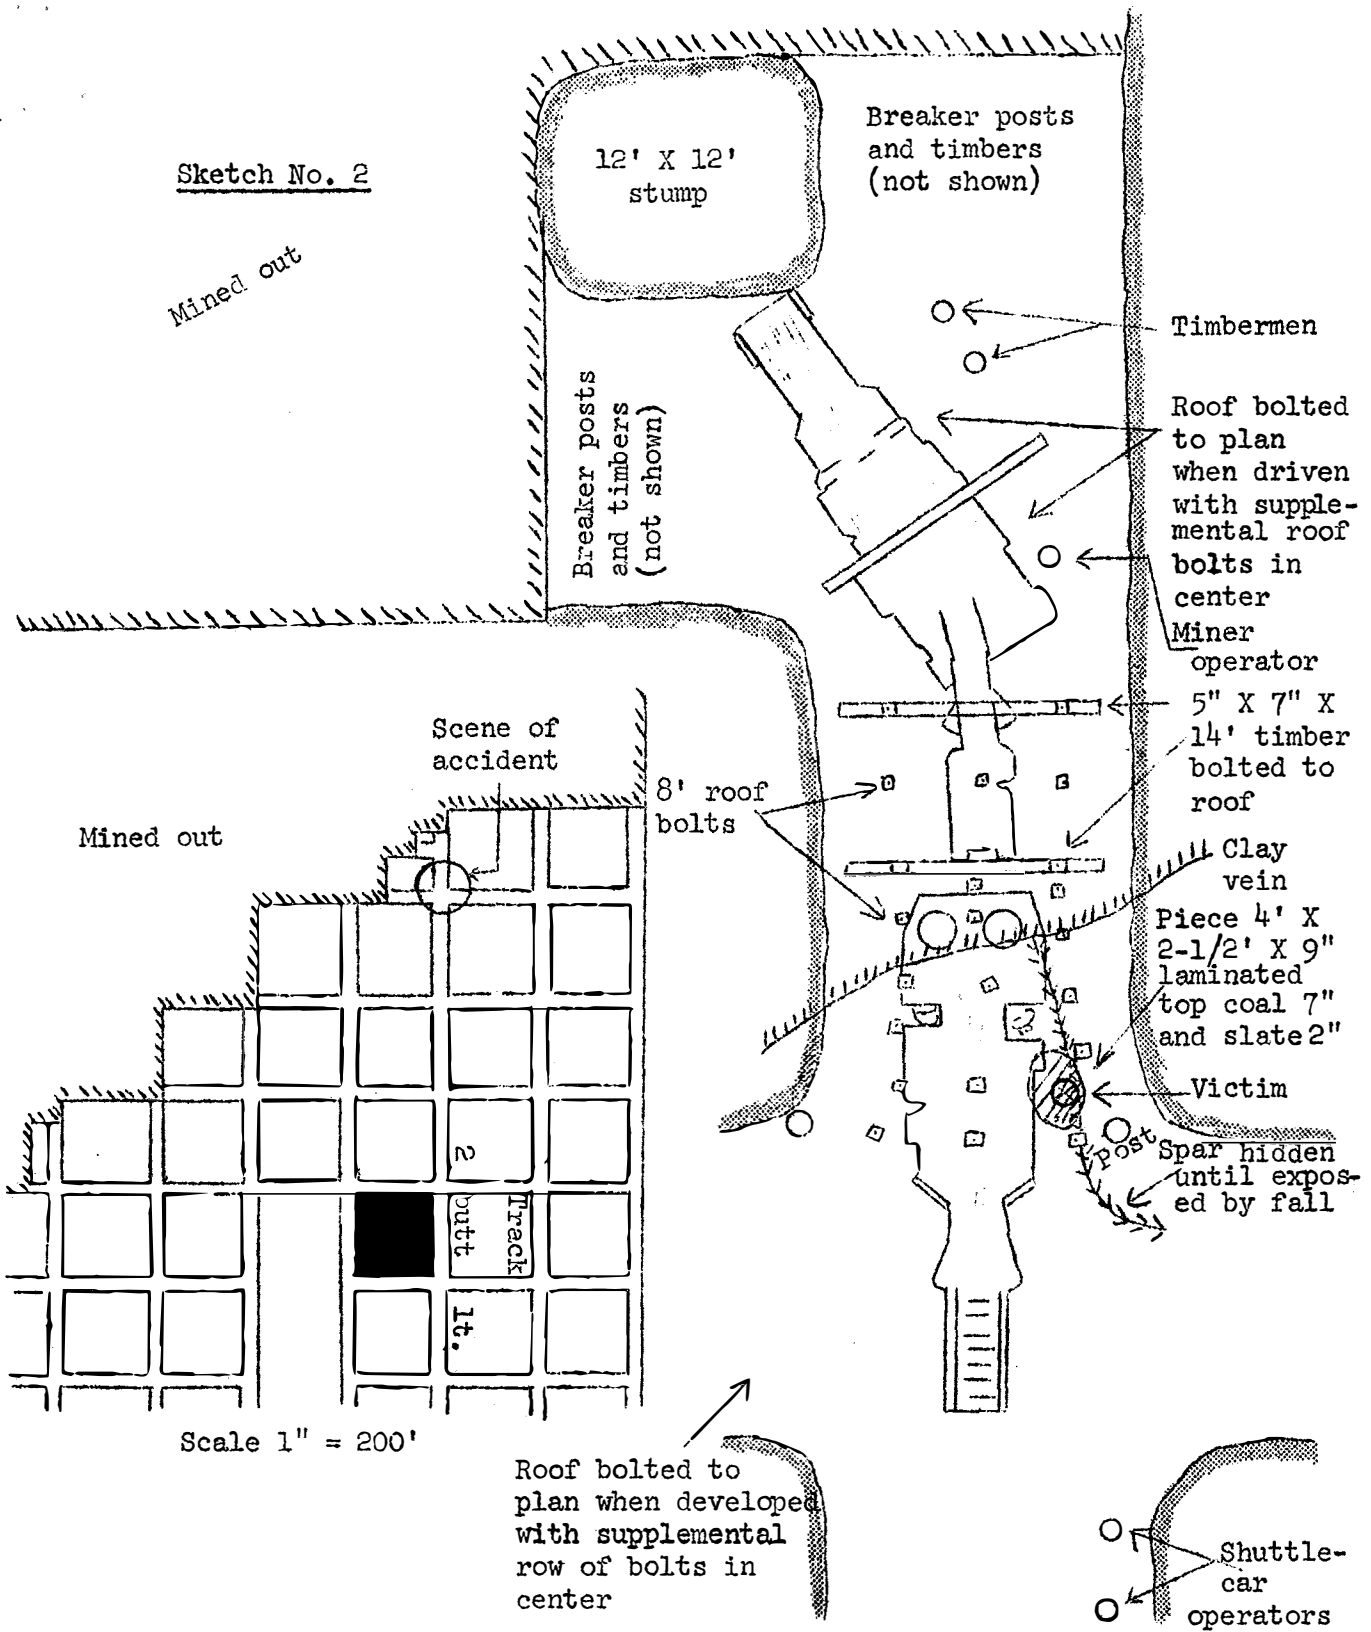
Sketch No. 2

The cause of this accident was inadequately supported roof. Failure to make thorough roof examinations in the area of the clay vein outby the pillar line where excessive roof stresses were evident was a contributing factor.

Roof bolted to plan when developed with supplemental row of bolts in center

1. Where abnormal roof conditions are encountered along travelways and roadways, sufficient additional roof supports such as planks or crossbars shall be installed to protect persons from falls of roof.

2. Where pillar stresses are evident, frequent thorough examinations of the roof should be made by officials and workmen so that an accurate evaluation of roof conditions can be made and adequate roof supports installed promptly.
