# COAL FATAL

UNITED STATES  
DEPARTMENT OF THE INTERIOR  
BUREAU OF MINES

REPORT OF FATAL COAL MINE (ELECTROCUTION) ACCIDENT  
BANNING NO. 4 MINE  
REPUBLIC STEEL CORPORATION  
NORTHERN COAL MINES DISTRICT  
WEST NEWTON, WESTMORELAND COUNTY, PENNSYLVANIA

August 10, 1970

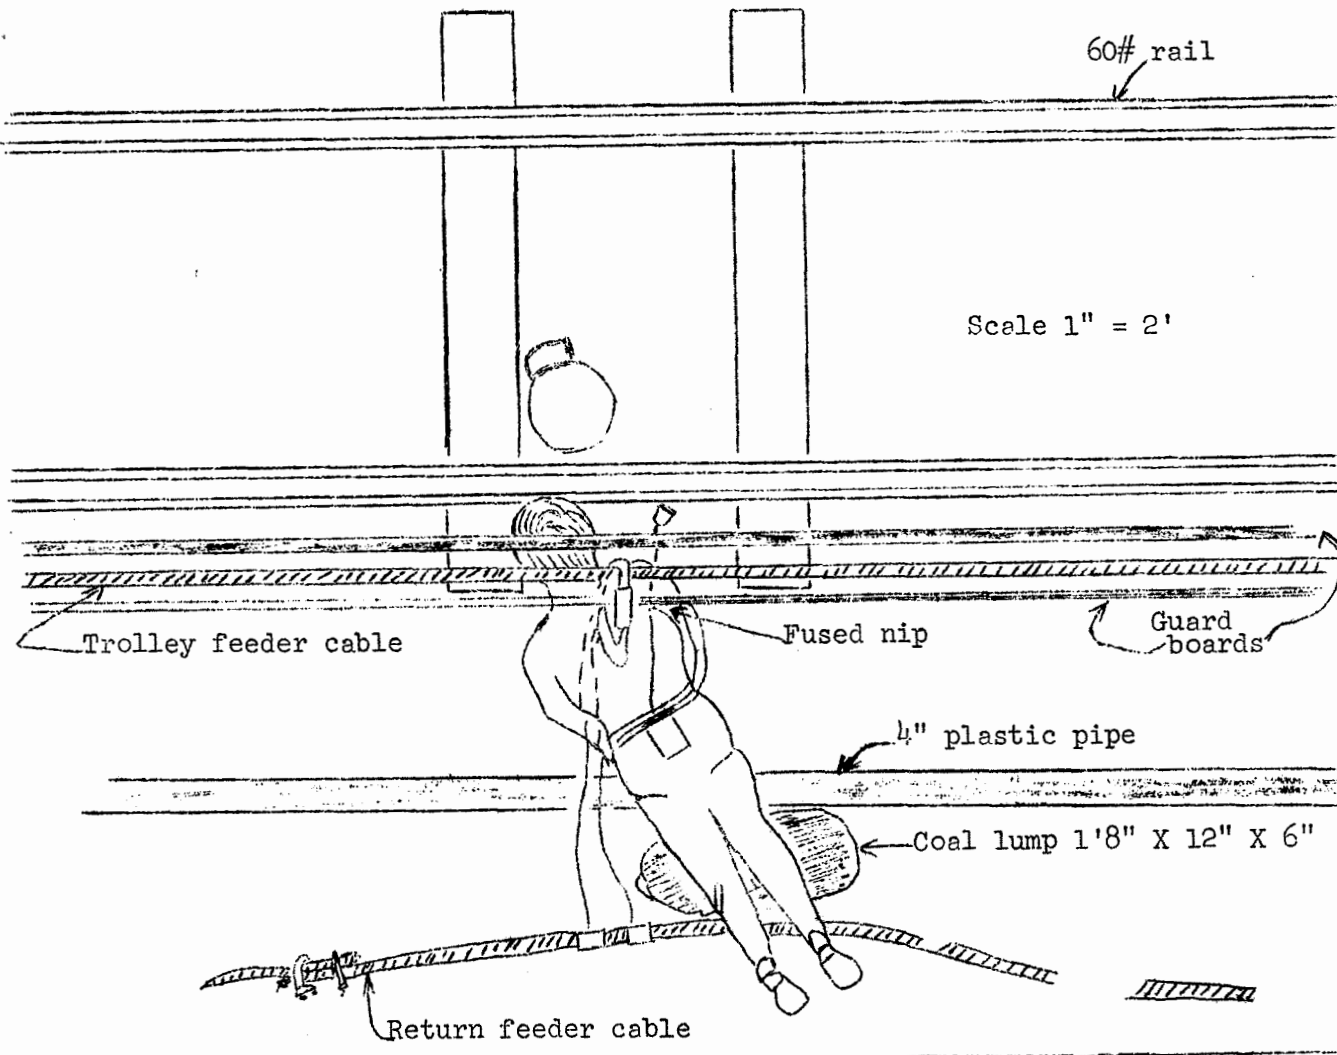
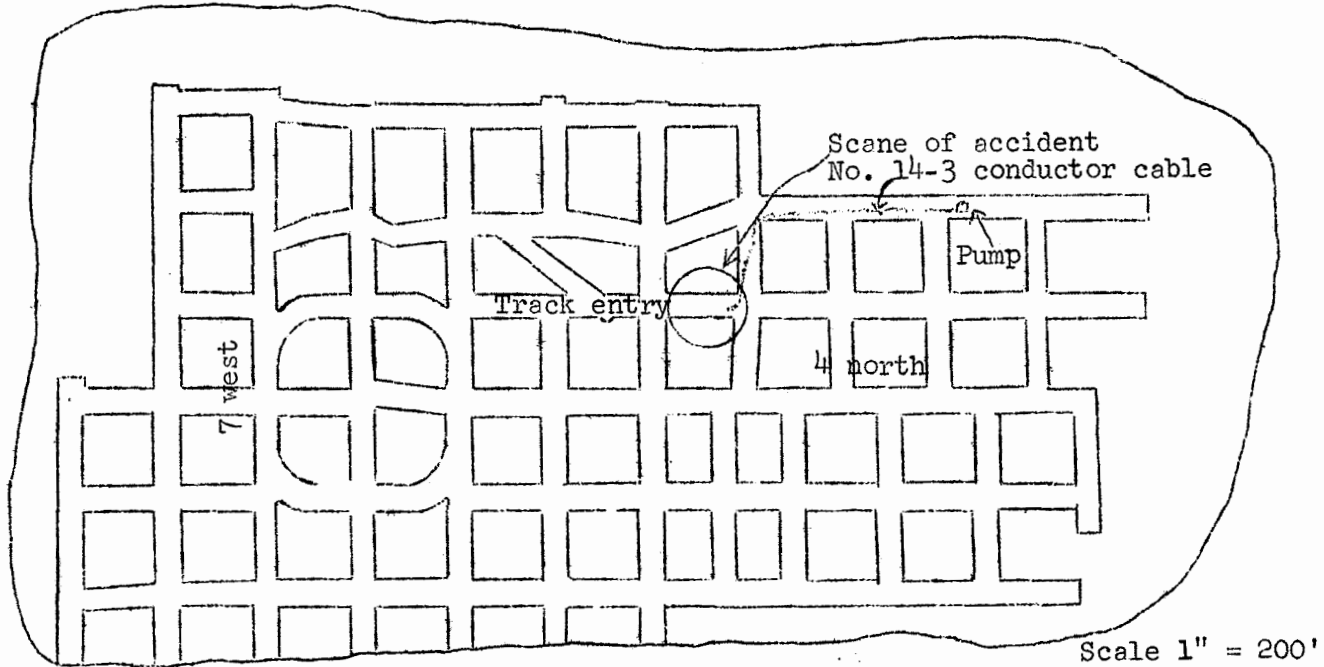
Sketch of Scene of Fatal Coal Mine (Electrocution) Accident  
 Banning No. 4 Mine  
 Republic Steel Corporation, Northern Coal Mines District  
 West Newton, Westmoreland County, Pennsylvania  
 August 10, 1970

There were no eyewitnesses to the accident; however, it was the consensus of opinion of the writers and some of the investigating committee, based on physical conditions in the accident area and the position of the victim when found, that Kmetz, while attempting to remove the fused nip from the trolley feeder wire or to replace it on the wire and while standing on a large lump of coal and/or a 4-inch plastic pipeline, lost his balance, fell, and struck his head against the track rail. Apparently while falling, he pulled the power conductor under his body without dislodging the nip from the trolley feeder wire. As a consequence, he contacted an exposed section of the energized power conductor which resulted in a deep wound in the right side of his neck and chest.

The distance from the mine floor to the top of the guard boards measured 7 feet 4 inches and the nip had been placed over top the guard board on the trolley feeder wire. The mine floor was wet throughout the area.

This accident happened because management failed to provide safe and adequate means to connect and disconnect the trailing cable to and from the power source (the trolley feeder wire which was more than 7 feet above the mine floor). The wet mine floor and tripping hazards (plastic pipeline and large lump of coal) could have been contributing factors. There is a possibility that the insulation for the power conductor was damaged prior to the accident and the conductor was bare where it touched the body, if so, this could have contributed to the seriousness of the accident.

1. Management should provide a safe means of connecting and disconnecting power taps. Special precautions should be taken where wet conditions exist and tripping hazards should be removed.
2. Whenever the outer sheath of portable cables having conductors smaller than No. 6 AWG is removed to facilitate connection to power-supply circuits, well-insulated single conductors not smaller than No. 6 should be spliced to the ends, or each conductor should be provided with hose conduit.
3. A dual-element fuse rated at 15 amperes or a circuit breaker with an instantaneous trip setting of 50 amperes should be provided for the No. 14 AWG pump trailing cable.
