THE UNITED MINE WORKERS OF AMERICA, AFL-CIO/CLC

Sago Mine Disaster

OF JANUARY 2, 2006

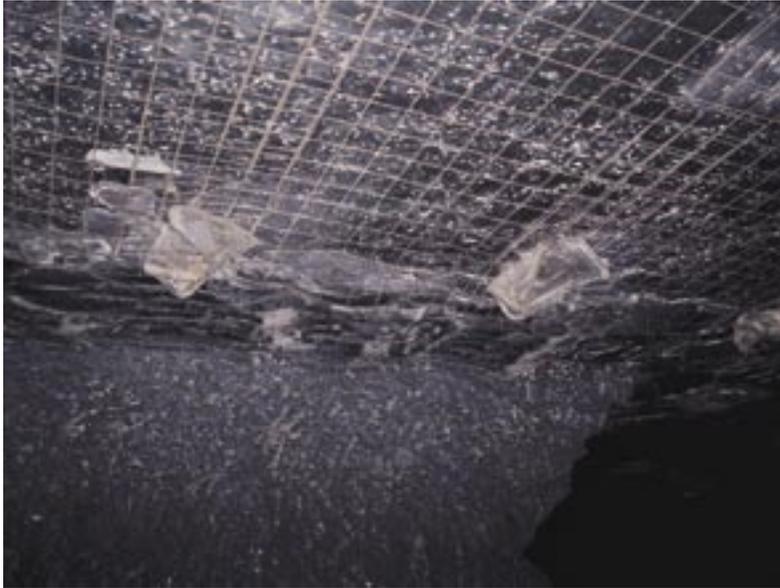
Wire screen, such as that in the picture to the left, was common in many areas of the Sago Mine. The West Virginia Office of Miners Health, Safety and Training required mine management to screen almost the entire roof area in the 2nd North Mains Section just prior to abandoning the Section.

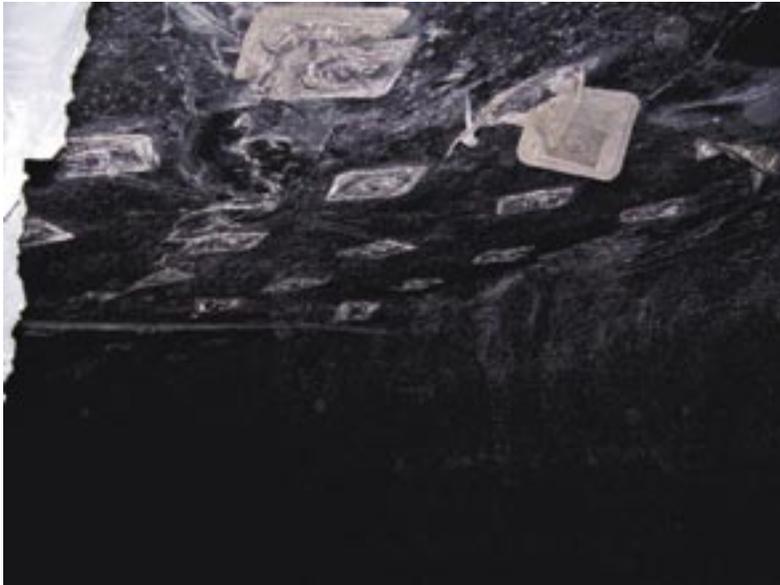
In areas that did not require wire mesh, management was required to install large roof bolt plates (pie pans) to support the local roof. Supplemental supports, such as cable bolts, were also required in many areas of the mine to address adverse conditions, including the 2nd North Mains Sections.

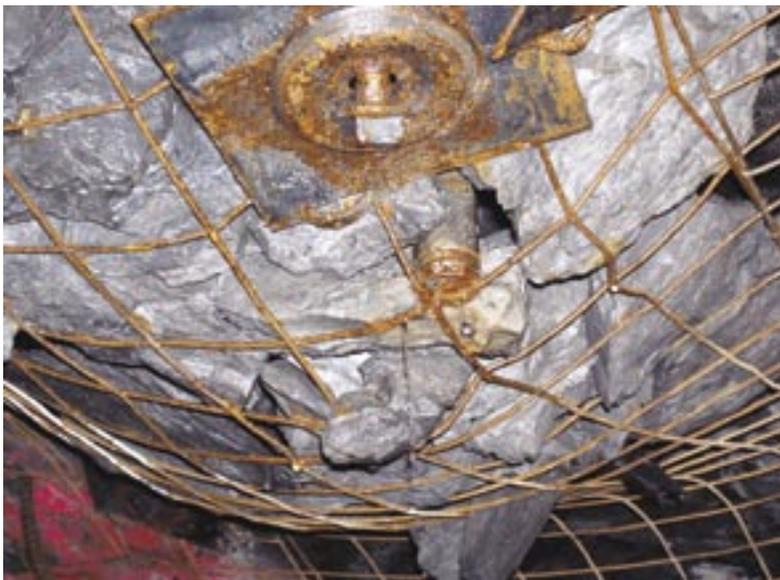
Continuously deteriorating roof conditions after an area has been supported by roof bolts and screening causes pressure on the supports as demonstrated in the picture. These stresses can cause the screening, bolts and roof to rub together or break under the pressure, potentially causing frictional arcing.

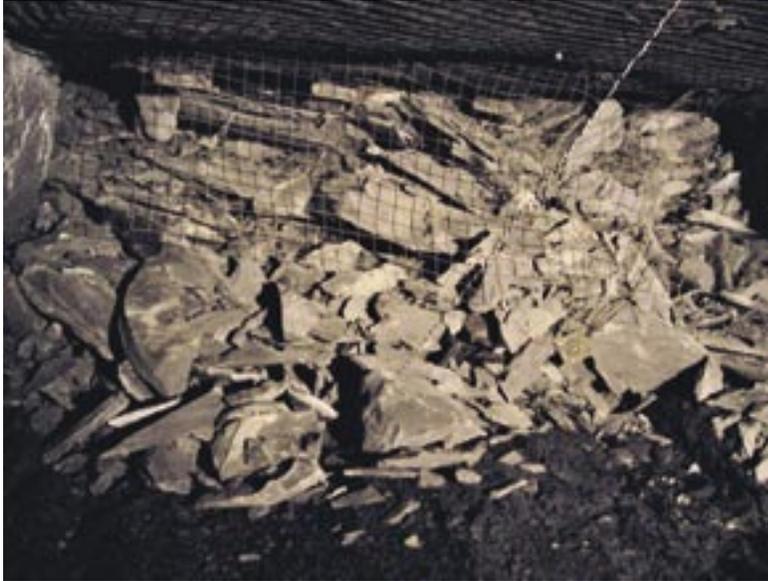
Roof falls are a hazard in the mining industry. The picture to the left was taken in the 2nd North Mains Section after the explosion. The investigation revealed numerous falls in the area that had occurred after it was sealed. Roof fall have been documented to cause frictional arcing.

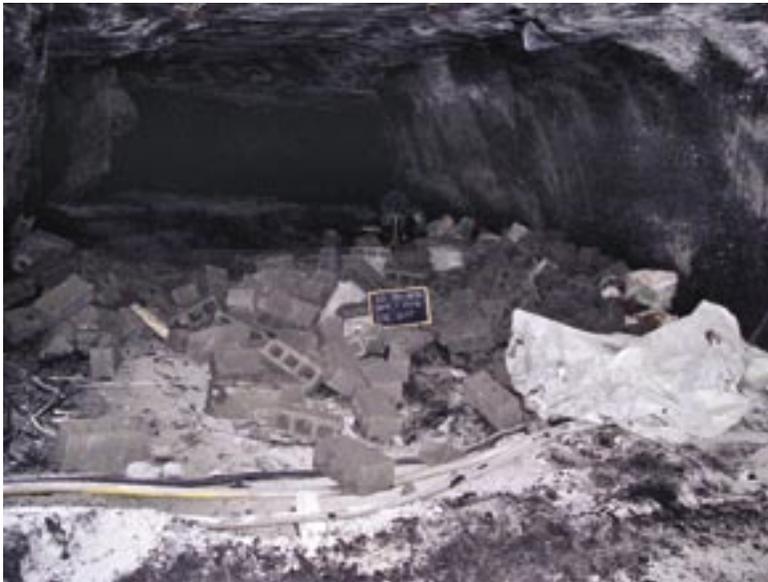
The remains of a concrete block wall after being struck by the forces of the explosion. It is still possible to see some of the blocks strewn around the area.

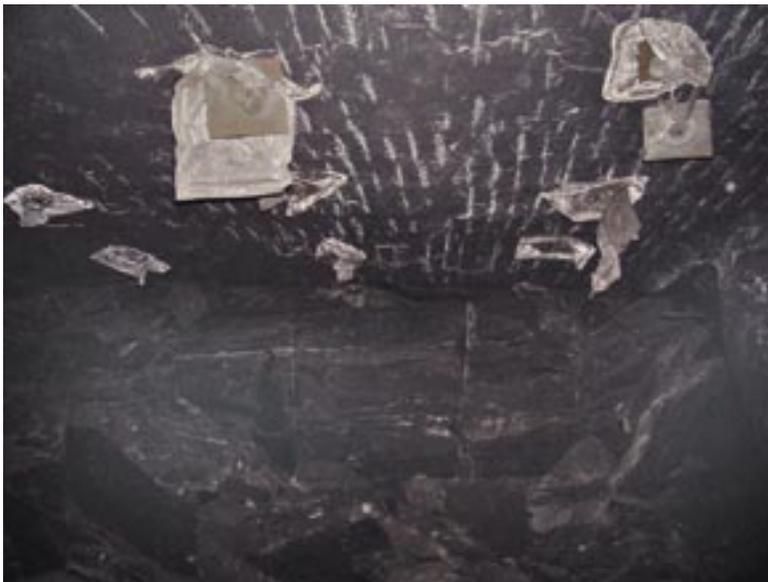
Damage to the roof supports (pie pans, roof bolts and plates) from the forces of the explosion. There is a roof fall in the foreground.

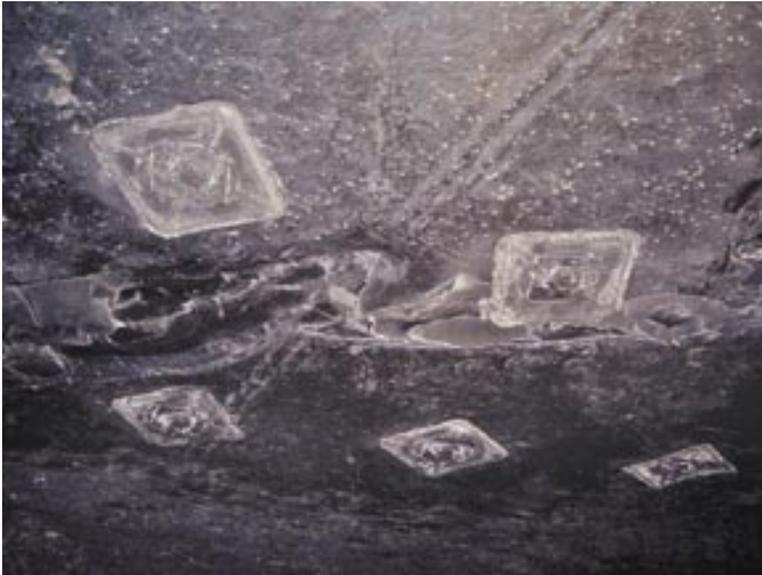
During the investigation the marks in the roof pictured at the left drew much attention. The "anomaly," as it became known, was later determined to be a fossil.

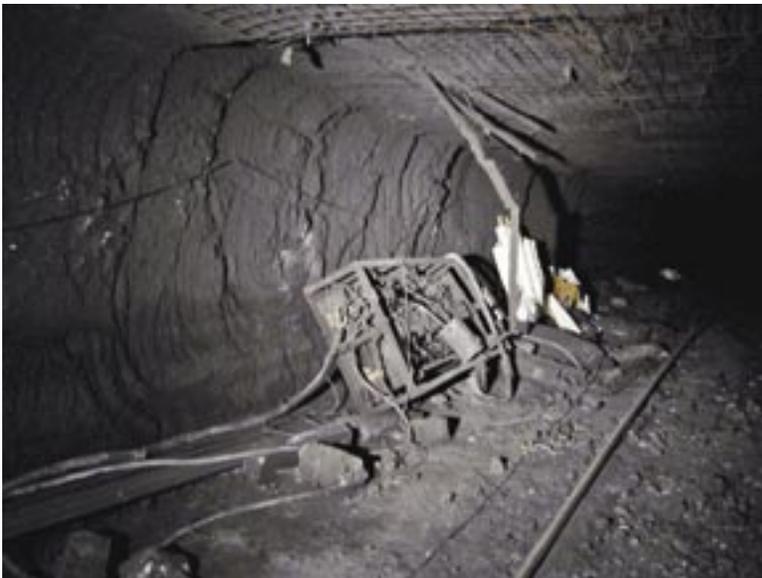
Damaged charging station located in the mains outby the sealed area.

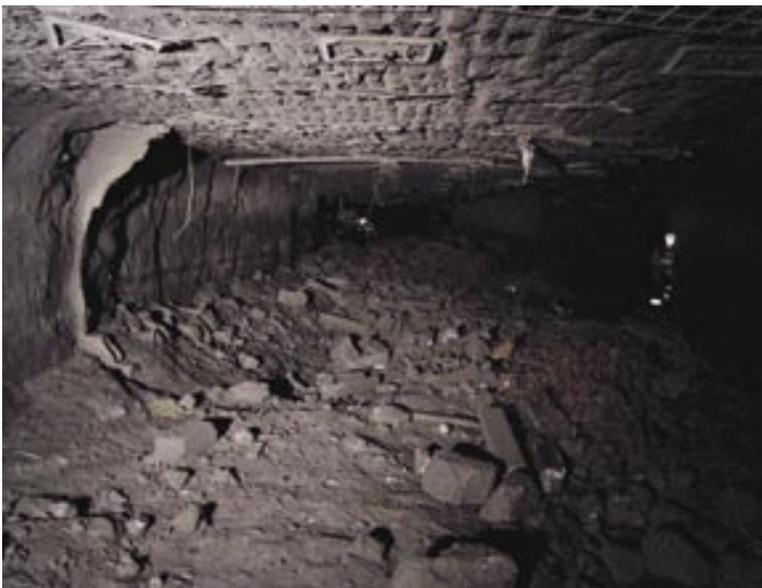
Area inby the Omega Block seals after the explosion. Debris is scattered over the entire area and a thick layer of soot covers everything.

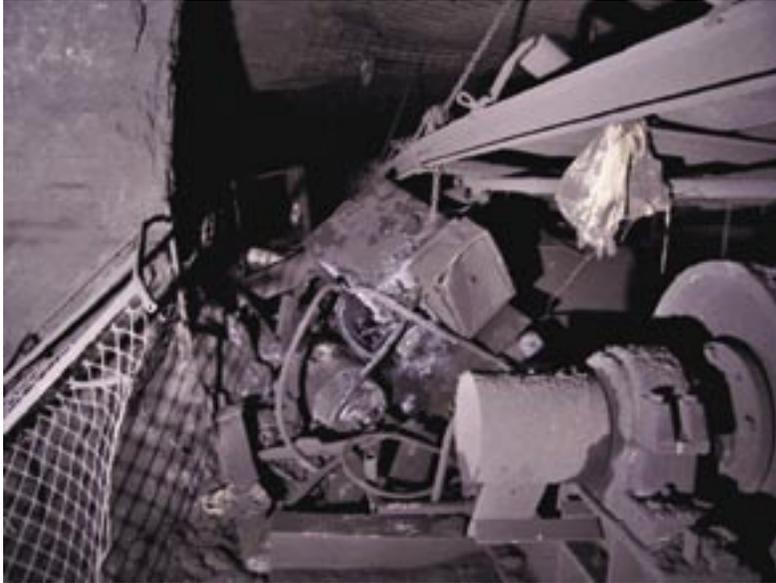
Damaged 2nd Left belt drive. The drive was located at 58 block, approximately the location where the miners were forced to abandon their first rescue attempt.

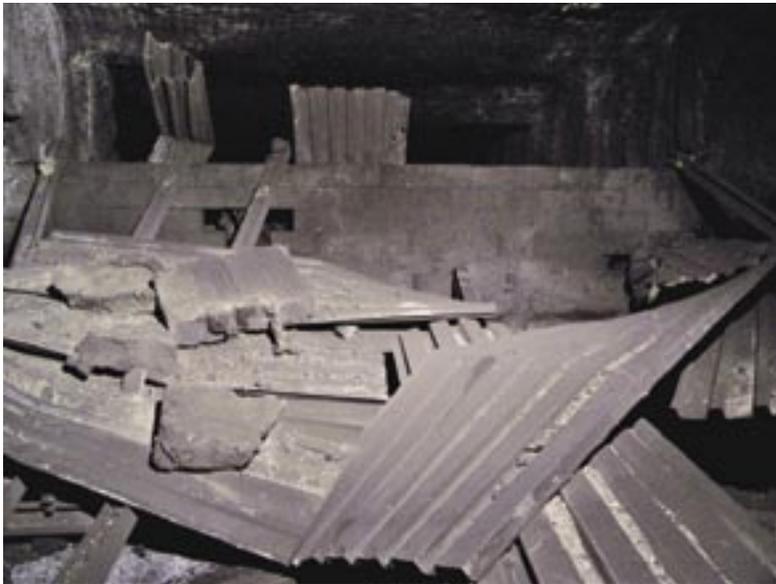
Ventilation overcast destroyed by the forces of the explosion.

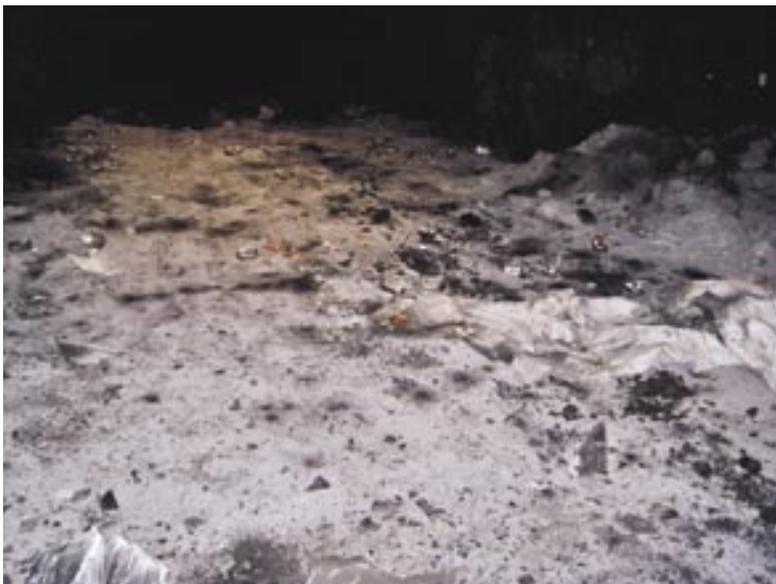
Discarded pieces of the 2nd Left crews SCSR's were found in the #7 entry at about the eleven block. The picture indicates all the miners donned their rescuers at the same time at this location.

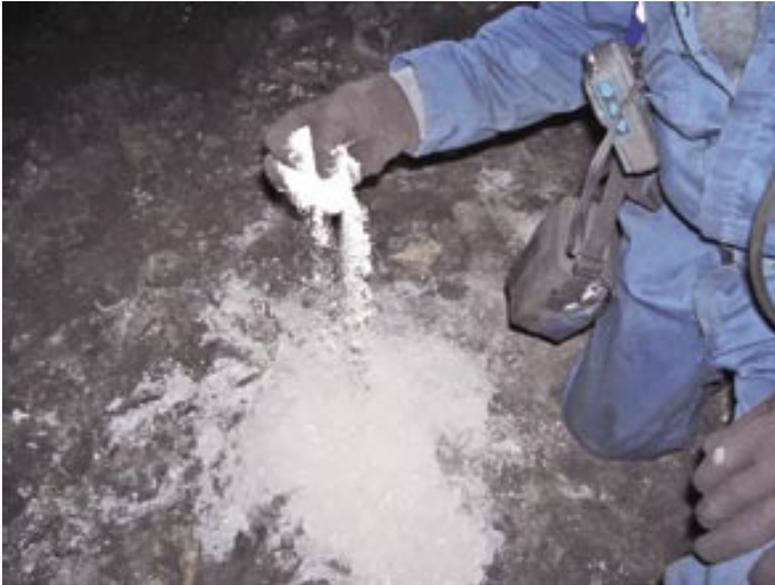
The explosion in the sealed area produced heat and extreme forces. These factors pulverized nine of the ten Omega Block seals. The remaining seal, located in the #1 entry, failed catastrophically.

The forces of the explosion completely destroyed the Omega Block seal. Fine powder and dust was all that remained of most of the seal material.

5. The use of Omega Blocks should not be permitted as a ventilation control in any underground mining operation.
6. The National Institute for Occupational Safety and Health (NIOSH) recently released a draft report entitled, "Explosive Pressure Design Criteria for New Seals in U.S. Coal Mines." The UMWA fully endorses the report and its recommendations, as follows:

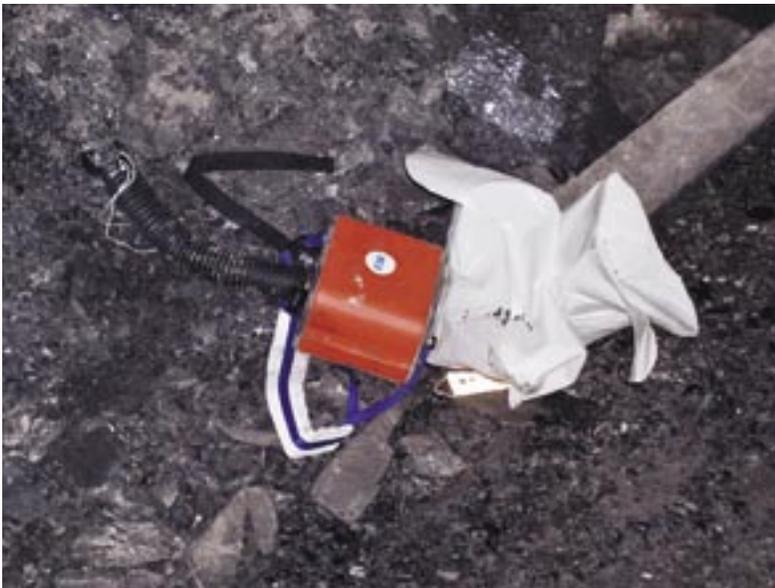
Discarded SCSR found in the 2nd Left Section.

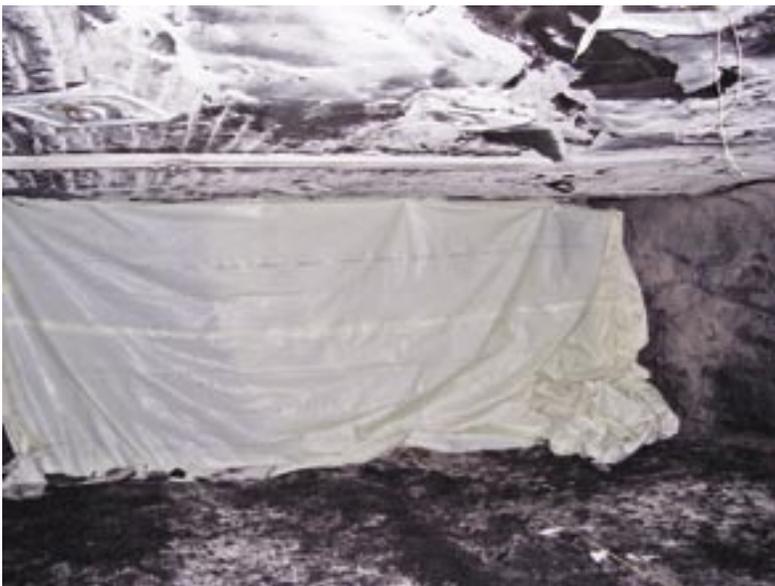
Outby view of the barricade constructed by the 2nd Left crew in an attempt to isolate themselves from the contaminated mine atmosphere.

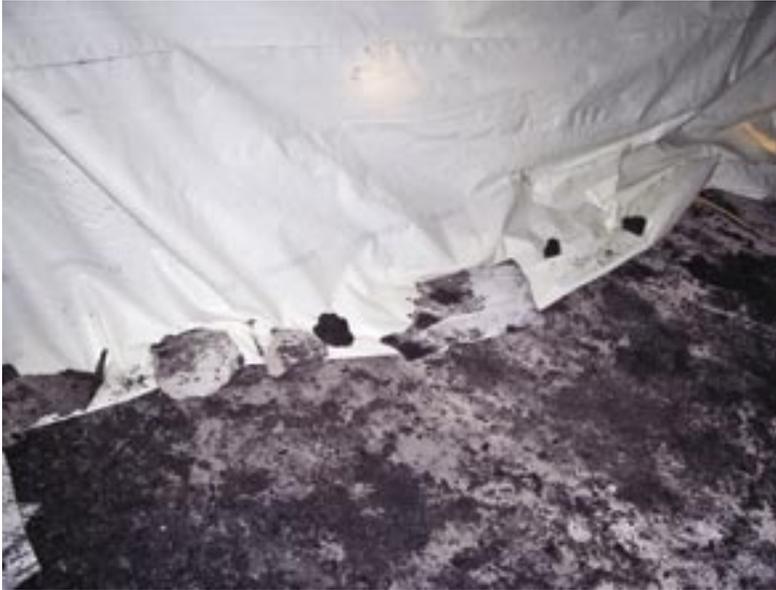
View of the barricade from the inby side.

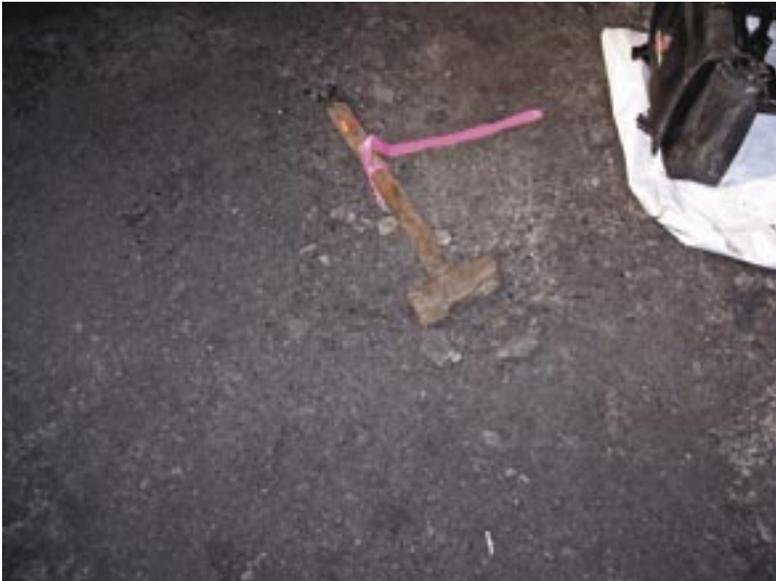
Sledge hammer used by the 2nd Left crew to signal their location to the surface.

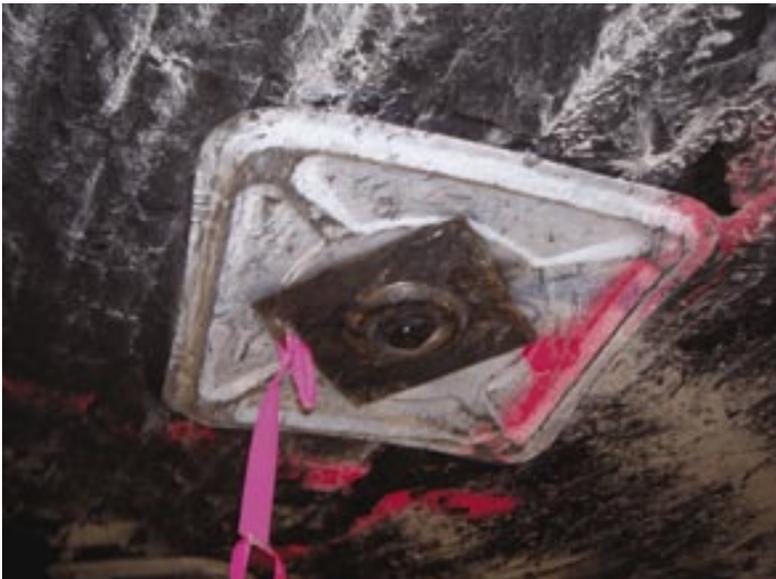
Roof bolt the 2nd Left crew hit to signal the surface of their location.

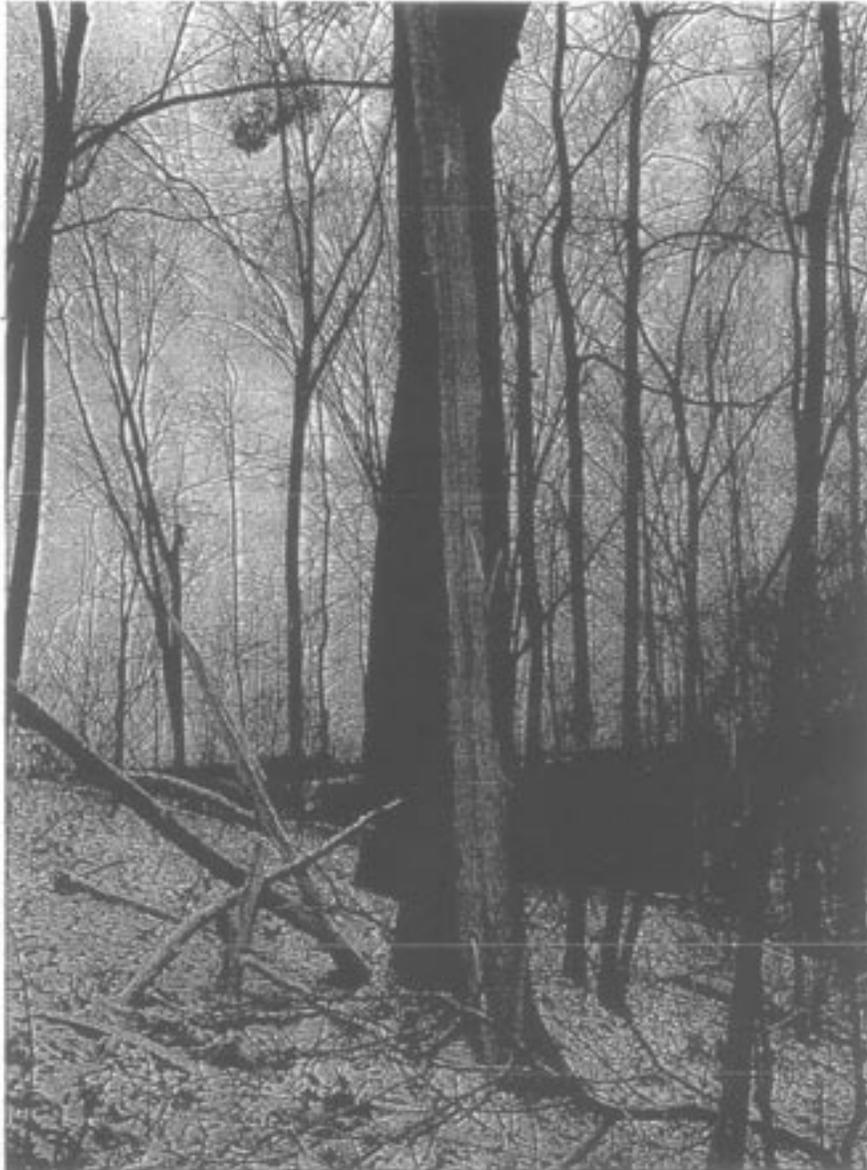
Photo 1. Poplar tree very recently hit by lightning and in close proximity to +110 kA hit recorded by Vaisala (StrikeNet) at LAT 38.926, LONG -80.233 at 06:26:35.680 am on January 2, 2006, Photo by Kermit Melvin, January 6, 2006.
