FINAL REPORT ON AN EXPLOSION IN THE
PANHANDLE MINE OF THE BICKNELL COAL
COMPANY AT BICKNELL, KNOX COUNTY, INDIANA
ON MAY 22, 1941

W. H. Tomlinson
Associate Mining Engineer

UNITED STATES
DEPARTMENT OF THE INTERIOR
BUREAU OF MINES

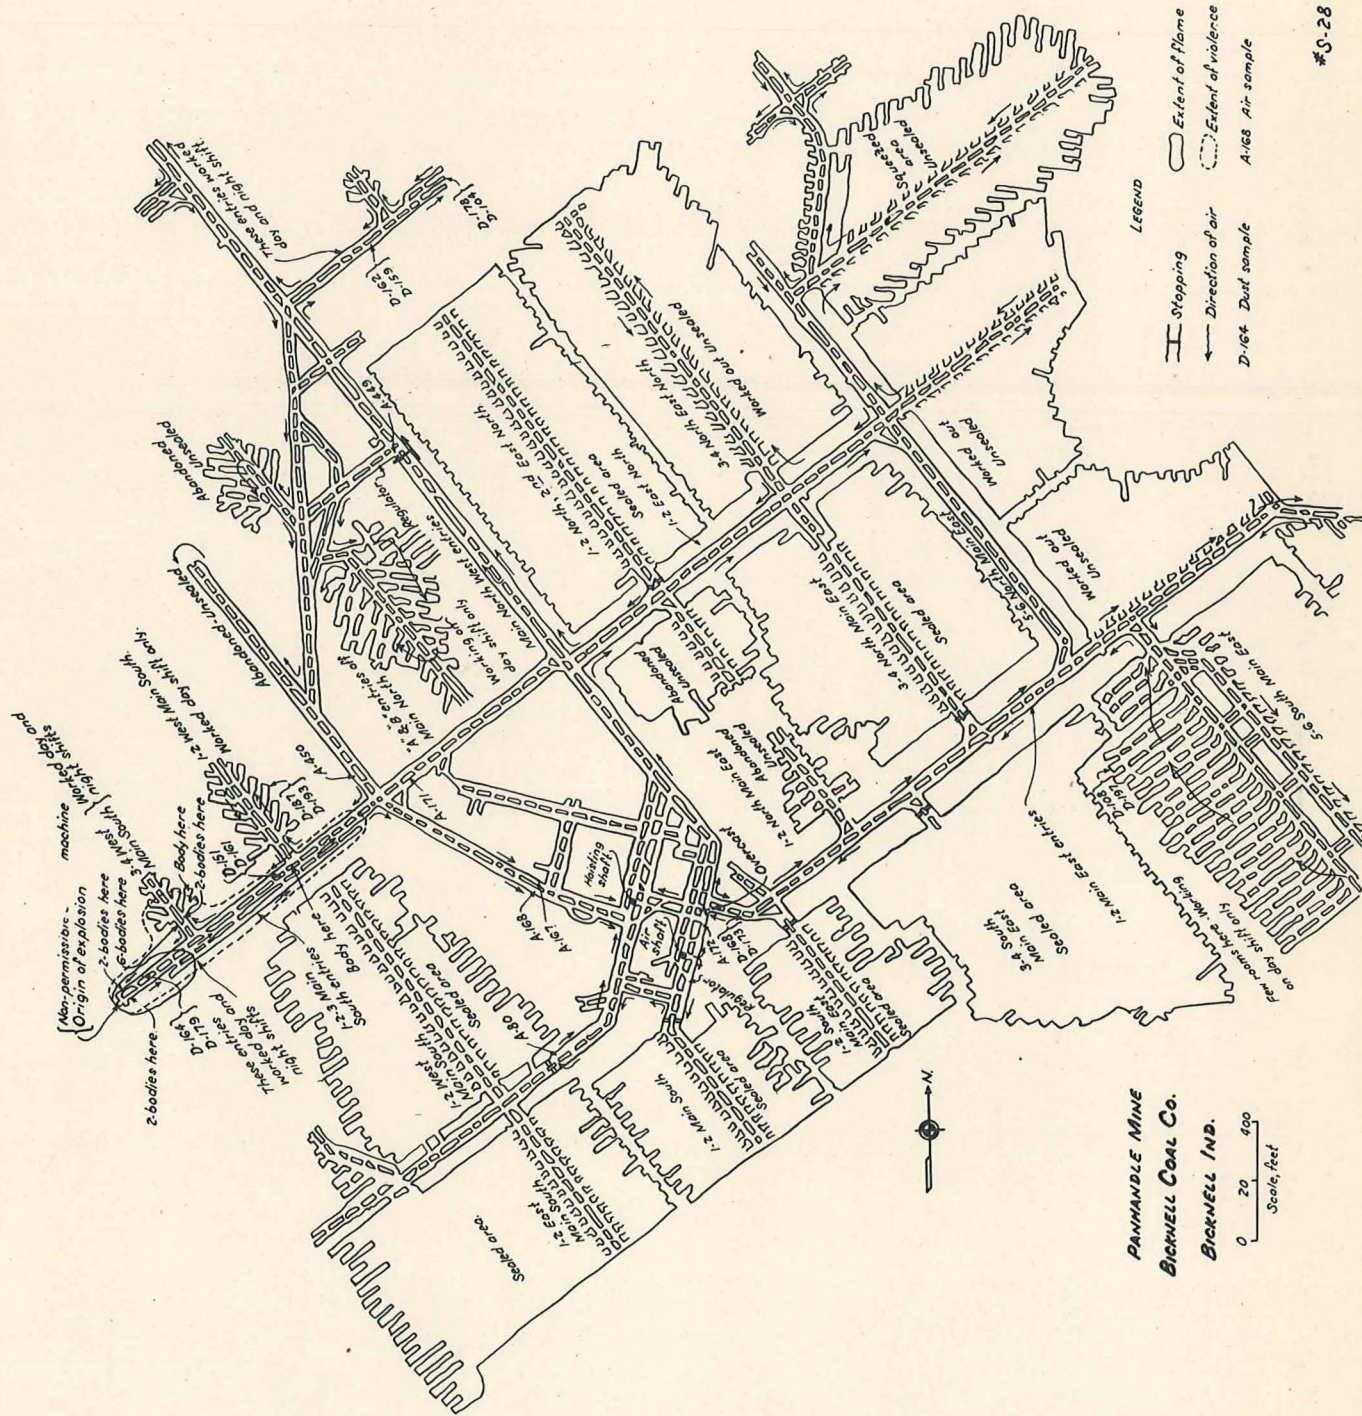
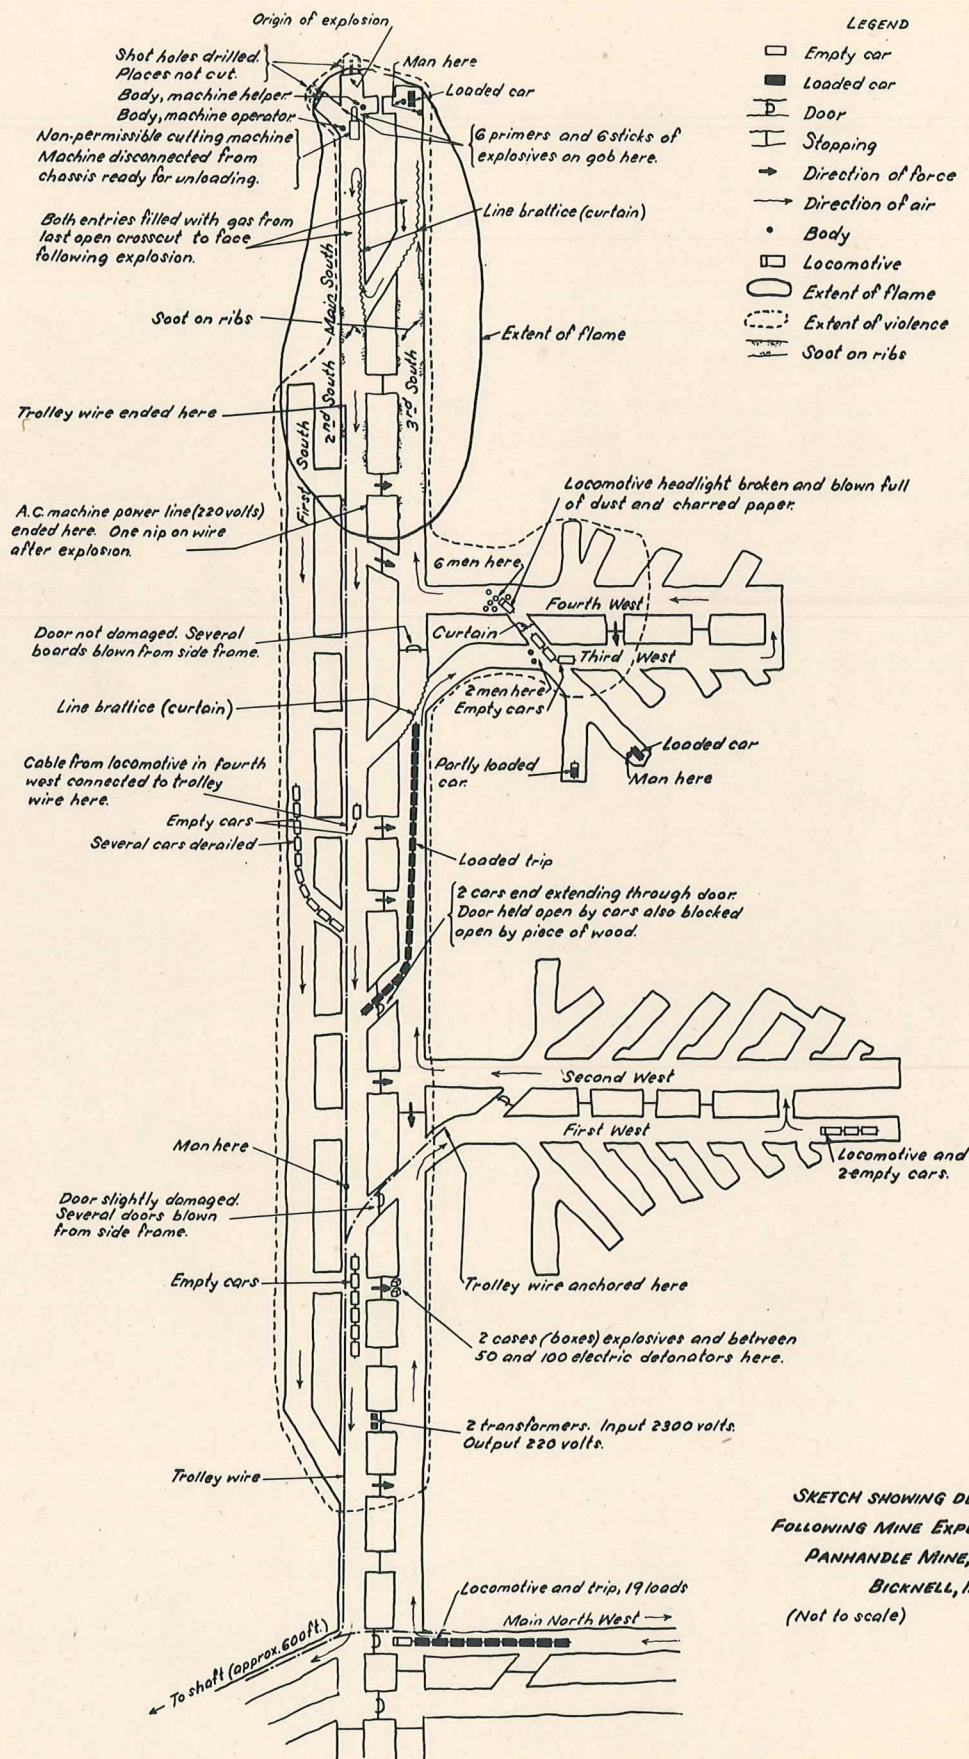
SKETCH SHOWING DETAIL OF EVIDENCE
FOLLOWING MINE EXPLOSION OF MAY 23, 1941.
PANHANDLE MINE, BICKNELL COAL CO.
BICKNELL, INDIANA.
(Not to scale)

Of the 14 killed, only three were burned; one, the cutting machine operator, received third degree burns of the arms, face and shoulders. This man's hair was also burned and his eyebrows singed off. The machine helper was also badly (though not fatally) burned. The third man burned was one of the loaders working in 3 south entry.

The property damage was slight. Starting at the face of the south entries the first stopping was intact; the next two outby stoppings were blown out. The "wings", or partition at the side of a door on 3 south entry between 3-4 west entries, were blown out though the door itself was not damaged. Evidently this door was open at the time of the explosion. A curtain in the first crosscut and a stopping in the second between 3-4 west entries were blown down. All stoppings (three) in crosscuts between 2-3 south entries from 3-4 west outby to 1-2 west were out, though a door in the second crosscut inby 2 west was undamaged. This is the door that was found blocked open by loaded cars. Two stoppings were in and two were out in crosscuts between 2-3 south entries from 1 west outby to the junction of the south entries with the main northwest. No damage was done in the 1-2 west entries except that the trolley wire which was anchored a few feet inby the entrance to 1 west was down. The condition of the door at the entrance to these entries was similar to that of the door at the 3-4 west. Evidently this door was also open at the time of the explosion. The trolley wire at the head of 2 south entry was down for some distance, however, the machine line was in place.

No other damage was done except a small fall of roof in 3 south entry inby 4 west. Since the roof in these entries was "good" no timbers were used which accounts for the absence of falls.
