INTRODUCTION

About 3:30 p.m., June 25, 1975, W. E. (Willie) Dodderer, millwright, SSN 555- , age 27, was asphyxiated when he and Eric R. Willis, millwright, entered a caisson in an attempt to rescue Brent Black, millwright, SSN 519- , age 35, who had succumbed earlier in an oxygen deficient atmosphere. The caisson was an upright corrugated steel tube about 6½ feet in diameter and 26 feet long, with approximately 10 feet protruding above ground. The caisson provided access to an underflow line and shutoff valve from a three-million-gallon thickener tank. The underflow line, near the bottom of the caisson, was being frozen with liquid nitrogen so that a faulty gate valve could be changed. Nitrogen leaking from the freeze jacket resulted in an oxygen deficient atmosphere.

The Boron open-pit borax mine and mill, operated by the United States Borax and Chemical Corporation, T. M. Cromwell, General Manager, is 3 miles north of Boron, Kern County, California. Working three 8-hour shifts a day, 7 days a week, were 945 employees.

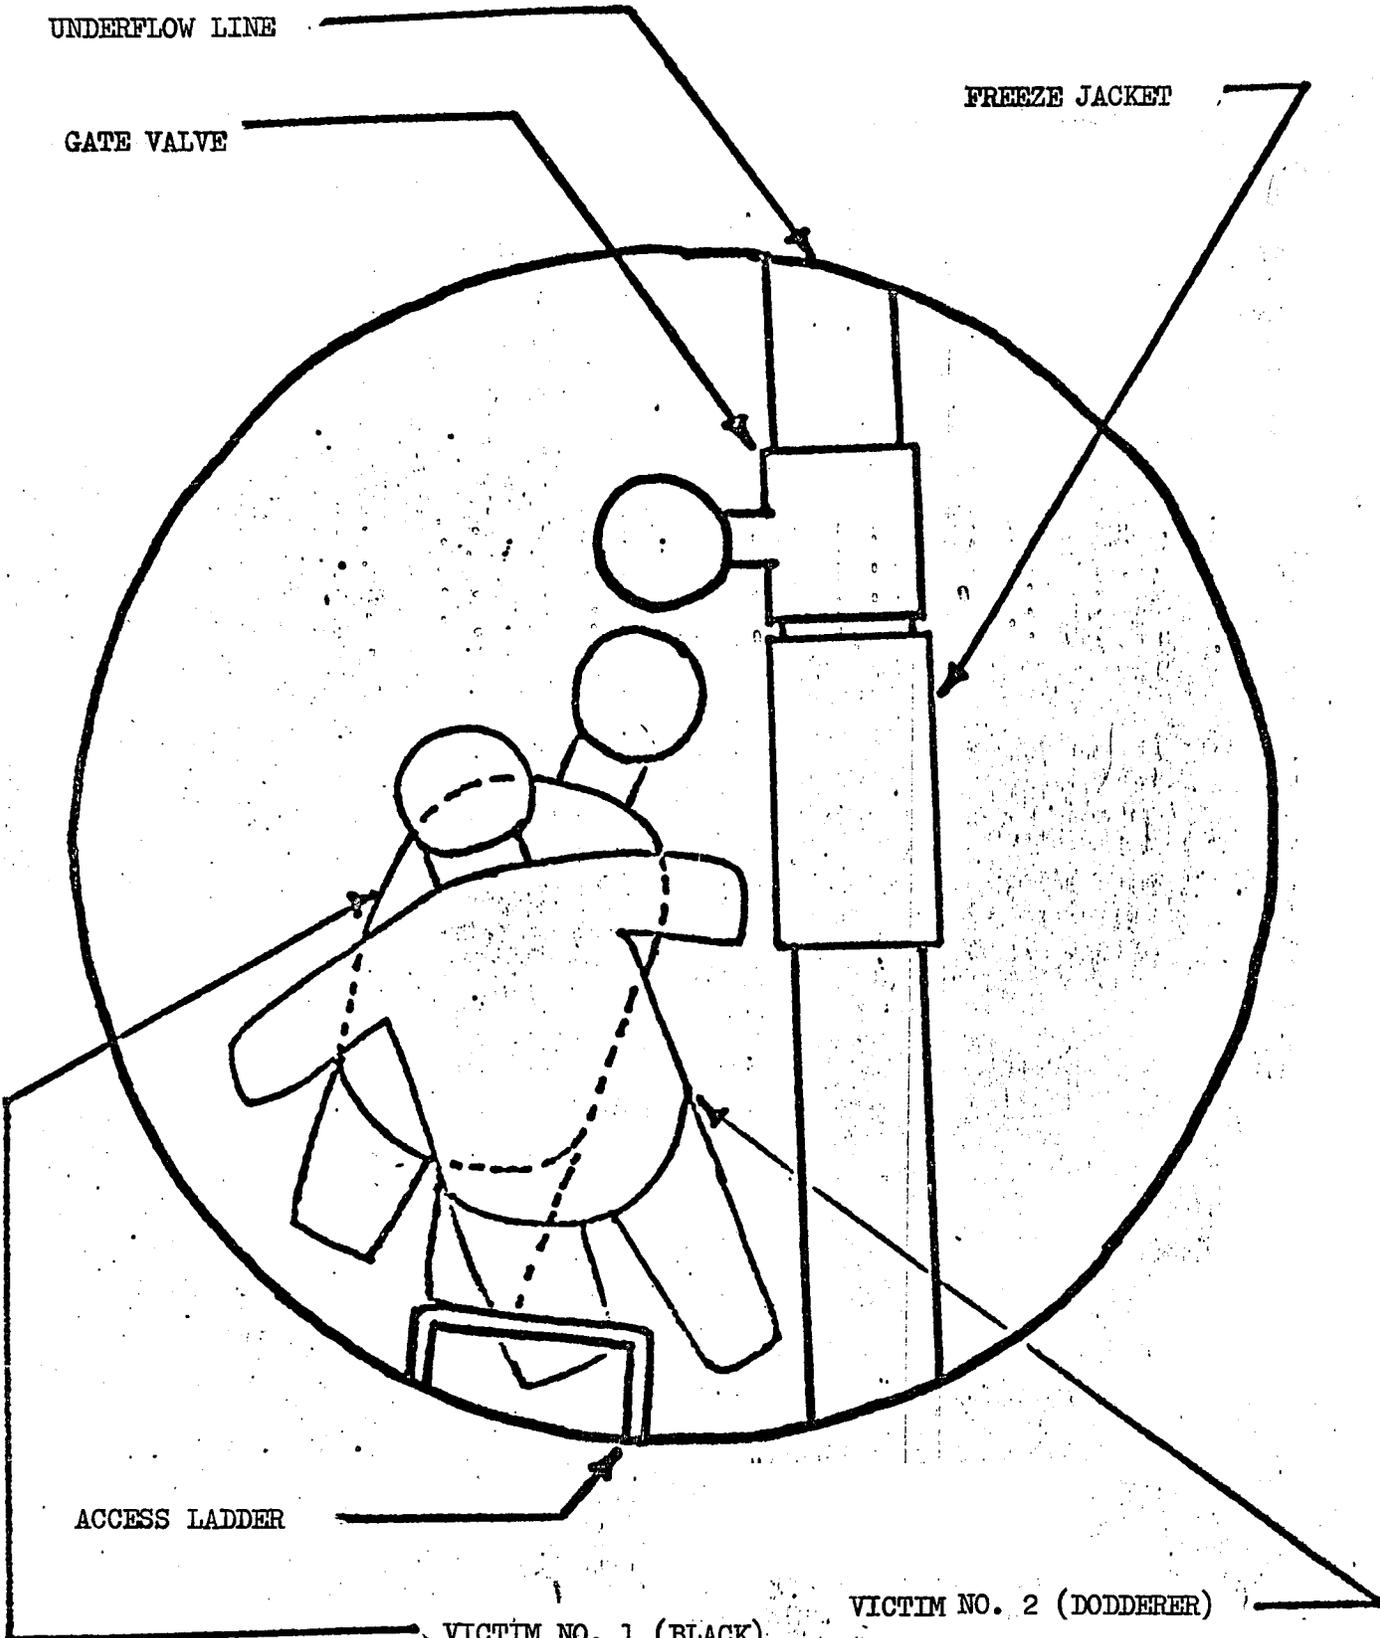
THICKENER TANK NO. 4 ACCESS CAISSON

UNDERFLOW LINE

GATE VALVE

FREEZE JACKET

ACCESS LADDER

VICTIM NO. 1 (BLACK)

VICTIM NO. 2 (DODDREER)

The direct cause of the accident was the failure of the company to provide and enforce a safe method for pretesting the freeze jacket and nitrogen piping. The apparently total lack of awareness of the hazards of using an inert gas such as nitrogen in a confined atmosphere indicated a failure of the company to provide adequate training for the workmen and supervisors involved.

A safe work procedure should be developed for maintenance and repair of the underflow lines. The procedure should be put in written form and made available to employees and supervisors who are assigned the work. The procedure should include:

A pressure check of the freeze system before the freezing agent is applied.

The material used for the freeze system should be compatible with the lowest possible temperature of the freezing agent. This would preclude the possibility of damage to the system because of extreme temperature.
