Homer City Mine

The Helen Mining Company

Methane and Coal Dust Explosion

July 3, 1983

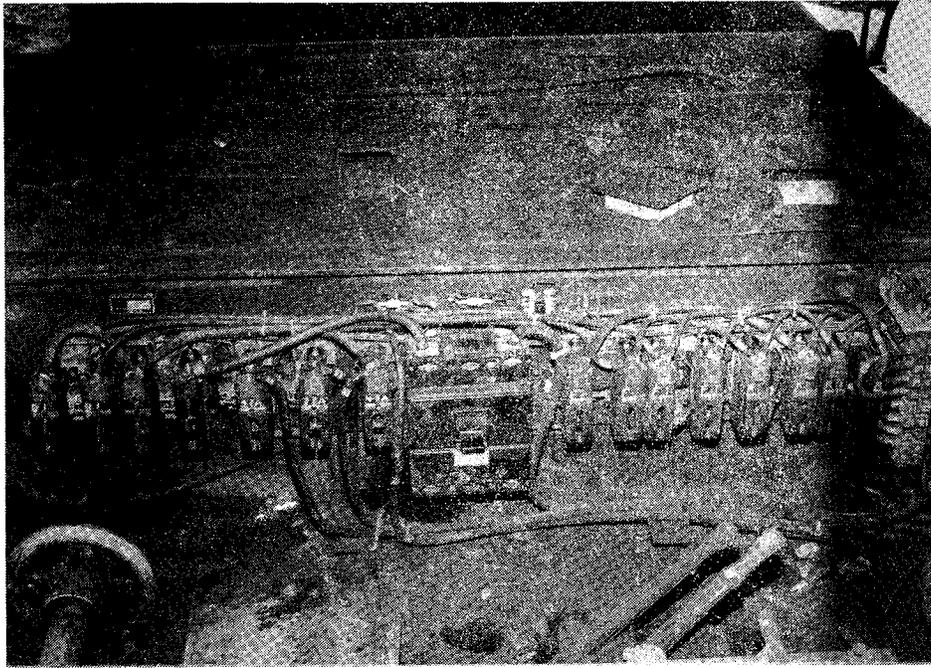
The West Virginia Armature Rail Runner Type II personnel carrier used by Mitsko (victim) was located in No. 2 entry just inby 36L crosscut. The only physical damage caused by the forces of the explosion were the two sealed beam headlights on the inby end which were broken by debris and loose coal. The open-type main contactor panel contained 15 contactors that under normal operation would create arcing of sufficient energy to ignite methane. The metal cover over the main contactor panel was loose fitting with open areas at the ends and around the molded case circuit breaker where methane could enter easily. An inspection of the tram controller compartment revealed no physical evidence of arcing or soot deposits around the cover flanges. The two 20-horsepower traction motors were opened up and tested for commutator arcing and grounding. These showed no evidence of being a source of ignition. The resistor, knife blade disconnect and battery compartments were covered with heavy soot and were considered as a source of ignition; however, there was no evidence of arcing, ground faults or short circuits.

PHOTOGRAPH NO. 1 - Battery-powered contact compartment on personnel carrier in by 36L crosscut.

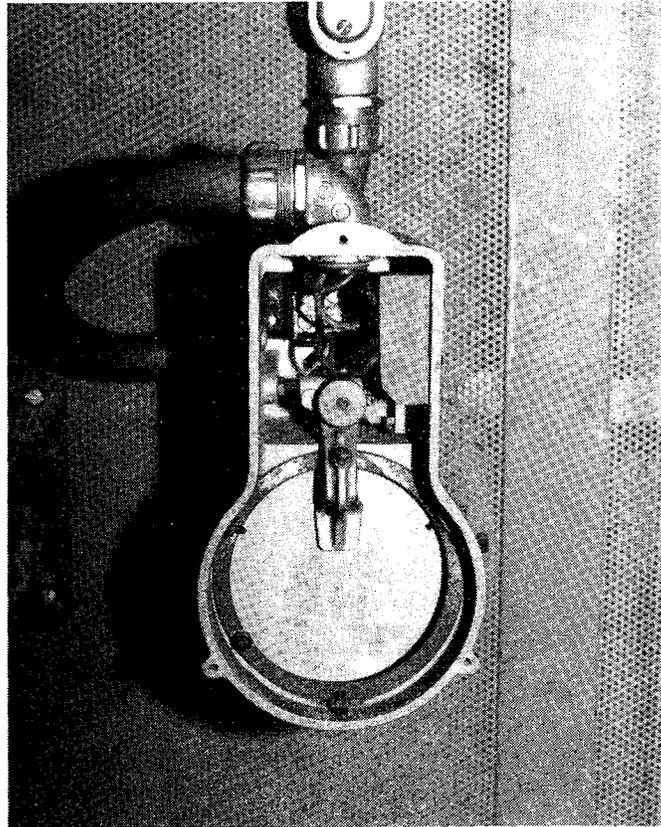
Each of the three mine fan installations was equipped with a single switch to activate the fan signal alarm system (See photograph No. 2, Appendix I). In the No. 3 fan, the switch was mounted on a wall of the fanhouse and a 2-inch-diameter pipe extended from the switch into the fan duct to sense the mine ventilating pressure. During normal fan operation, the negative pressure developed by the exhaust fan causes an aluminum flapper to close. With the flapper in the closed position, electrical contacts close and keep the alarm system from operating. The device is designed so that when the ventilating pressure decreases to less than negative 0.12 inches of water, the switch will open the electrical contacts activating the alarm system at the mine portal and the hoisthouse.

1. The automatic signal device which was installed in the No. 3 fan ducting did not give an alarm at the manned No. 2 shaft portal when the No. 3 mine ventilation fan shut down.
2. The day shift assistant foremen who traveled and worked in the Muddy Run area of the mine between 8:00 a.m. and 4:00 p.m., failed to recognize that the ventilation had been drastically reduced.
3. The person (Mitsko) who was required to make examinations in E-Butt did not have in his possession a means approved by the Secretary for detecting methane.

PHOTOGRAPH NO. 2 - Fan signal alarm switch.

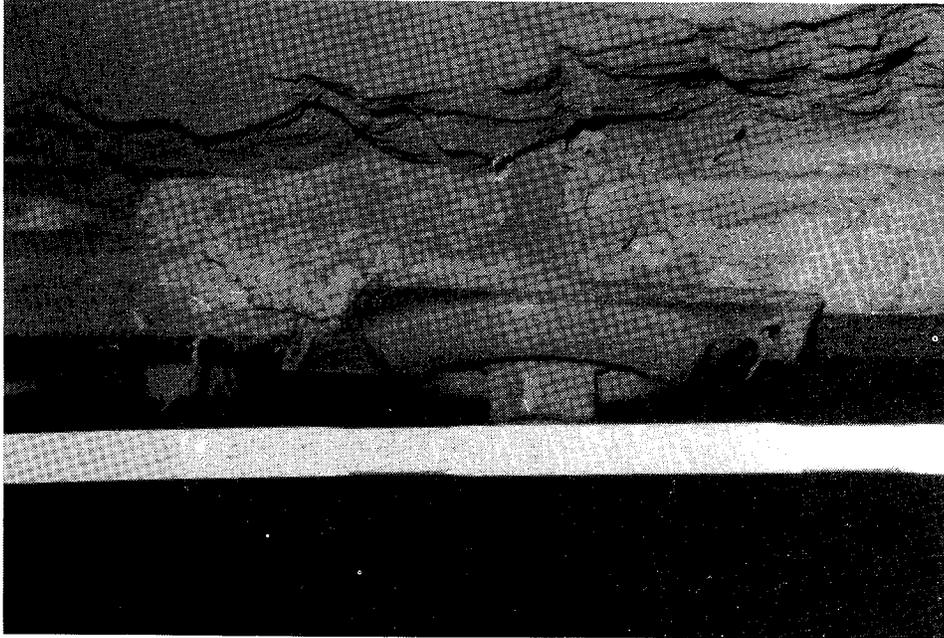
PHOTOGRAPH NO. 3 - Coke deposits in area of power distribution center in 40R crosscut.
