REPORT OF UNDERGROUND COAL MINE INVESTIGATION

FATAL ROOF-FALL ACCIDENT

SEGCO NO. 1 MINE (I.D. 01-00347)
ALABAMA BY-PRODUCTS CORPORATION
PARRISH, WALKER COUNTY, ALABAMA

October 11, 1977

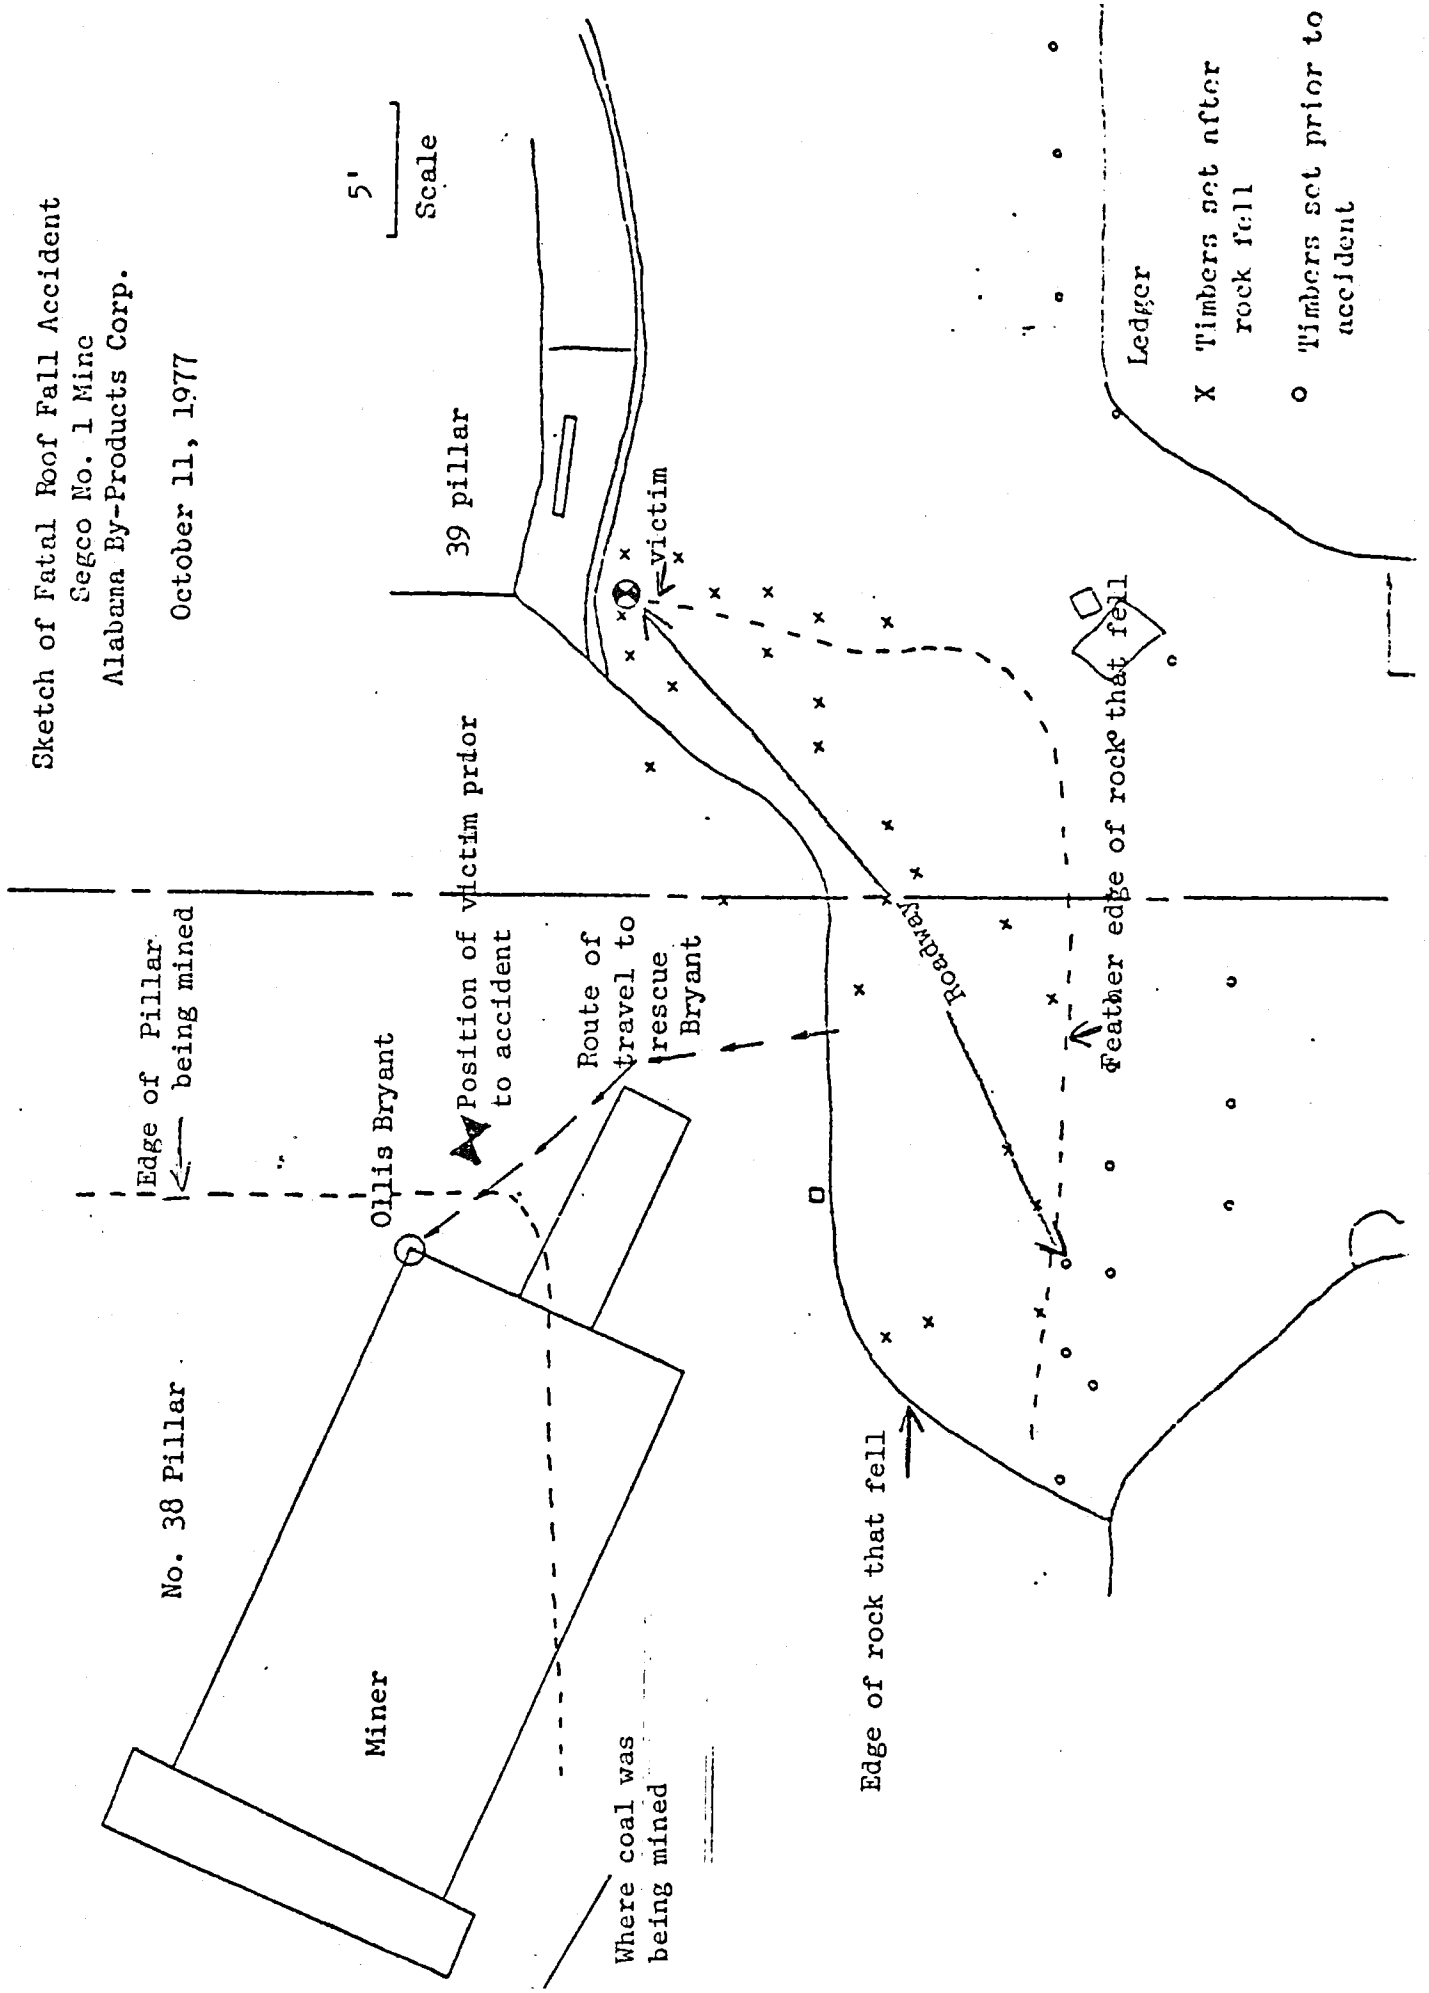
Sketch of Fatal Roof Fall Accident
 Segco No. 1 Mine
 Alabama By-Products Corp.

1. Observation of the accident scene during the investigation revealed that the roof fall extended outby the corner of the right side of the intersection of No. 38 and No. 39 pillar block of coal. According to the crew members, at the crack of the timbers, the roof fell without any other warning.

3. In the case of this accident, the roof fall extended about 5 feet outby the normal break-line. It is also possible that Kilpatrick might have thought the roof fall was not imminent, since the roof in the retreat mining areas "works" for varying lengths of time before the fall actually occurs.

4. The rock fell 5 feet outby the normal break-line.
5. The adopted roof support plan required timbers to be set on 4-foot centers maintaining a 18-foot wide roadway.

1. The widths of the No. 09 room roadway were in excess of 18 feet in width. A violation of section 75.200.
2. The roadway was 24 feet in width.

The cause of the accident was management's failure to properly examine, evaluate, and adequately support the mine roof.
