REPORT OF INVESTIGATION
NOVEMBER 30, 1993
UNDERGROUND COAL MINE EXPLOSION
ELMO #5 MINE - I.D. NO. 15-16856
A.A. & W. COALS, INC.
FEDS CREEK, PIKE COUNTY, KENTUCKY

Originating Office
Mine Safety and Health Administration
Office of the Administrator
Coal Mine Safety and Health
4015 Wilson Boulevard
Arlington, Virginia 22203
Marvin W. Nichols, Jr., Administrator

Release Date: January 4, 1995

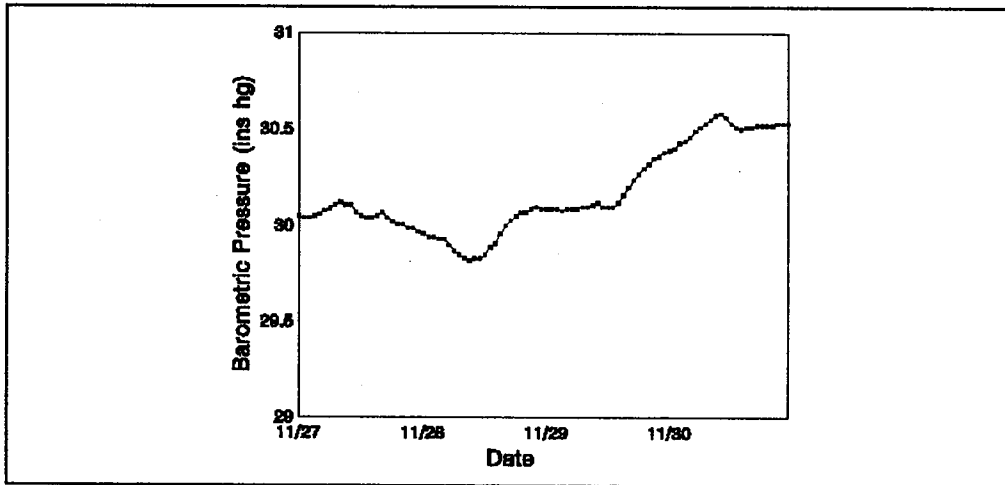
FIGURE 1

Atmospheric weather conditions for the Feds Creek, Kentucky area are recorded hourly by the National Weather Service station located at the Huntington, West Virginia airport, approximately seventy miles north of the mine. A review of this information was conducted to determine if any significant decrease in barometric pressure had occurred prior to the explosion. Figure 1 is a graph of the barometric pressure from November 27-30, 1993.

Figure 1 illustrates a slight drop in barometric pressure which occurred immediately prior to the explosion. A decrease in barometric pressure prior to the explosion would have increased the potential for methane to migrate from the pillared panels to outby areas.
