REPORT OF THE CATASTROPHE AT SAN TOY No. 1 MINE, PERRY COUNTY, BY THE CHIEF INSPECTOR OF MINES.

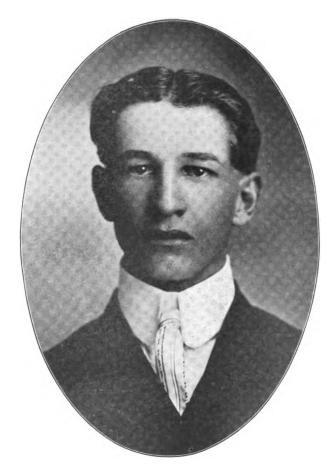
JOHN HENRY WRIGHT.

Mr. Wright was one of the six persons precipitated to the bottom of the shaft of the San Toy No. 1 mine, November 3, 1906, by the accident to the cage, and the only one who escaped with his life. Both of his limbs were broken, and he suffered other injuries from the accident. His escape from instant death was almost miraculous. A detailed account of this deplorable accident will be found on the opposite page, and also in Mr. Pritchard's report on page 295.
