C. A. Herbert
Supervising Engineer

UNITED STATES
DEPARTMENT OF THE INTERIOR
BUREAU OF MINES

REPORT OF EXPLOSION
IN
LIQUID OXYGEN EXPLOSIVE PLANT,
FIDELITY STRIP MINE,
UNITED ELECTRIC COAL COMPANY
DUQUOIN, PERRY COUNTY, ILLINOIS.

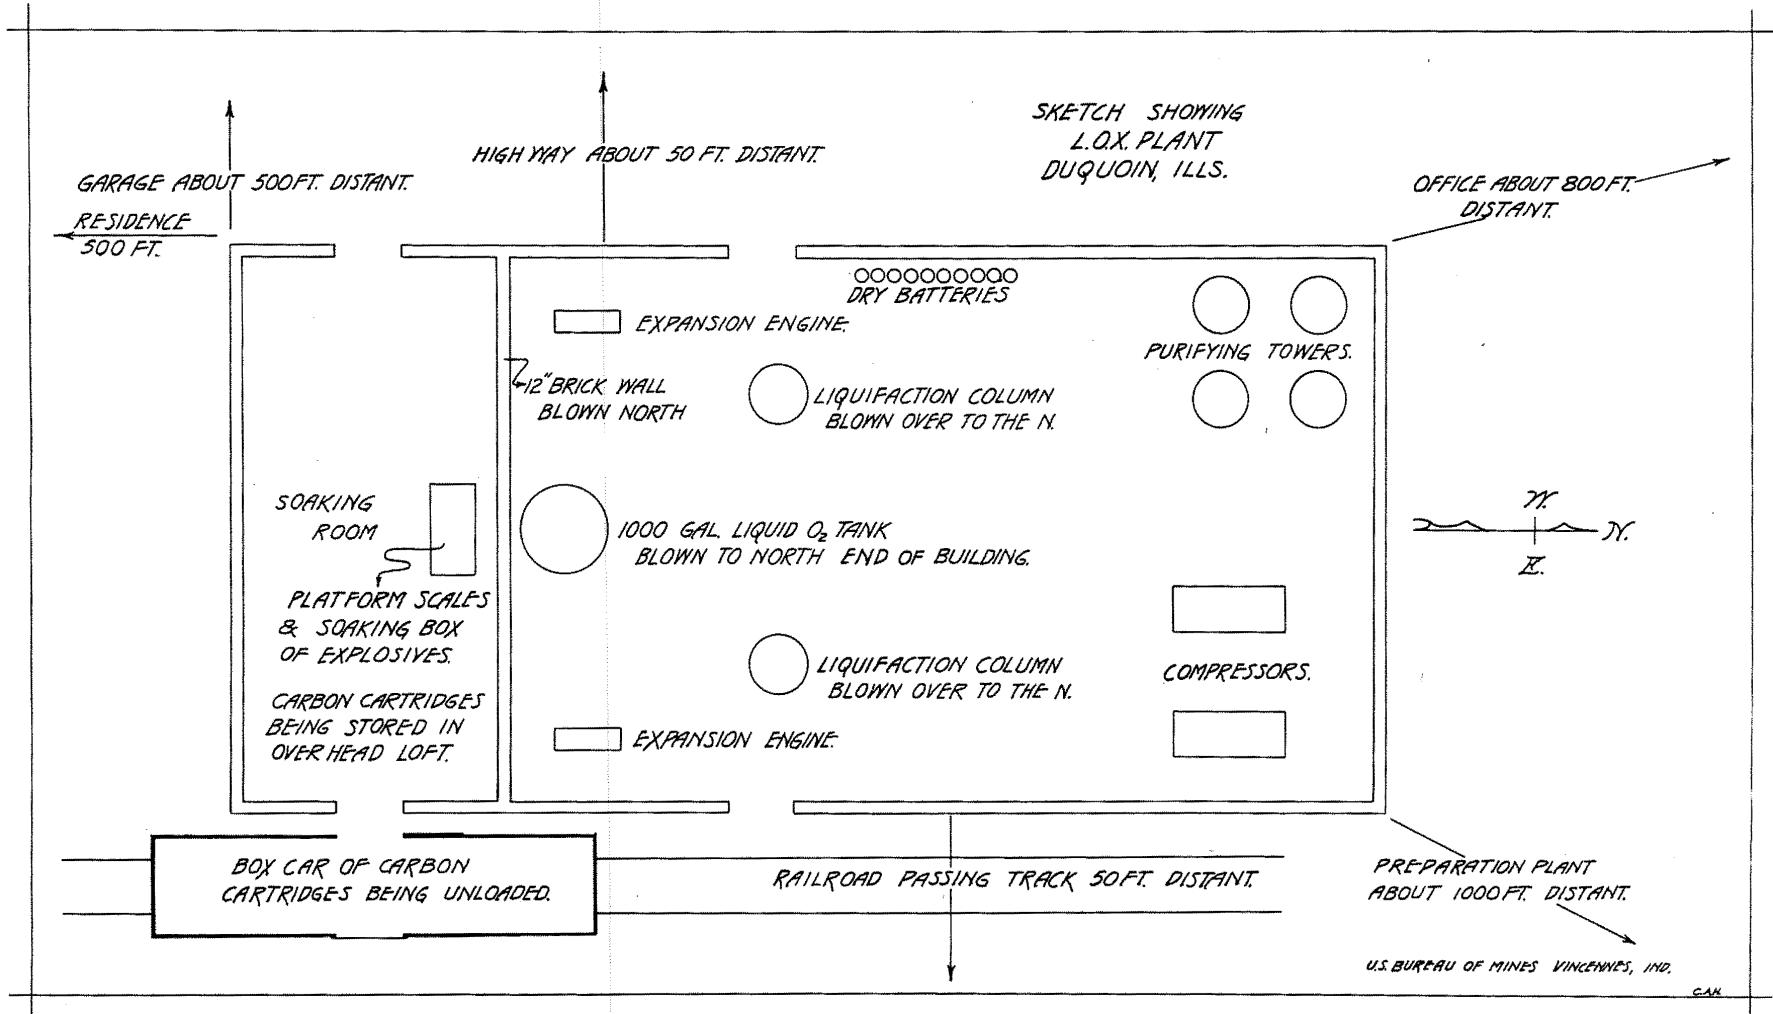
The attached sketch shows the layout of the plant and
approximate location with respect to other plant buildings.
