FINAL REPORT OF MINE EXPLOSION  
MINE NO. 47, PEABODY COAL COMPANY  
HARCO, SALINE COUNTY, ILLINOIS

12-28-41

L. H. McGuire  
Associate Mining Engineer

UNITED STATES  
DEPARTMENT OF THE INTERIOR  
BUREAU OF MINES

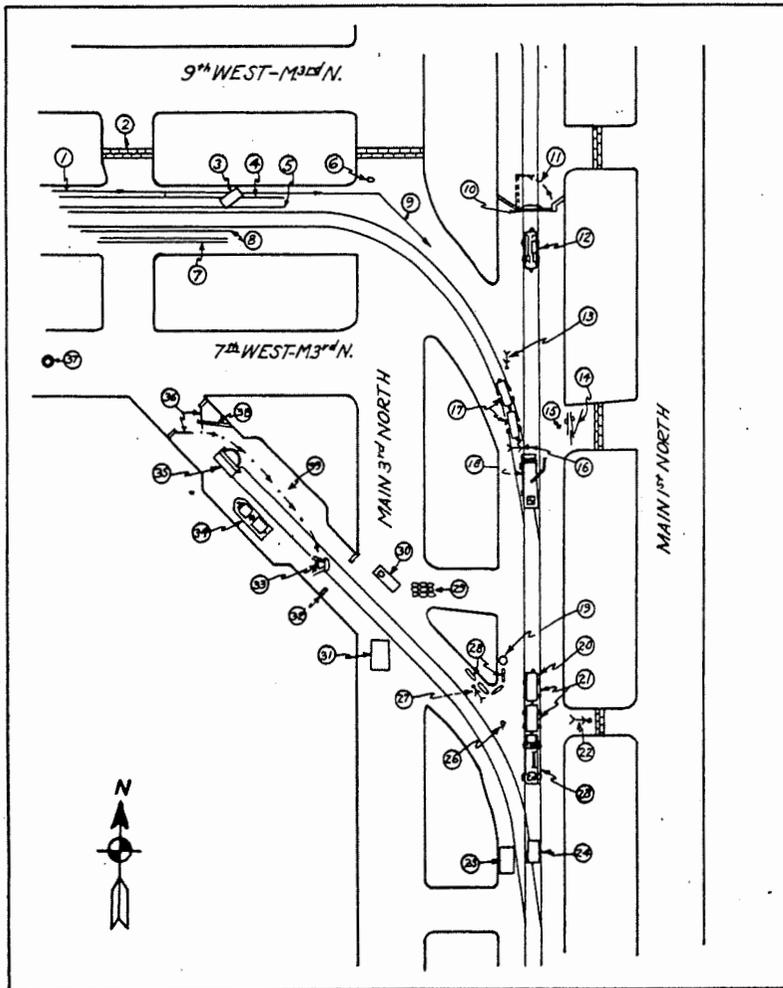
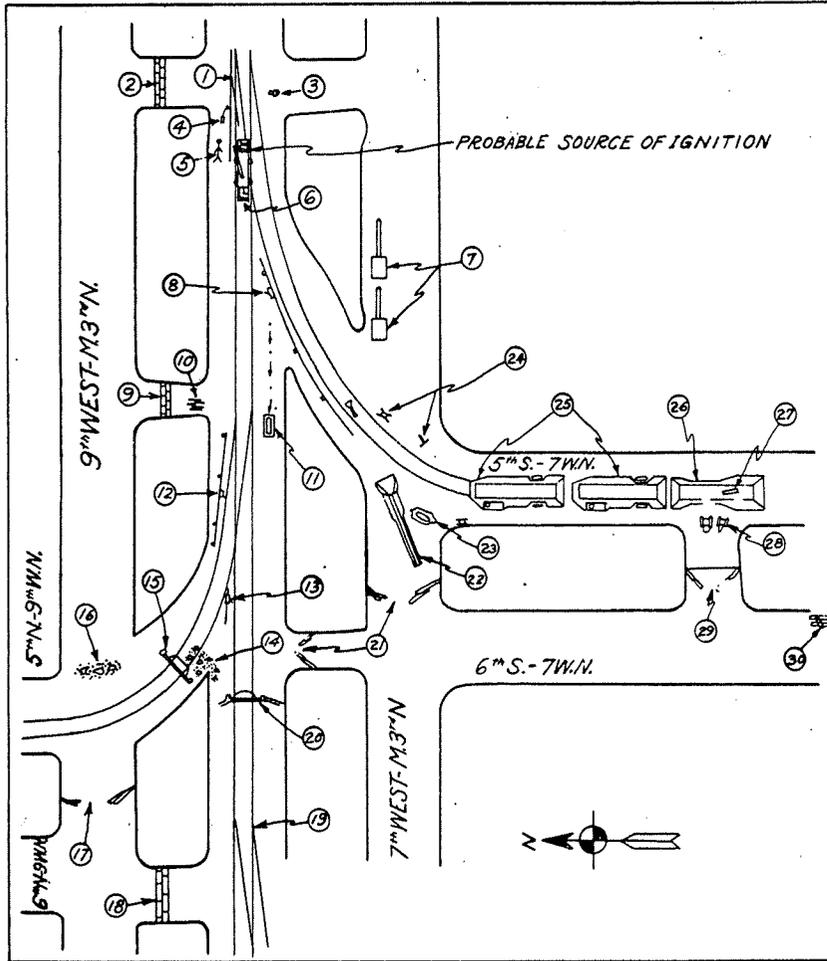
PLAN VIEW AT SECTION B-B'  
SHOWING DETAILS OF MINE EXPLOSION

The explosion was probably due to the ignition by electrical arcs or sparks of an inrush of explosive gas in 5th and 6th south entries and rooms thereof, off 7th west off main 3rd north. The origin was probably one of the following two places: A short distance inby past the first cross-over track on 5th south due to an electrical short circuit caused by a roof fall knocking the trolley wire down and against the rail; the other on 8th west at 5th south by arcs or sparks from the mine examiner's trolley locomotive.

The conditions surrounding the trolley locomotive operated by the mine examiner, Harold Holden, located on 8th west at 5th south are as follows; the trolley pole was against the roof and was undamaged; the pole was between the trolley wire leading into 5th south and 8th west, indicating that it was either placed there by the examiner or had jumped off the trolley wire frog and was not moved by the force of the explosion; the hand brake was set; the controller was in the off position, and the permissible flame safety lamp hanging on the brake rod was found to be properly assembled with no defective parts. It is assumed that the ignition took place as the trolley wheel passed through the trolley-wire frog. It would appear at first that the examiner would have insufficient time to remove his trolley pole, turn the controller in the off position, set the hand brakes, and get between the locomotive and rib before the explosion caught him. On the other hand, it is likely that the gas-air mixture was at the lower explosive point and close to the roof, having come out of 5th and 6th south into the 7th and 8th return air entries shortly after the electrical crew left for the outside. Upon ignition the flame probably traveled slowly back into 5th and 6th south, perhaps several seconds before the "back lash" of the explosion coming out of these entries caught the examiner. He probably had his hand brake set when he threw the track switch at 5th

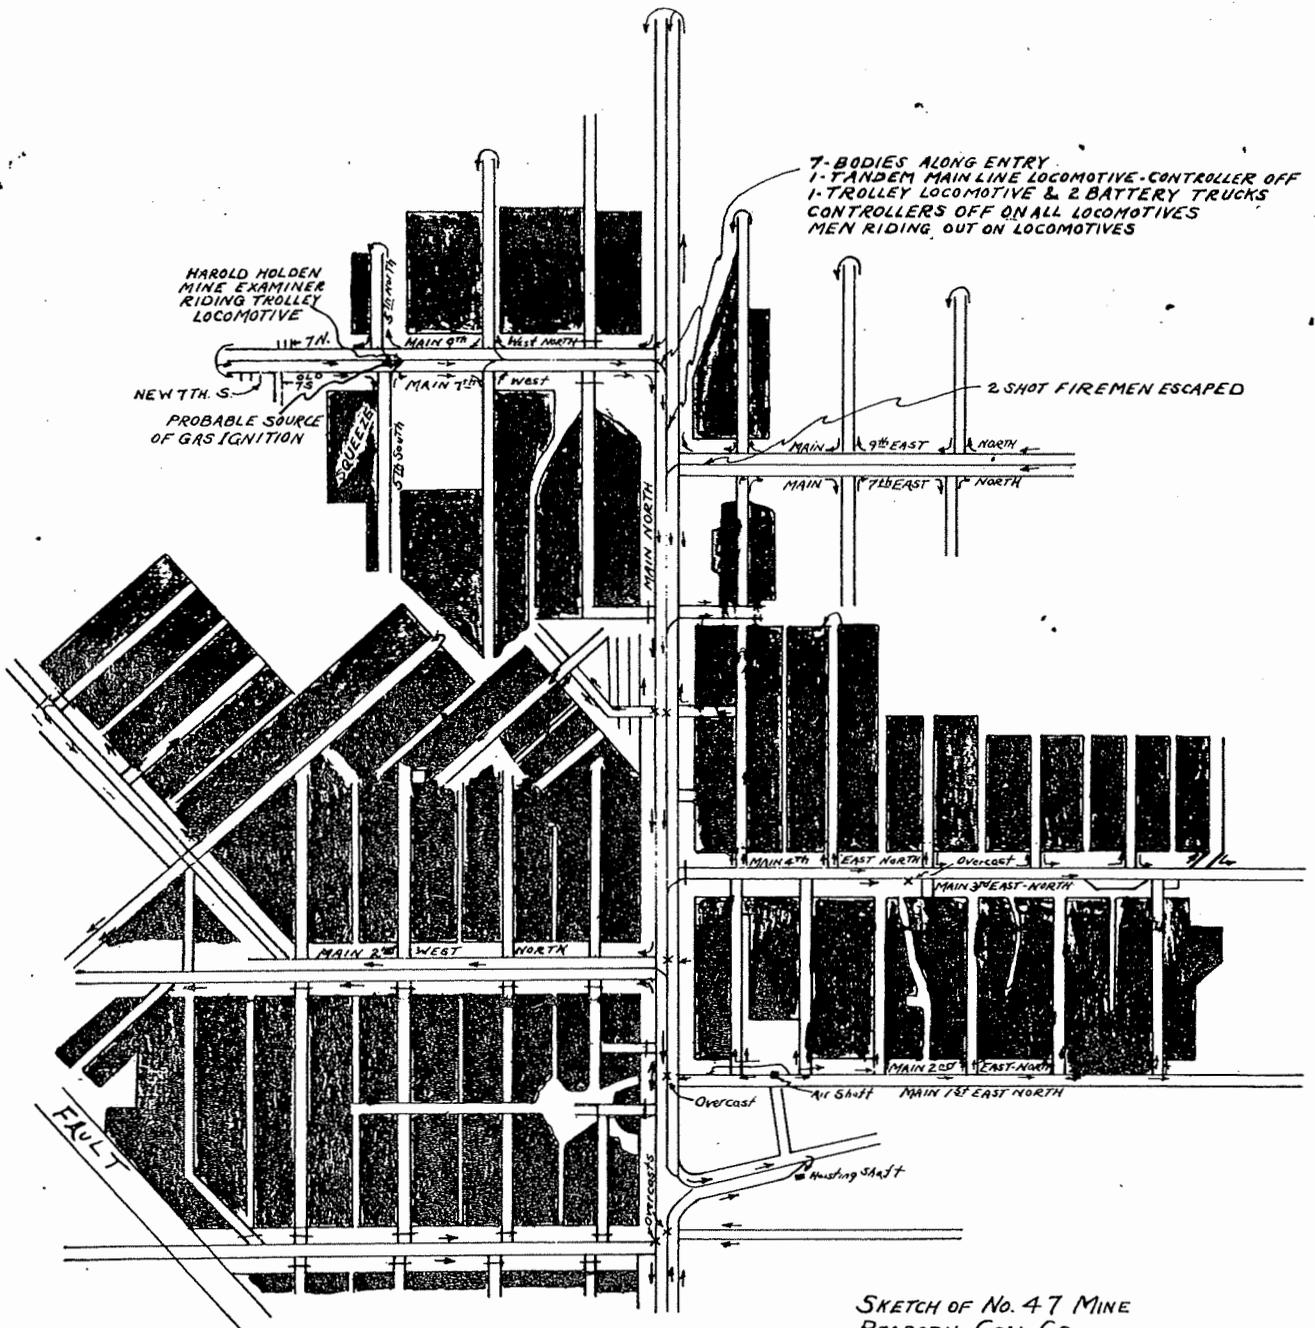
SKETCH OF No. 47 MINE  
PEABODY COAL CO.  
HARCO, ILLINOIS  
SCALE 1"=600'

HAROLD HOLDEN  
MINE EXAMINER  
RIDING TROLLEY  
LOCOMOTIVE

PROBABLE SOURCE  
OF GAS IGNITION
