*Report on a Mine Explosion That
Occurred at the Smith Mine,
Washoe, Montana, on
February 27, 1943*

MONTANA COAL & IRON COMPANY
BILLINGS, MONTANA

June 10, 1943

Prepared by
J. M. FREEMAN,
Vice President and General Manager

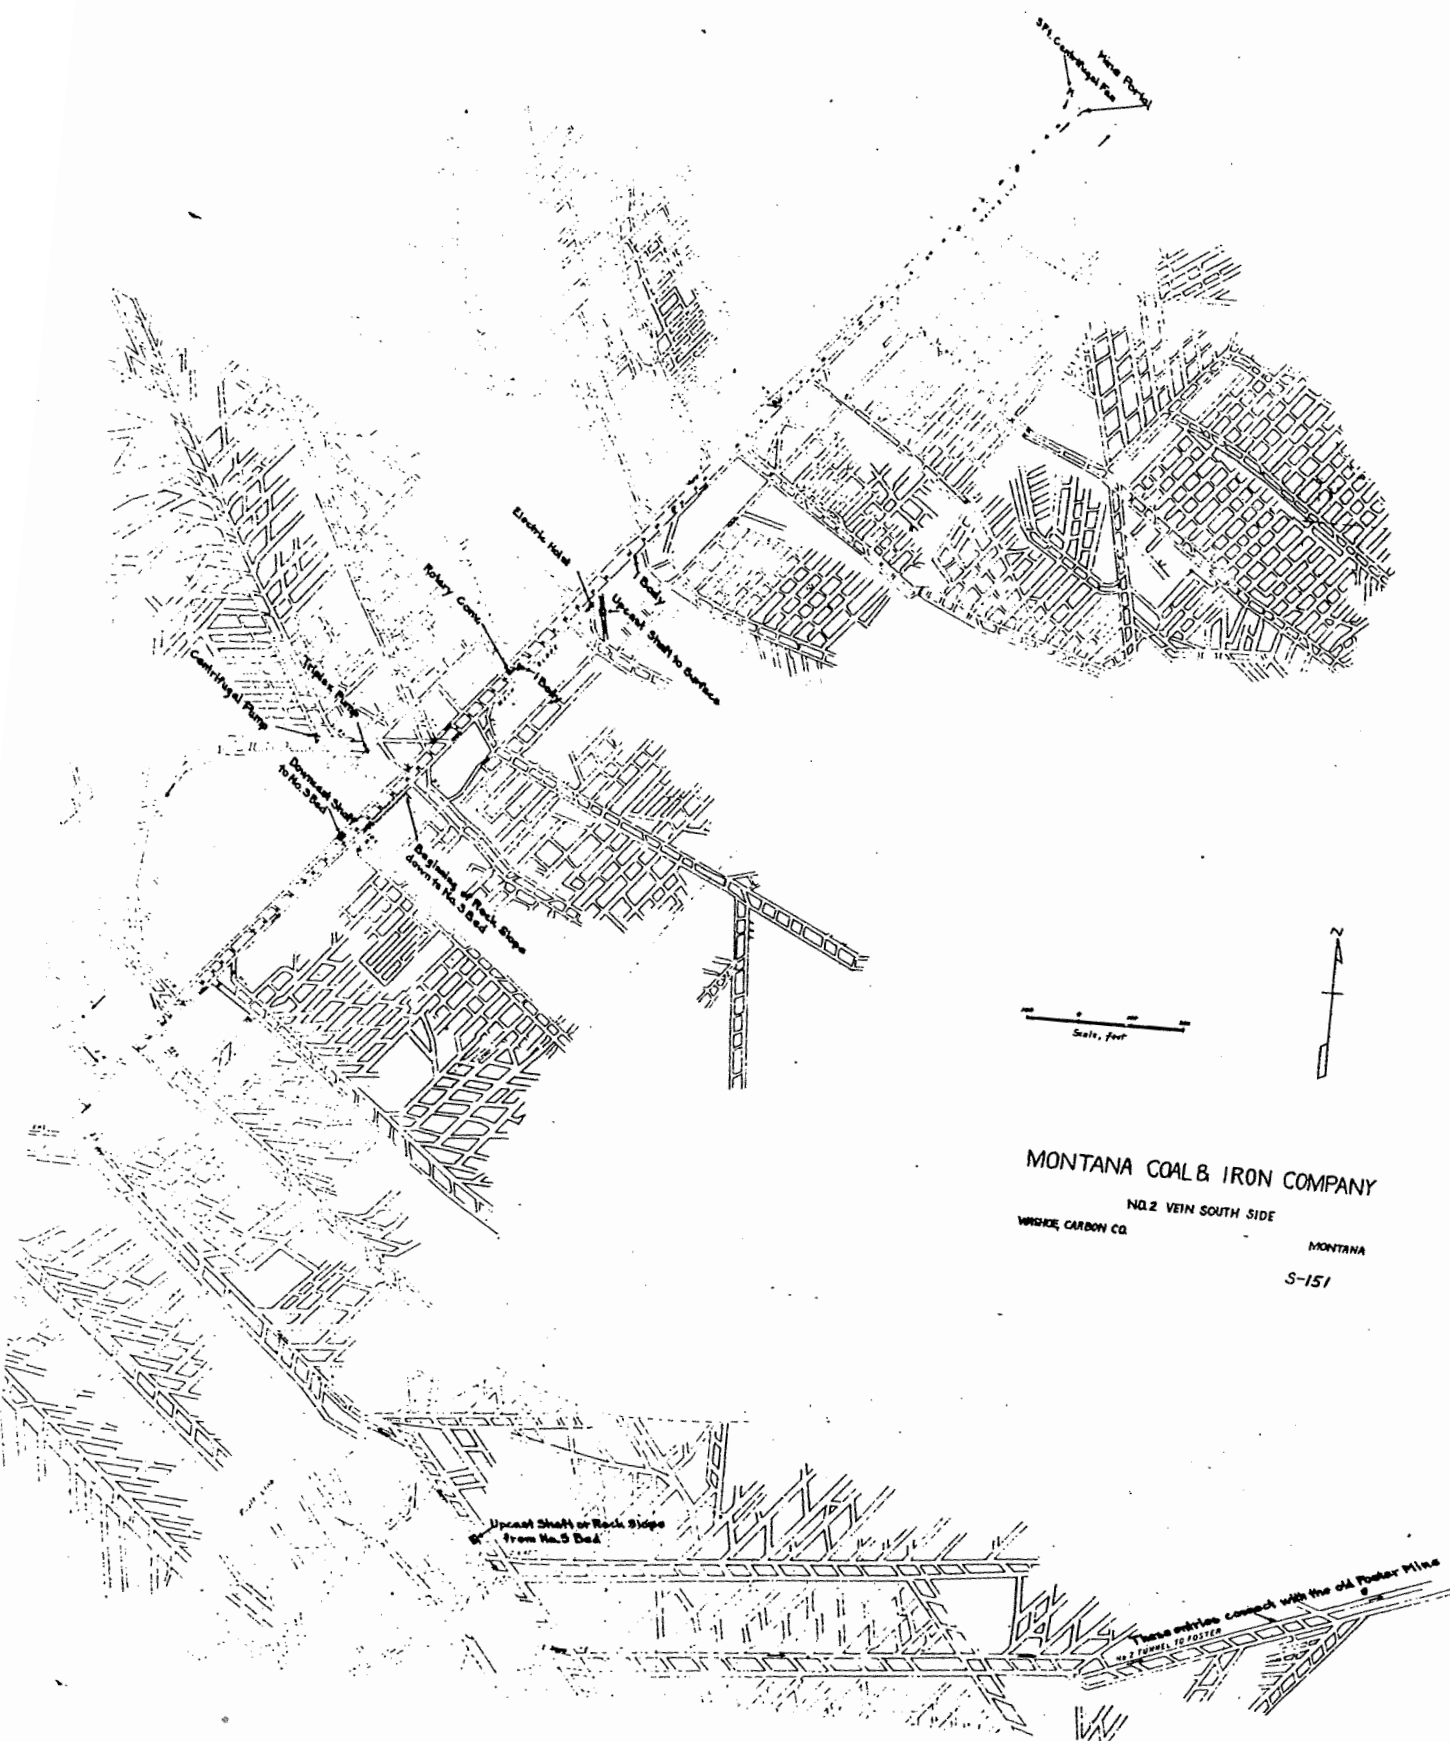
The cause of the explosion, as determined by the Bureau of Mines' investigating party, is thought to have been an ignition of explosive gas by a miner wearing an open light in No. 5 room off the 9 southeast entry in No. 3 bed.

The explosion was confined to the workings in No. 3 bed, and evidences of force and heat were found in about two-thirds of the workings. Propagation of the explosion was made possible by the presence of coal dust throughout the mine, and there was evidence of gas having burned in many places. The explosion was violent only in parts of the mine, and property damage was limited to the destruction of three booster fans, nearly all stoppings and doors (which were constructed of wood) in No. 3 bed, some damage to haulage locomotives and rotary-converter stations, and to the derangement of trolley and power wires.

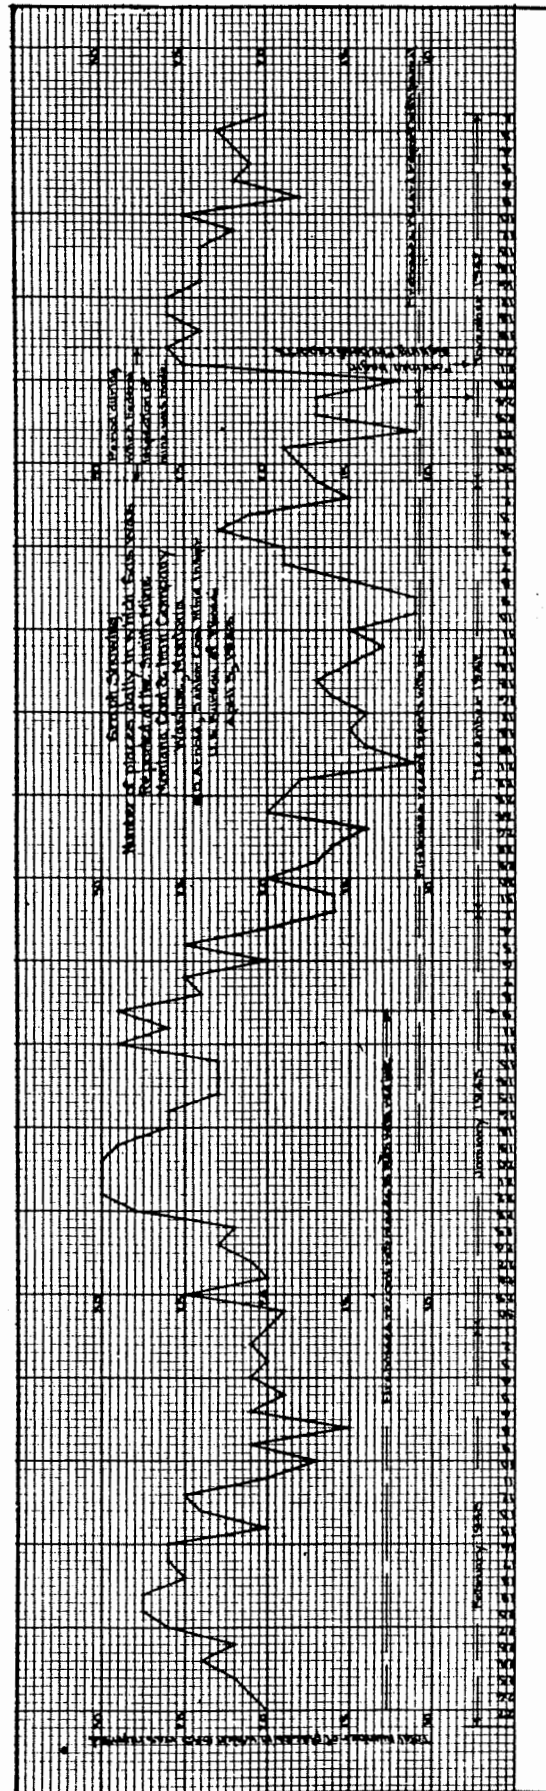
The fire bosses begin recording all references to gas in red ink. It would be interesting to know why this suggestion of the Federal inspectors was recalled so long after the inspection. Could it be that someone wanted to call attention to the gassy condition of the mine?

The graph will prove interesting to study in reference to conditions prior to the explosion.
