*posted, C*  
**FINAL REPORT  
MAJOR ROOF-FALL DISASTER IN CRUCIBLE MINE  
CRUCIBLE FUEL DIVISION, CRUCIBLE STEEL COMPANY OF AMERICA  
CRUCIBLE, GREENE COUNTY, PENNSYLVANIA  
MARCH 12, 1945**

**F. E. Griffith  
Mining Engineer**

**E. M. Lewis  
Coal-Mine Inspector**

**G. M. Smith  
Mining-Explosives Engineer**

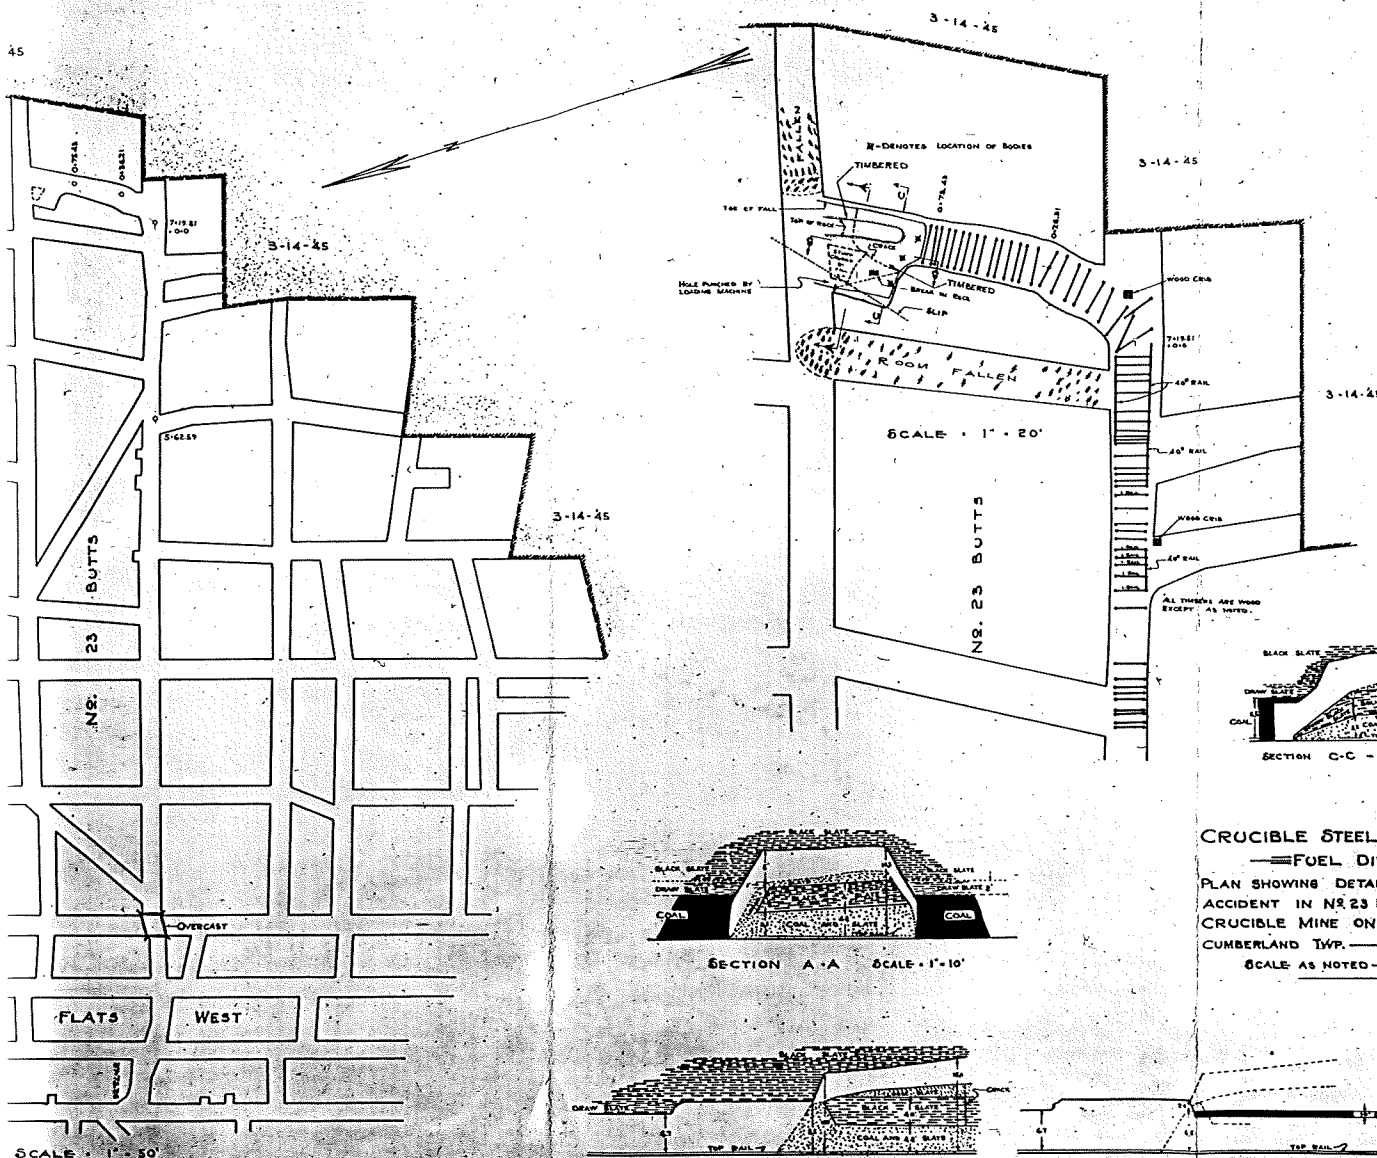
PLAN SHOWING DETAIL AND LOCATION OF  
ACCIDENT IN NR 23 BUTT, NR 3 FLAT WEST,  
CRUCIBLE MINE ON MARCH 12<sup>TH</sup>, 1945  
CUMBERLAND TWP. — GREENE COUNTY, PA.  
SCALE AS NOTED — F.E. Co. 3-13-45

It is estimated that more than 500 tons of roof material had fallen in the first and second falls that occurred when the timbers collapsed under roof in a split and a pocket driven into the 90-foot-square block of coal near No. 5 room, 23 butt left, off 3 flat west entries. The material in the first fall, that buried the five men beneath it, consisted of 12 to 14 inches of roof coal, 12 inches <sup>or more</sup> of draw slate, and several inches of black shale. The material of the second fall consisted of a solid black "slate" boulder, approximately 30 feet long by 30 feet wide with an average thickness of about 4 feet.

It was learned in the investigation that a split had been driven through a 90-foot-square block of coal and two 8-1/2-foot cuts of coal had been taken from a pocket to the left of this split. The right rib of the pocket was started 6 to 8 feet outby the point where the split had cut through into No. 4 of a group of five entries known as 23 butts. This procedure of splitting the block of coal was contrary to the normal procedure followed at this mine. It was stated that it was carried out in this case because of heavy falls in a breakthrough and falls in the No. 4 entry.

It was observed that a hidden, almost vertical, slip or cleavage plane was parallel with the face of the pocket and another was almost parallel to the right rib of the split. From the statement of the trackman, who narrowly escaped injury when the initial fall occurred, the roof started falling at the face of the pocket. It is thought that the falling of this roof material tripped out the supporting leg posts of the cross bars without breaking them or giving much advance warning.

The Bureau investigators believe that the cause of the accident was inadequate timbering for the unusual roof conditions encountered. The timbers collapsed without giving sufficient warning for the men to escape. It is believed that the timbers would have given ample warning before collapsing if cribs had been placed on the outside of the curved track entering the pillar pocket and braces had been placed between the three-piece sets to give collective lateral support.

4. In sections where cleavage or slip planes are frequently encountered, three-piece framed timber sets should be erected, with the legs placed in hitches cut into the bottom, and braces or sprags should be placed between the timber sets to give collective longitudinal support.

5. In pillar mining, cribs should be placed wherever break-throughs are made and on the outside of the curved track entering pillar pockets.
