FINAL REPORT OF MINE EXPLOSION
NO. 8 MINE
OLD BEN COAL CORPORATION
WEST FRANKFORT, FRANKLIN COUNTY, ILLINOIS
July 24, 1947

W. A. Gallagher
W. R. Chick
H. C. Brumbaugh
T. C. Higgins

Originating Office--Bureau of Mines
201 Post Office Building
Vincennes, Indiana
C. A. Herbert, Supervising Engineer

UNITED STATES
DEPARTMENT OF THE INTERIOR
BUREAU OF MINES

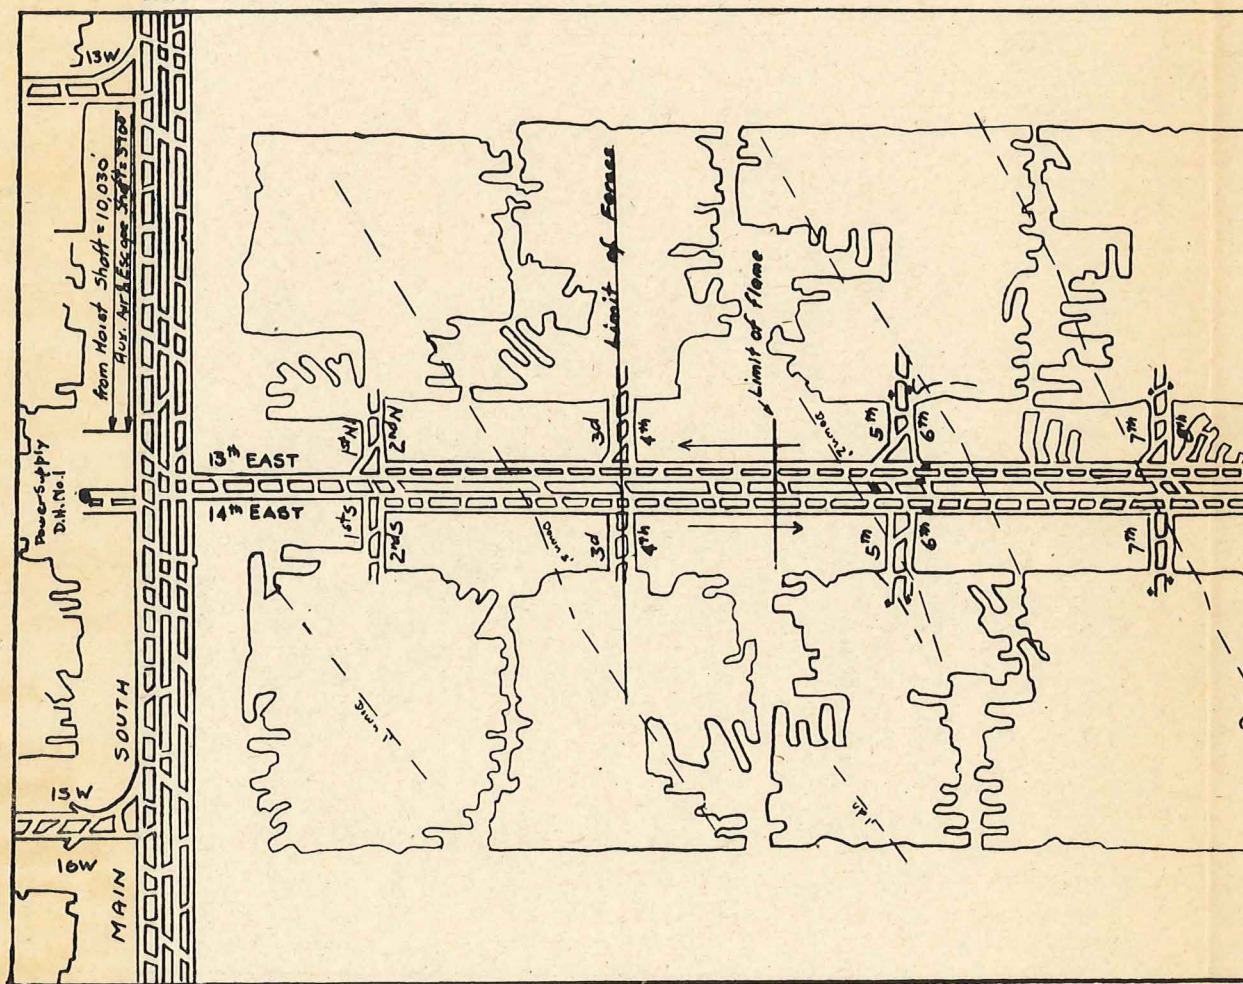
For a distance of 200 feet inby the 9 and 10 panels, it was observed that there were streamers of soot from the roof and deposits of coke on the floor, indicating slow burning of the gas and dust with little or no violence.

The absence of violence and the slow burning evidenced by the soot streamers on the roof is a phenomenon often observed in mines following explosions in tight ends where a balanced pressure builds up, such as in a room or entries inby the last crosscut, and substantiates the belief that the 13 and 14 entries were closed tight at some point beyond the 9 and 10 panels.

SOOT STREAMERS WERE FOUND IN THIS AREA
