FINAL REPORT OF MINE EXPLOSION  
PEERLESS NO. 3 MINE  
PEERLESS COAL COMPANY  
EXCELSIOR, SEBASTIAN COUNTY, ARKANSAS  
(Post Office - Greenwood, Sebastian County, Arkansas)

December 11, 1957

R. D. Bradford  
Subdistrict Supervisor, Health and Safety District G

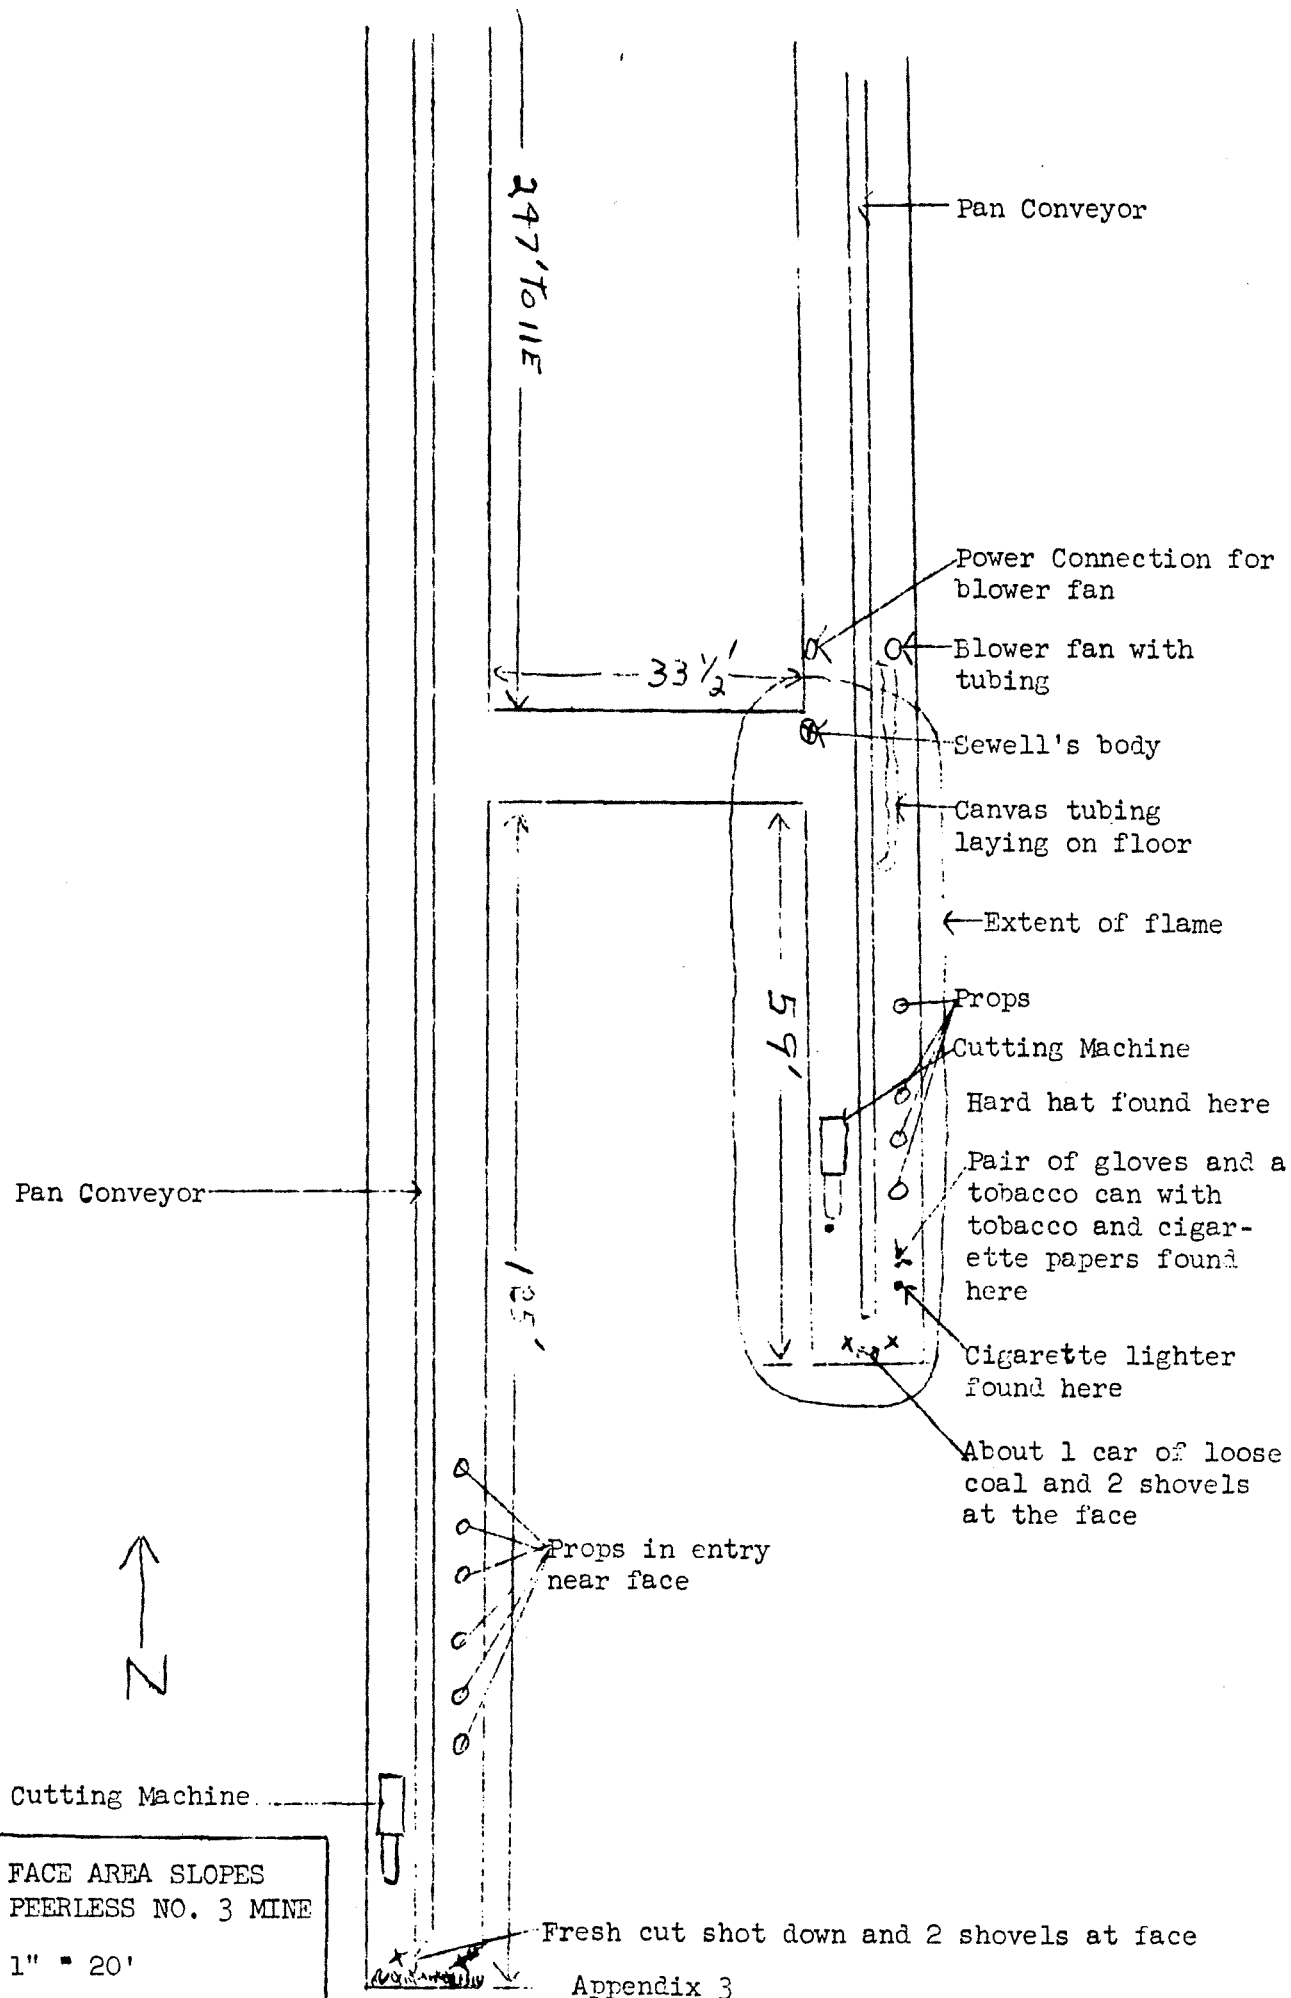
APPENDIX 3

Moore and Martin were able to travel, from their working place at the face of the slope, a distance of approximately 680 feet where their bodies were found, 50 feet apart, face down headed toward the outside. According to the undertaker, they had received no burns or other injuries, and both were overcome by the afterdamp. It is possible that Simmons, Moore and Martin could have escaped if self-rescuers had been available to them. (See Appendix 3 for details in face area, and Appendix 2 for location of bodies).
