UNITED STATES
DEPARTMENT OF THE INTERIOR
BUREAU OF MINES

REPORT OF MULTIPLE FATAL ROOF-FALL ACCIDENT
NO. 1 MINE
SHADE AND MILLARD COAL COMPANY
PANTHER, McDOWELL COUNTY, WEST VIRGINIA

April 18, 1957

Edward M. Lewis
Health and Safety Engineer

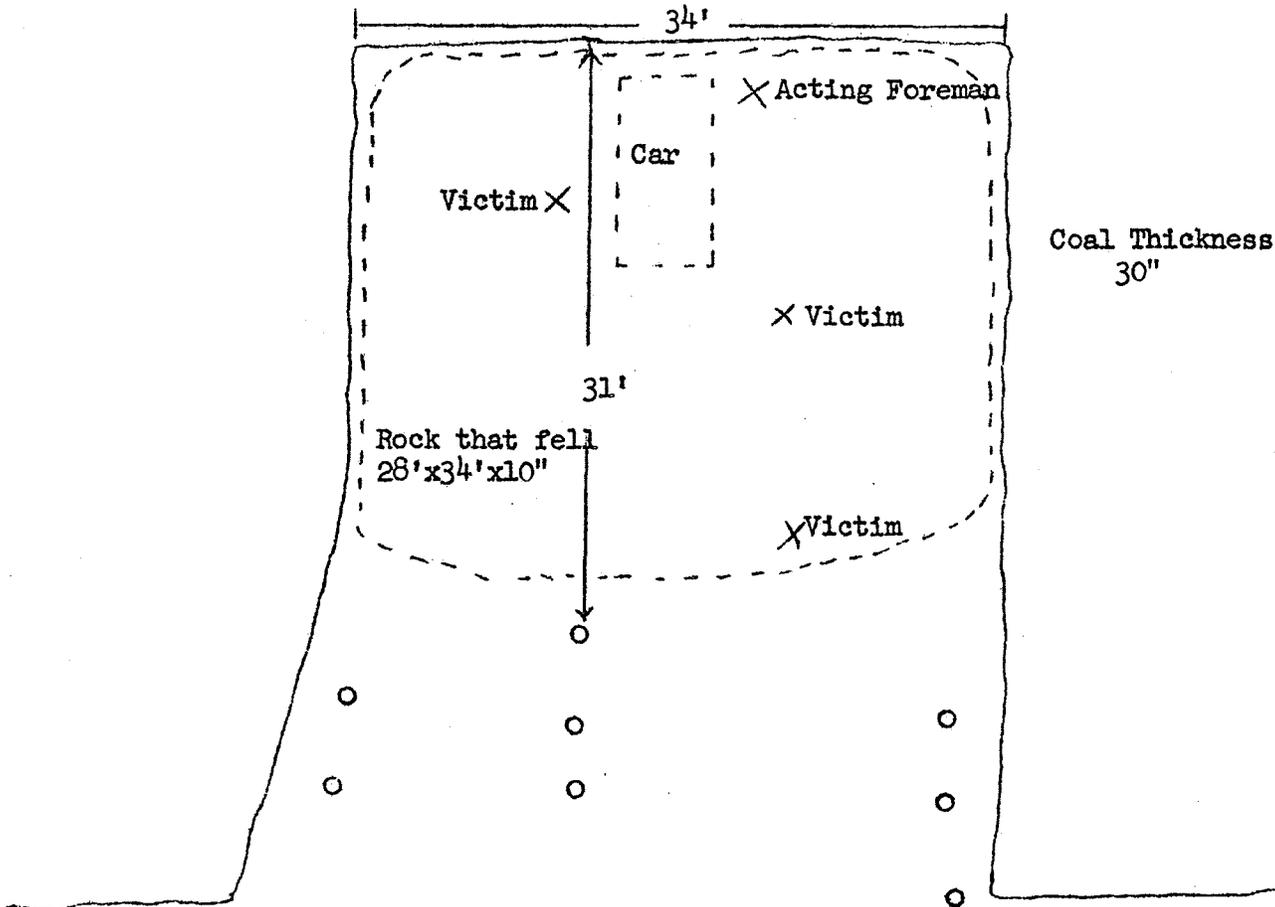
MULTIPLE FATAL ROOF-FALL ACCIDENT
NO. 1 MINE
SHADE AND MILLARD COAL COMPANY
PANTHER, McDOWELL COUNTY, WEST VIRGINIA

~~Four miners were killed instantly by a fall of roof in the No. 1 mine, Shade and Millard Coal Company, at about 4:00 p.m., Thursday, April 18, 1957. The accident occurred near the face of No. 2 barrier pillar off 3 left.~~

On the day of the accident, April 18, 1957, the mine was in normal operation, and Calvin Lester and Anse Estep were loading coal in No. 1 barrier pillar almost directly opposite No. 2 barrier pillar, the place where the roof fall occurred; Junior Estep, Vesper Lester, and Johnnie Patrick were working in No. 2 barrier pillar. Calvin Lester and Anse Estep had loaded their last car of coal and Estep went into No. 2 barrier pillar to wait for the man-trip. Lester stated that he (Lester) looked at his watch a few minutes after Estep left No. 1 barrier pillar; the time was 4:00 p.m., and immediately thereafter he heard the rock fall in No. 2 barrier pillar. Lester investigated the roof fall and found that all of the men in the place had been caught by the fall and apparently killed instantly. Lester further stated that the motorman returned with the locomotive a few minutes after the fall occurred and upon being informed of the accident went to the surface and obtained help from nearby mines. James Gillispie, State mine inspector, arrived at the mine when the first body was brought to the surface about 30 minutes after the accident. Gillispie traveled to No. 2 barrier pillar where he required several additional posts to be set and supervised the recovery of the remaining bodies; the last body was recovered by 6:30 p.m. The rock that fell was 28 feet in length, 34 feet in width or as wide as the place, and averaged 10 inches in thickness; it broke into several pieces in falling, two of the pieces were about 8 by 10 feet in size. Evidence indicated that the last post set in the place was 31 feet outby the face and that no posts had been set in the place during the last 5 or 6 shifts. The No. 1 barrier pillar place was 35 feet wide and the last post set in the place was 25 feet back from the face. There were several posts lying in each place. Junior Estep, an uncertified person, was acting mine foreman.

The direct cause of the accident was the failure of the supervisor and employees to provide roof support in the face area.

1. No person should work or be permitted to work under unsupported roof.
2. Mine officials should see that all areas of the mine in which men work or travel are timbered sufficiently to protect employees from falls of roof.
3. The minimum standards for roof support, which requires permanent posts to be set on 4-foot centers and to within 6 feet of the face and at least 4 safety posts in by the permanent timbers, should be complied with by officials and workmen. Mine officials should see that the working places are timbered according to this standard.
4. Each mine should be supervised by a certified mine foreman. The mine foreman or his assistant should be examined carefully each working place on each shift as frequently as possible.
5. A preshift examination should be made in a nongassy mine at least once in each calendar day during which coal is produced.
