UNITED STATES  
DEPARTMENT OF THE INTERIOR  
BUREAU OF MINES

DIVISION OF COAL MINE INSPECTION

REPORT OF MULTIPLE FATAL ROOF-FALL ACCIDENT  
MONTANA QUEEN MINE  
MOUNTAIN STATES MINING COMPANY  
QUEEN'S POINT, MUSSELSHELL COUNTY, MONTANA  
(Post Office - Roundup, Musselshell County, Montana)

January 28, 1958

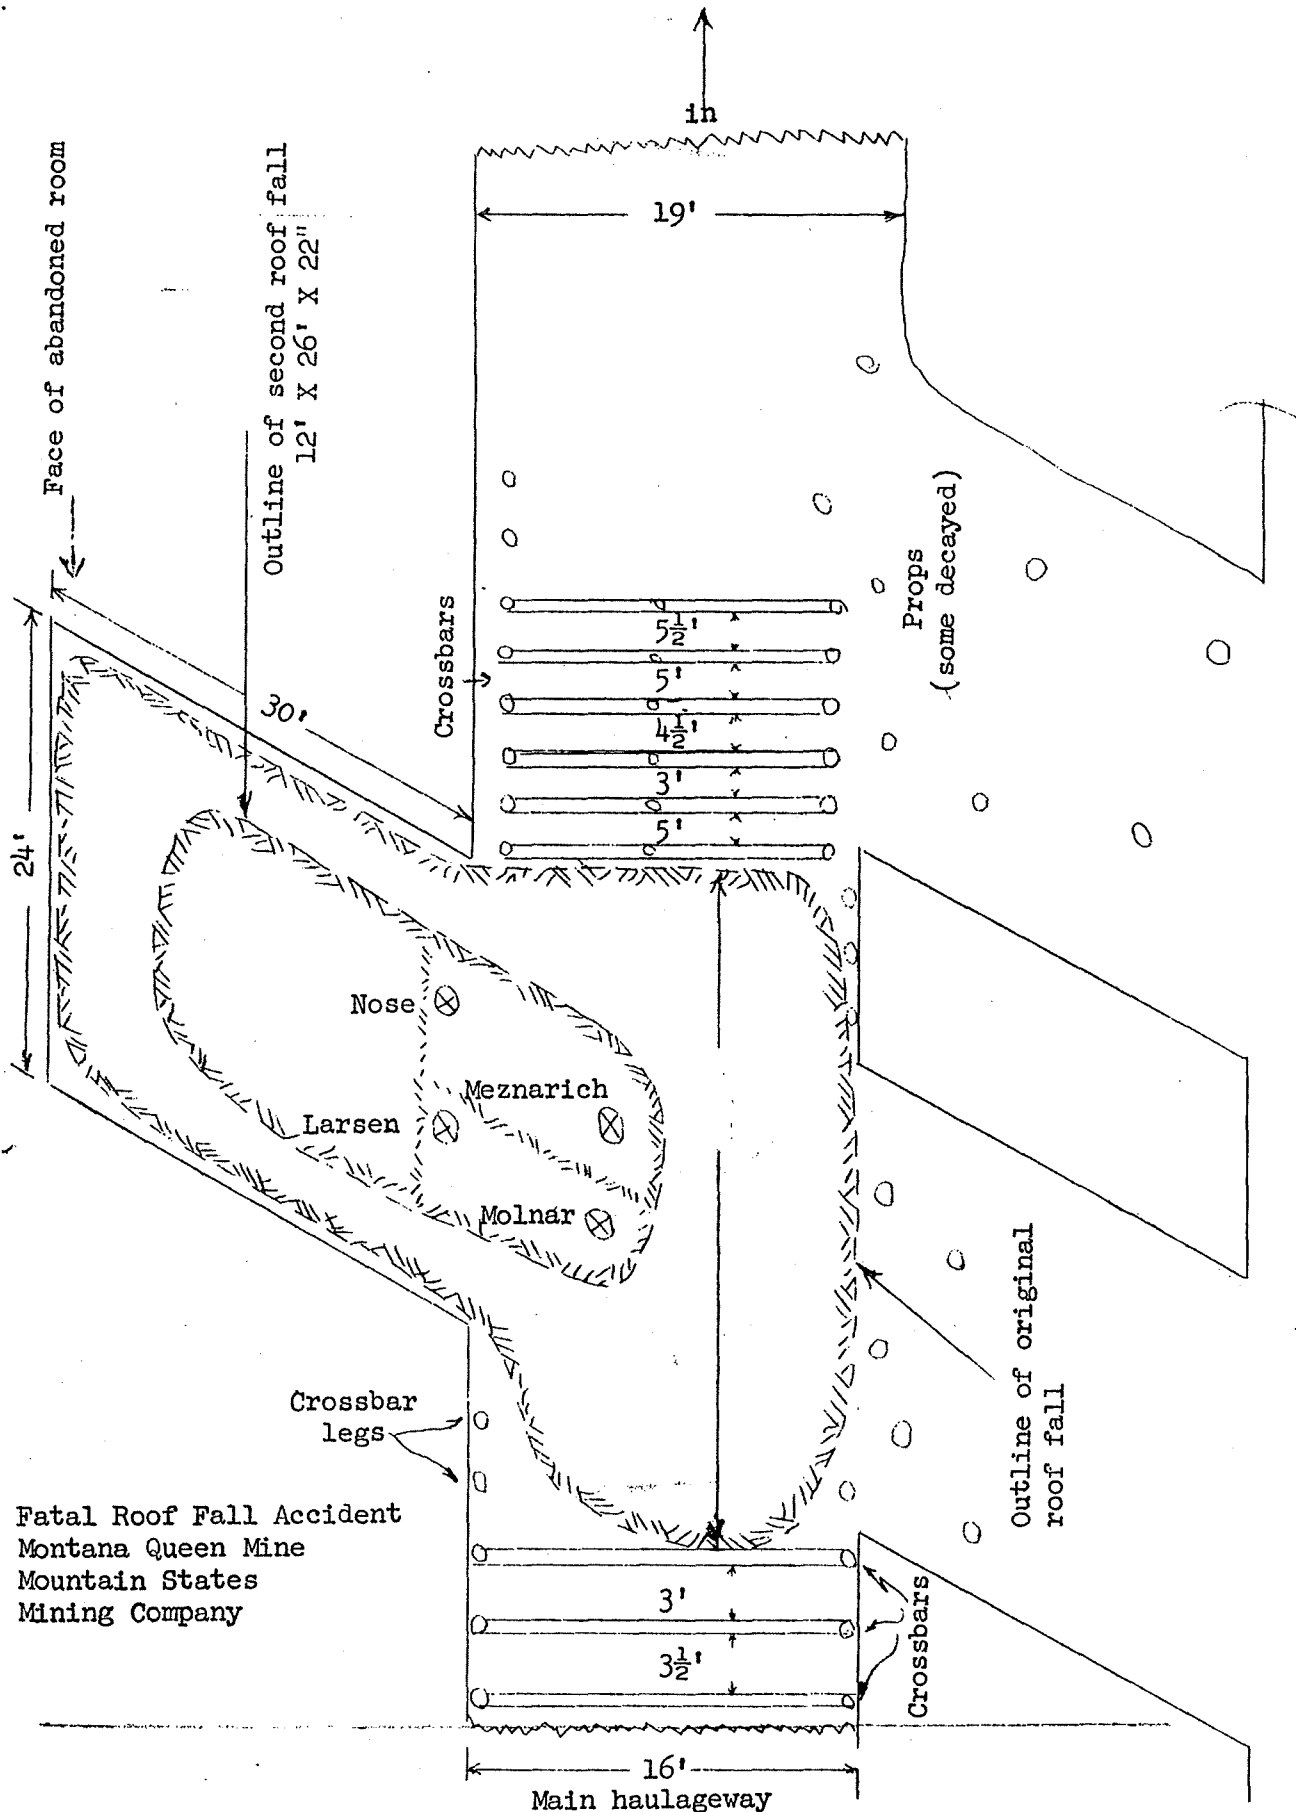
Fatal Roof Fall Accident  
 Montana Queen Mine  
 Mountain States  
 Mining Company

The accident occurred on the main haulageway at a point about 5,800 feet from the mine portal. This section of the haulageway had been re-routed through a worked-out area and intersected two rooms; the fall occurred at the intersection with one room.

The acting fire boss, Lynn Miller, detected a large roof fall at this location during his preshift examination of the mine on Monday, January 27, 1958; the mine had last been worked on Friday, January 24, and no unusual condition had been detected. The roof fall broke through the crossbars for a distance of 39 feet along the haulageway, and extended a distance of about 30 feet to the face of the worked-out room. The rock

broke to a height of about seven feet over the center of the haulageway and arched to about two feet in thickness at the face of the room. The outby end of the roof fall, for a distance of 15 feet, ranged from 12 inches in thickness to a feather edge. The fire boss returned to the surface and reported the condition to J. J. Boyle, company president and acting mine foreman. After examining the roof fall, Mr. Boyle assigned a crew of six men to start the cleanup operations. The crew, in charge of Mr. Boyle, entered the mine at 8:15 a.m. and erected three permanent crossbars under the lip at the outby end of the roof fall. Posts were also set in the center of six crossbars formerly installed along the haulageway immediately inby the roof fall. During the remainder of the shift, the crew was engaged in barring down loose rock above and surrounding the caved area, and gobbing the loose material in adjacent old rooms. Testimony given by members of the crew disclosed that the roof above the fall was considered safe and not in need of temporary support as determined by frequent tests made during the shift by the mine official and Frank Nose, timberman.

men to assist in removing the bodies from underneath the roof fall. A sketch of the accident is appended.

The accident was caused by a fall of roof which had not been supported during the cleanup operations following the initial roof fall. The roof had been judged to be safe by frequent tests with picks and a steel pinch bar. Firing of unconfined shots to break large pieces of fallen rock and to remove overhanging rock probably contributed to the accident, owing to vibrations and concussions.

1. Temporary roof supports should be provided to protect workmen engaged in cleanup operations following roof fall, until permanent roof support can be provided.
2. Roof testing rods should be used for proper testing of roof.
3. Unconfined shots should not be fired underground.
