REPORT OF MULTIPLE FATAL ROOF-FALL (MAN-TRIP) ACCIDENT  
ELZO MINE  
HARLAN FUEL COMPANY  
YANCEY, HARLAN COUNTY, KENTUCKY

April 28, 1961

R. B. Jones  
Federal Coal-Mine Inspector (Roof-Control)

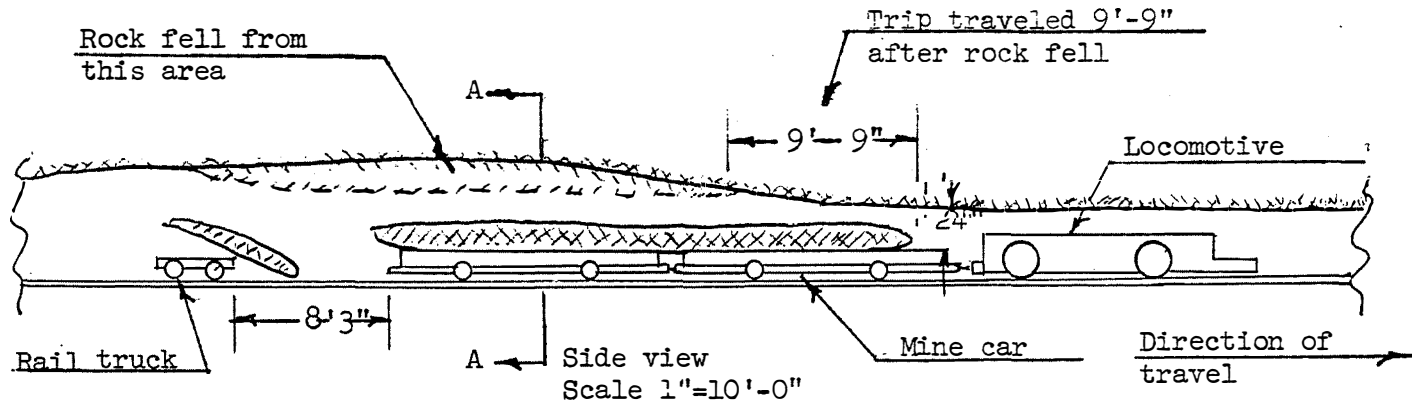
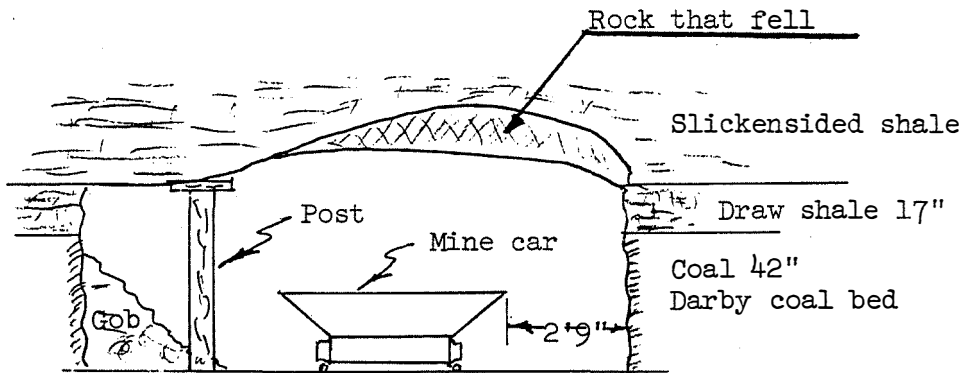
SKETCH NO. 2  
 MULTIPLE FATAL ROOF-FALL (MAN-TRIP) ACCIDENT  
 ELZO MINE  
 HARLAN FUEL COMPANY  
 YANCEY, HARLAN COUNTY, KENTUCKY

Section A-A  
Scale 1"=5'-0"

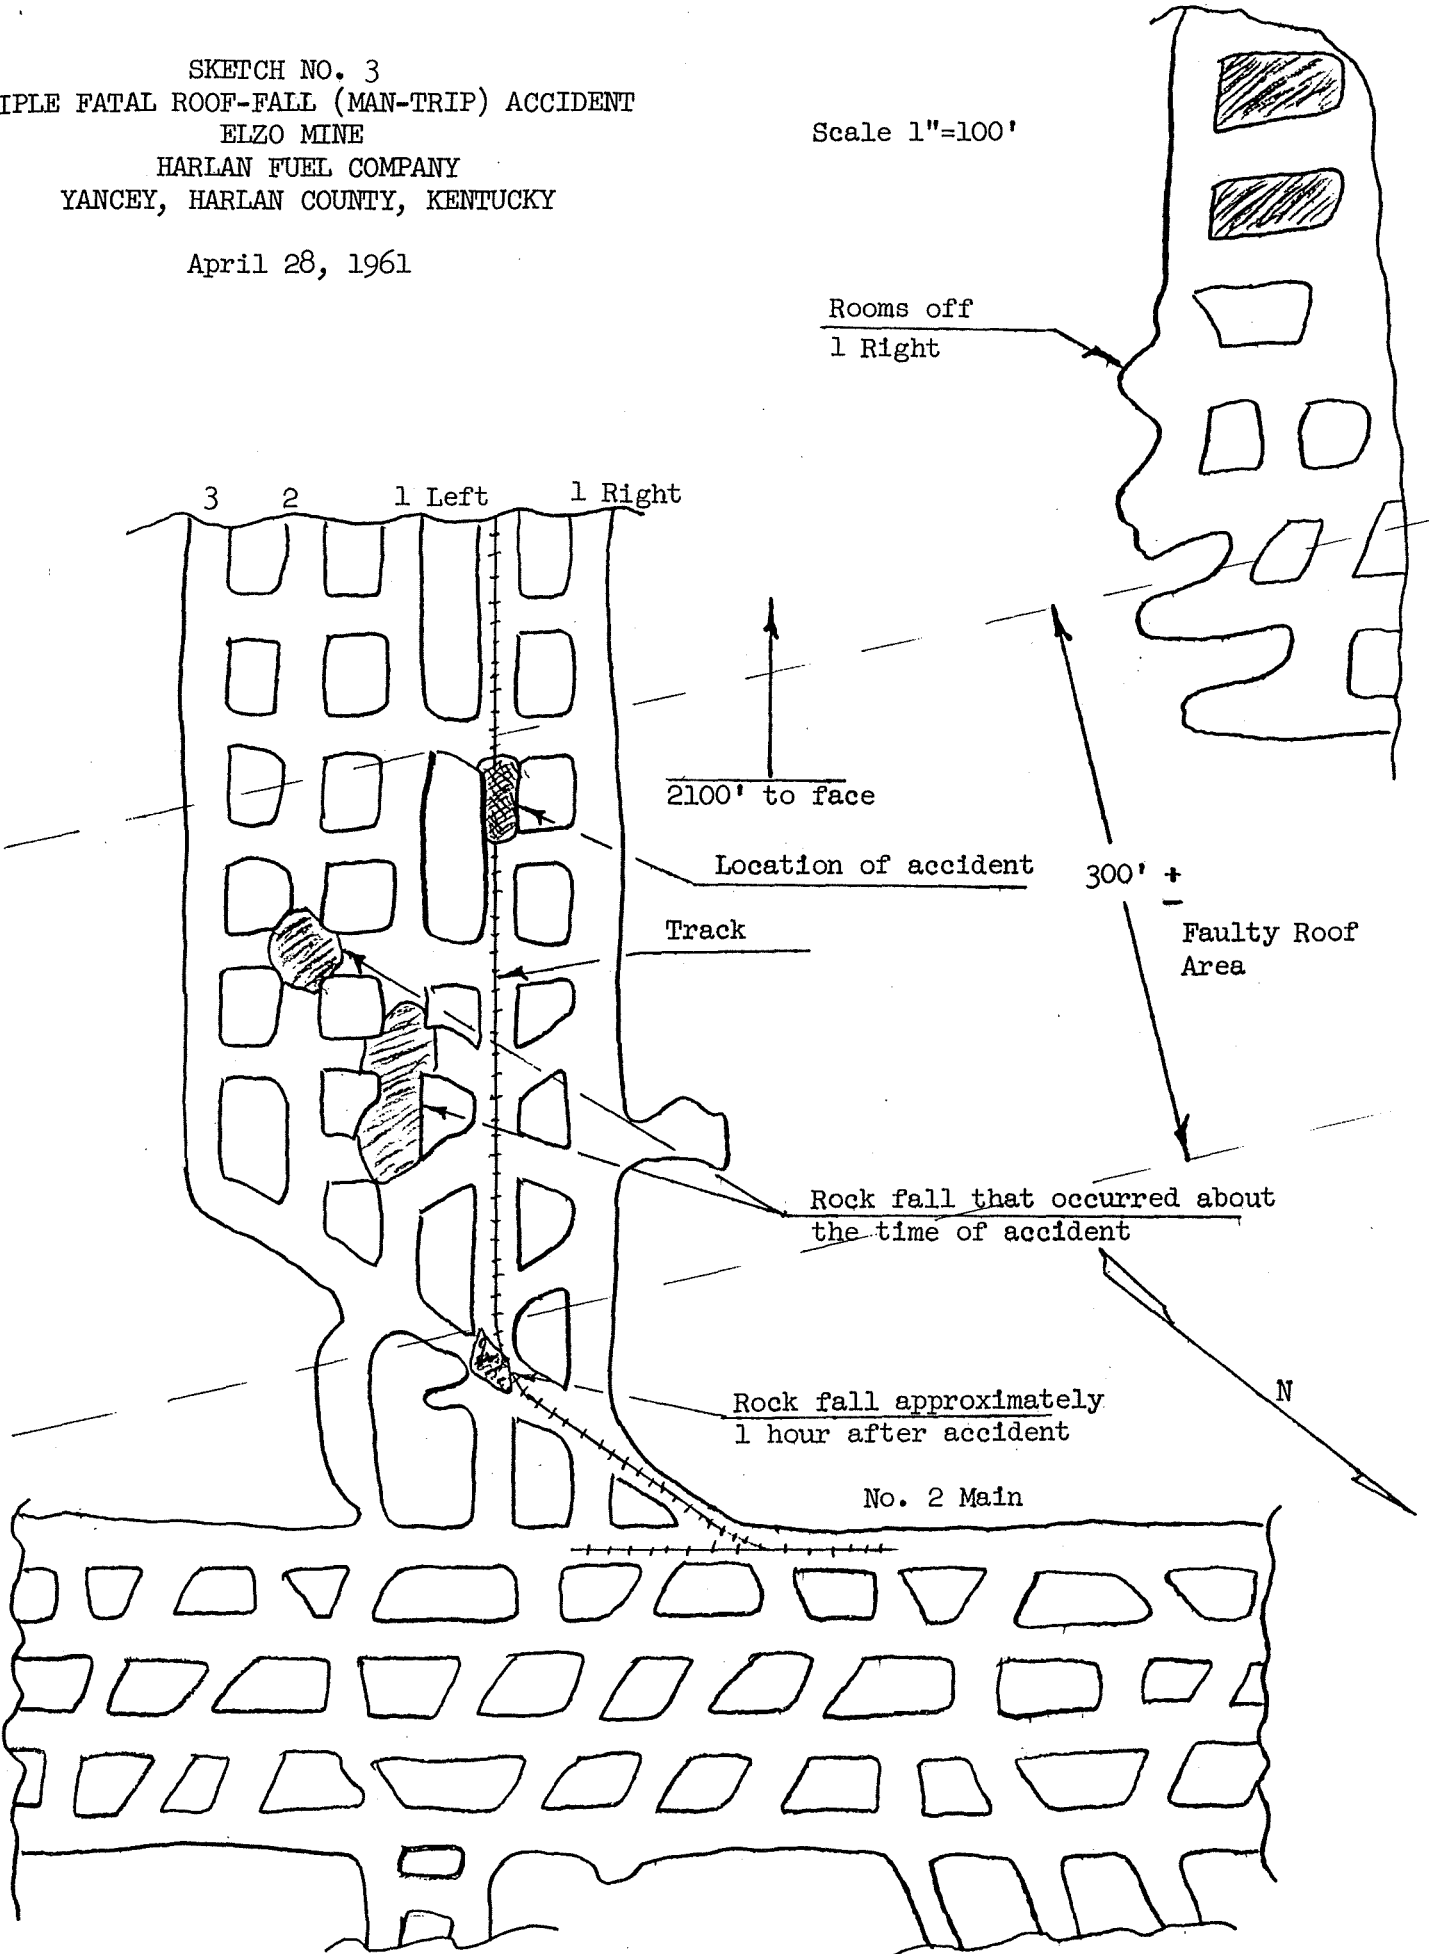
SKETCH NO. 3

The investigation indicated that a movement or disturbance of the unstable faulty roof occurred on the right side of No. 2 mains, which was about 300 feet wide and extended from 1 right across 1 west entries to the faces of No. 2 main, a distance of about 3,500 feet. The investigation also indicated that the disturbance caused a 90-foot long and 10- to 15-foot high fall in the No. 1 aircourse entry, which was adjacent to the track haulageway, about the time of the accident. A fall occurred at an intersection in the No. 2 aircourse entry and about 100 feet from the accident area about the same time. Another fall occurred along the haulageway 250 feet out by the accident area about 1 hour after the accident happened and during recovery operations. A new fall, about 15 feet long and on top of the 90-foot fall previously mentioned, occurred between 1:00 p.m., April 29 and 10:00 a.m., May 1, 1961. The investigation further indicated that a possible disturbance or movement from the mined-out Harlan coal bed, which was 290 feet below the Darby coal bed and/or from the worked-out area in 1 right which was 250 feet through solid coal from 1 west, may have been the cause of the movement or disturbance in the area of the accident.

Location of accident

Faulty Roof  
Area

Rock fall that occurred about  
the time of accident

Rock fall approximately  
1 hour after accident

1. Additional roof support such as bolts or crossbars should be installed when unstable roof is encountered such as that which was present in the 300-foot area extending from 1 right to the face of No. 2 main and crossing 1 west entries.
2. Roof along all places where men work or travel should be examined frequently and thoroughly enough to properly evaluate its condition. The sound-and-vibration method of testing roof should be included in the examinations.
3. The management should give serious consideration to the purchase of covered man-trip cars.
