REPORT OF FATAL COAL MINE ROOF-FALL ACCIDENT  
BANNING NO. 4 MINE  
REPUBLIC STEEL CORPORATION  
NORTHERN COAL MINES DISTRICT  
WEST NEWTON, WESTMORELAND COUNTY, PENNSYLVANIA

March 29, 1965

J. W. Holcomb and Everett Turner  
Federal Coal Mine Inspectors

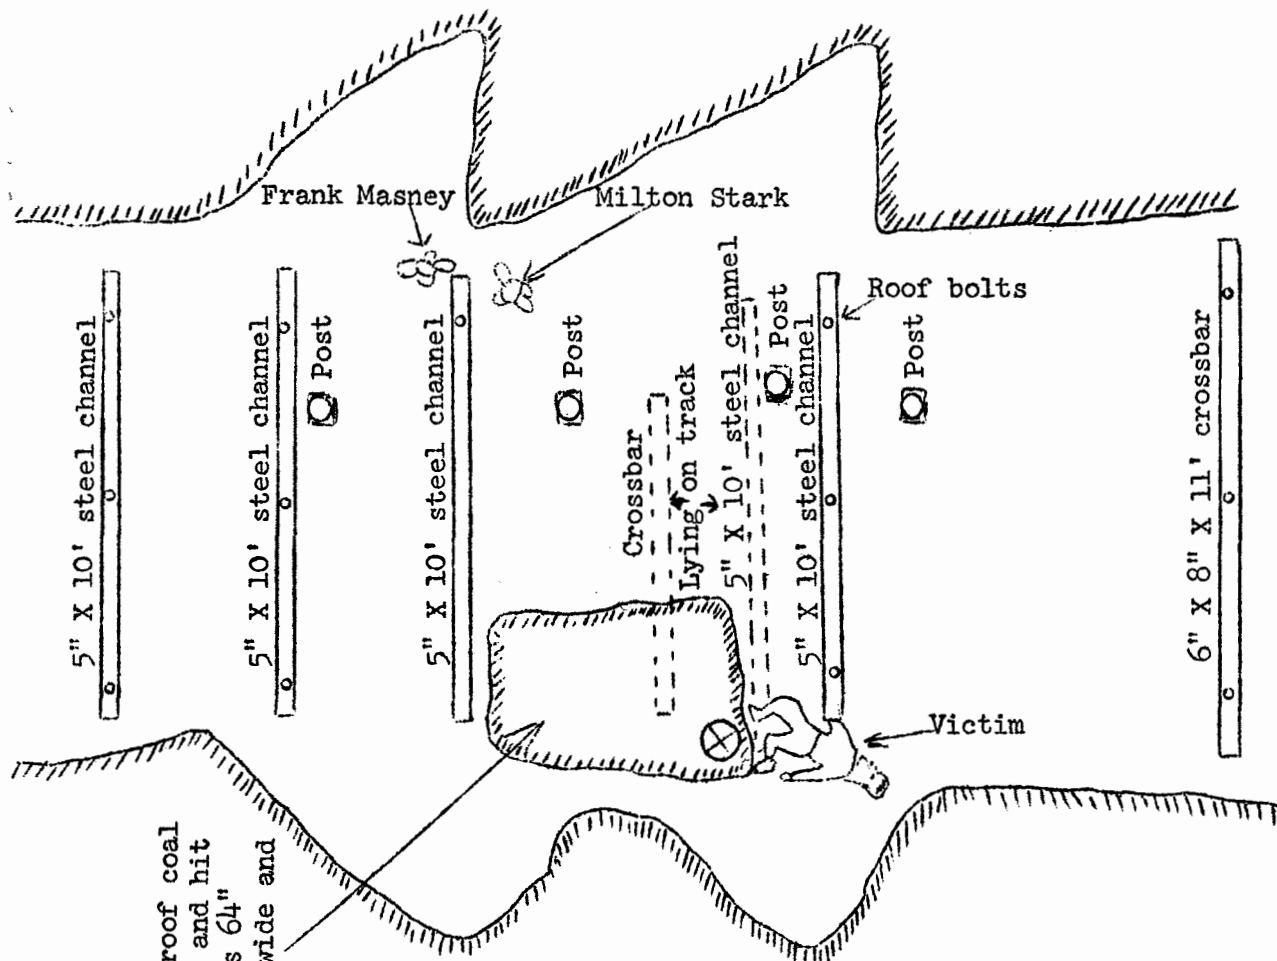
Sketch of Scene of Fatal Coal Mine Roof-Fall Accident  
 Banning No. 4 Mine  
 Republic Steel Corporation  
 Northern Coal Mines District  
 West Newton, Westmoreland County, Pennsylvania

The removal of roof bolts, steel channels, and crossbars in an area that had been considerably weakened by the shearing of the roof, as much as 3 feet and the shearing of large offsets in the ribs (for the bulkheads), without providing adequate temporary supports, was the cause of the accident. The four posts set in the clearance space were not located so as to give maximum protection. The failure of the foreman and workmen to properly examine and evaluate the weakened roof condition was a contributing factor.

Piece of roof coal that fell and hit victim was 64" long 41" wide and 13" thick

1. The adopted roof-support plans that prohibit any person from advancing beyond the last permanent support, except those who are assigned to install temporary supports, should be strictly followed.
2. Permanent roof supports, such as roof bolts, crossbars, or channels, should not be removed unless equivalent protection is provided. Good evaluation of conditions should be made by all underground personnel before setting substitute or temporary roof supports.
3. Persons exposed to danger from falls of roof, face, or ribs should examine and test the roof, face, and ribs before starting work and at frequent intervals thereafter. A visual examination should not be substituted for a sound-and-vibration test but should be in addition to the accepted sound-and-vibration method of testing roof.
