REPORT OF FATAL COAL MINE ROOF-FALL ACCIDENT
SAPPER MINE
McGEE COAL COMPANY ✓
NEWCOMER, FAYETTE COUNTY, PENNSYLVANIA

December 9, 1966

REPORT OF FATAL COAL MINE ROOF-FALL ACCIDENT
SAPPER MINE
McGEE COAL COMPANY
NEWCOMER, FAYETTE COUNTY, PENNSYLVANIA

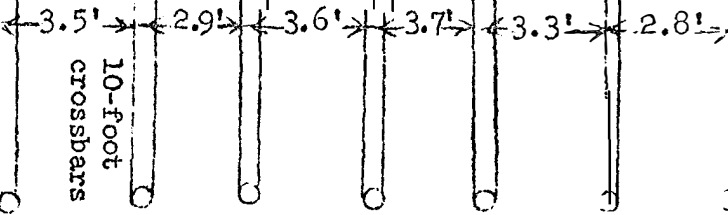
Sketch of Scene of Fatal Coal Mine Roof-Fall Accident

It was the concensus of the investigating committee that Kerwin had apparently observed some loose roof material on the right side of the crosscut connection and while prying the material with the coal shovel was struck by the falling material. The height of the working place in the accident area was 13 feet (see sketch). A clay vein was observed in the coal rib. Two large pieces of slickensided rock that were reportedly lying on the victim's legs measured 18 inches wide, 18 inches thick, and 16 inches long. Smaller pieces of roof rock were in close proximity to the accident area and had apparently been removed from the victim.

Working inby the last permanent roof supports and attempting to pry down loose roof material with a coal shovel was the cause of this accident. Failure to evaluate properly dangerous roof conditions was a contributing factor.

Old entry fallen 13 feet high

Two pieces of rock 18" X 18" & 16" plus several small pieces

1. No person should travel inby or perform any work under unsupported roof.
2. A thorough and complete examination of the mine roof, both visually and by the sound-and-vibration method, should be made at frequent intervals so that a true evaluation of the mine roof can be made.
3. When it is necessary to bar down loose material, only a bar of proper length should be used.
4. Extreme caution should be exercised where working places intersect abandoned areas and roof conditions have been subjected to weathering and/or deterioration.
