REPORT OF COAL MINE MULTIPLE FATAL FALL-OF-ROOF-COAL ACCIDENT

NO. 1 LYKENS VEIN SLOPE

LENDEL COAL COMPANY

JOLIETT, SCHUYLKILL COUNTY, PENNSYLVANIA

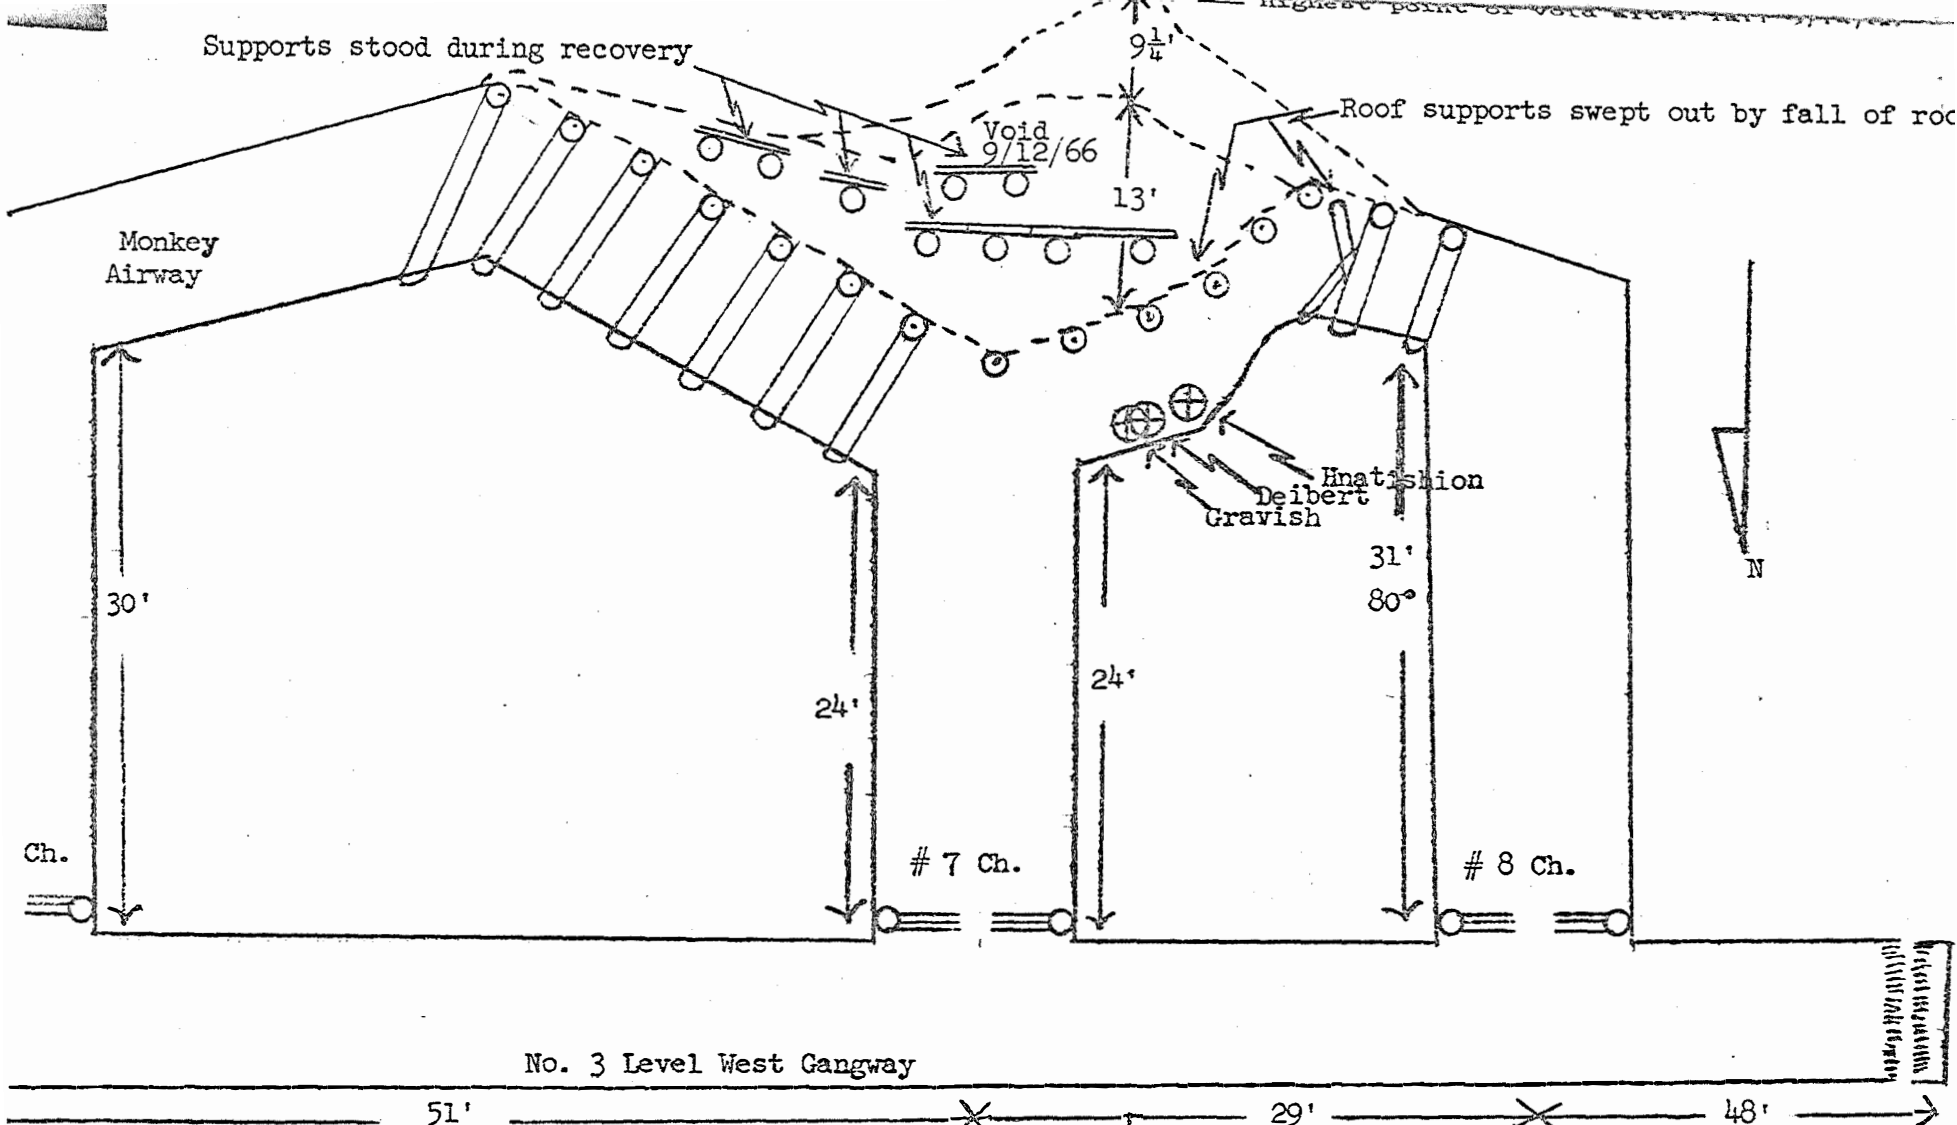
APPENDIX A

The investigation disclosed that the coal overlying the monkey airway at the scene of the accident had fallen to a height of  $22\frac{1}{4}$  feet at a point 9 feet inby the center of the No. 7 chute almost directly over the point where the three victims were recovered. The length of the fall extended from the east side of No. 7 chute to about 9 feet outby No. 8 chute; the timber along the affected portion of the airway had been swept out by the force of the fall. The highest point of the voided area above No. 7 chute on Monday, September 12, was reported to have been 13 feet above the airway timber; or slightly more than 9 feet less than that measured during the investigation.

Supports stood during recovery

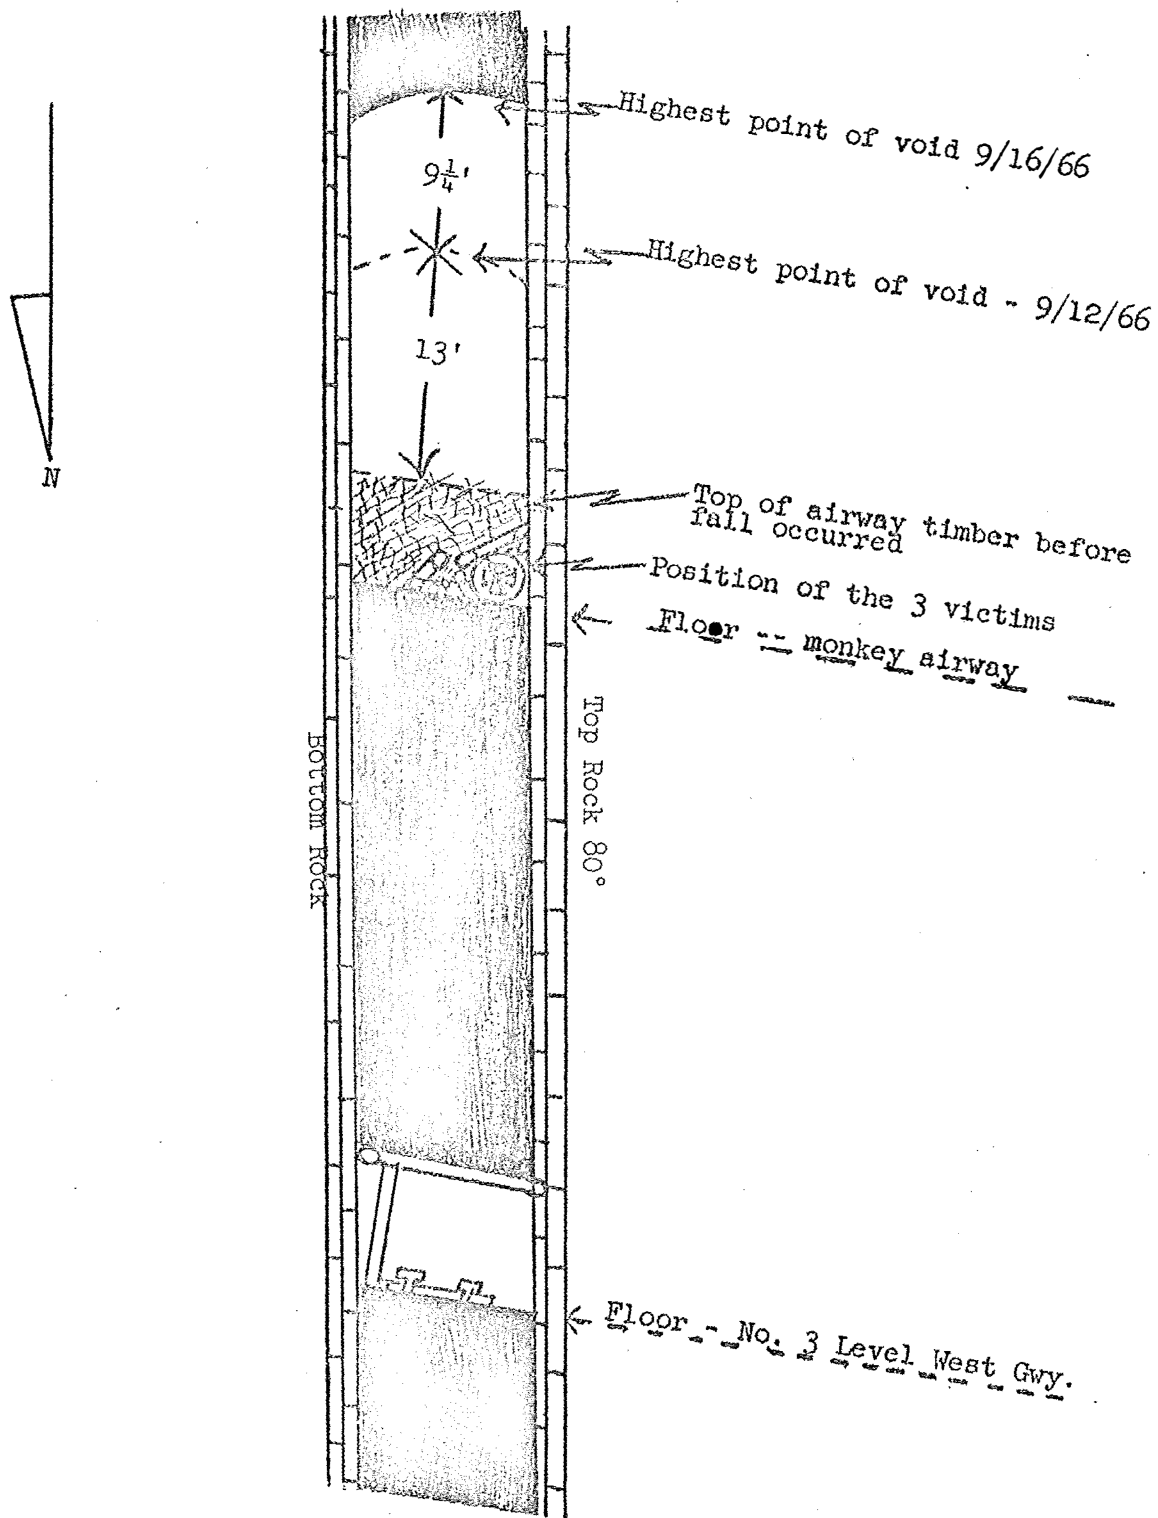
APPENDIX B

Cross Section A-A
