REPORT ON MINE FIRE AND SEALING OPERATIONS
RED TAIL NO. 2 MINE
MORGAN COAL MINING CORP.
BETHESDA, BELMONT COUNTY, OHIO

September 14, 1966

A. J. Fumich
Assistant to Subdistrict Manager

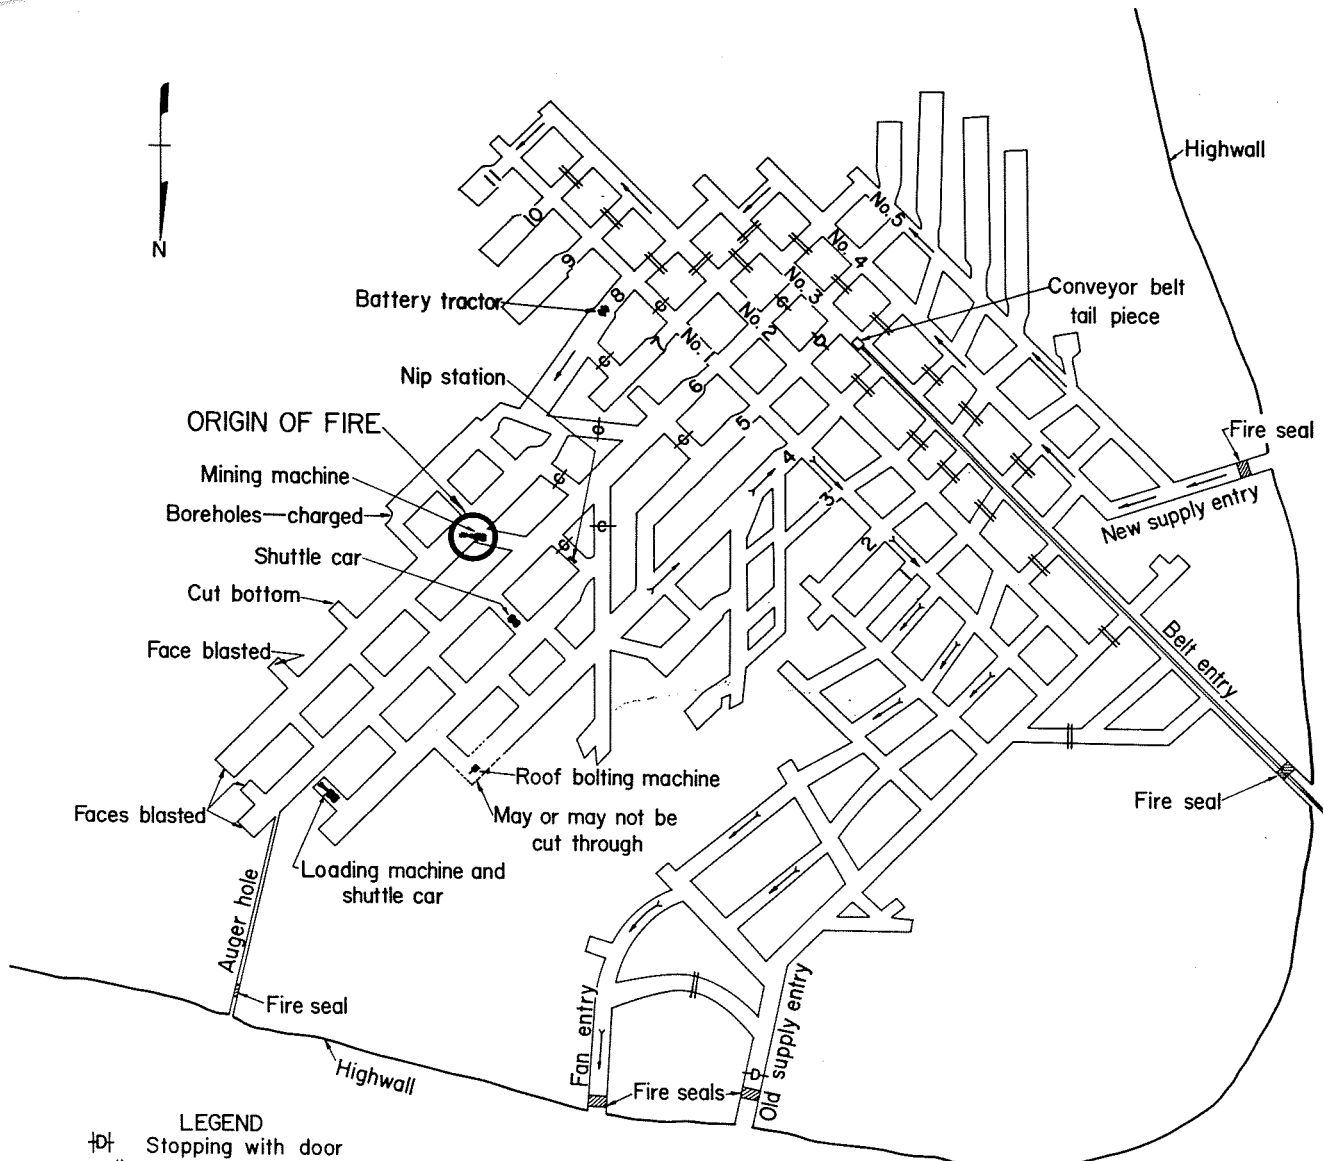
MAP OF MINE FIRE
RED TAIL NO. 2 MINE
MORGAN COAL MINING CORPORATION
BETHESDA, BELMONT COUNTY, OHIO
SEPTEMBER 14, 1966

Probable Point of Origin: The fire reportedly started when the mining machine was being trammed into a chute from No. 7 room to No. 6 room, approximately 300 feet from the face area. ✓

Cause of Fire: Based on available information, it is believed that this fire originated when a short circuit occurred in the trailing cable when it was crushed beneath the rubber tire of a mining machine. It is also believed that the fire was intensified when the flammable hydraulic fluid became involved. ✓
