REPORT OF MULTIPLE FATAL ROOF-FALL ACCIDENT
STEPHENS ELKHORN MINE
STEPHENS ELKHORN FUEL CORPORATION
MANTON, FLOYD COUNTY, KENTUCKY

February 8, 1966

Raymond Linville
Federal Coal Mine Inspection Supervisor

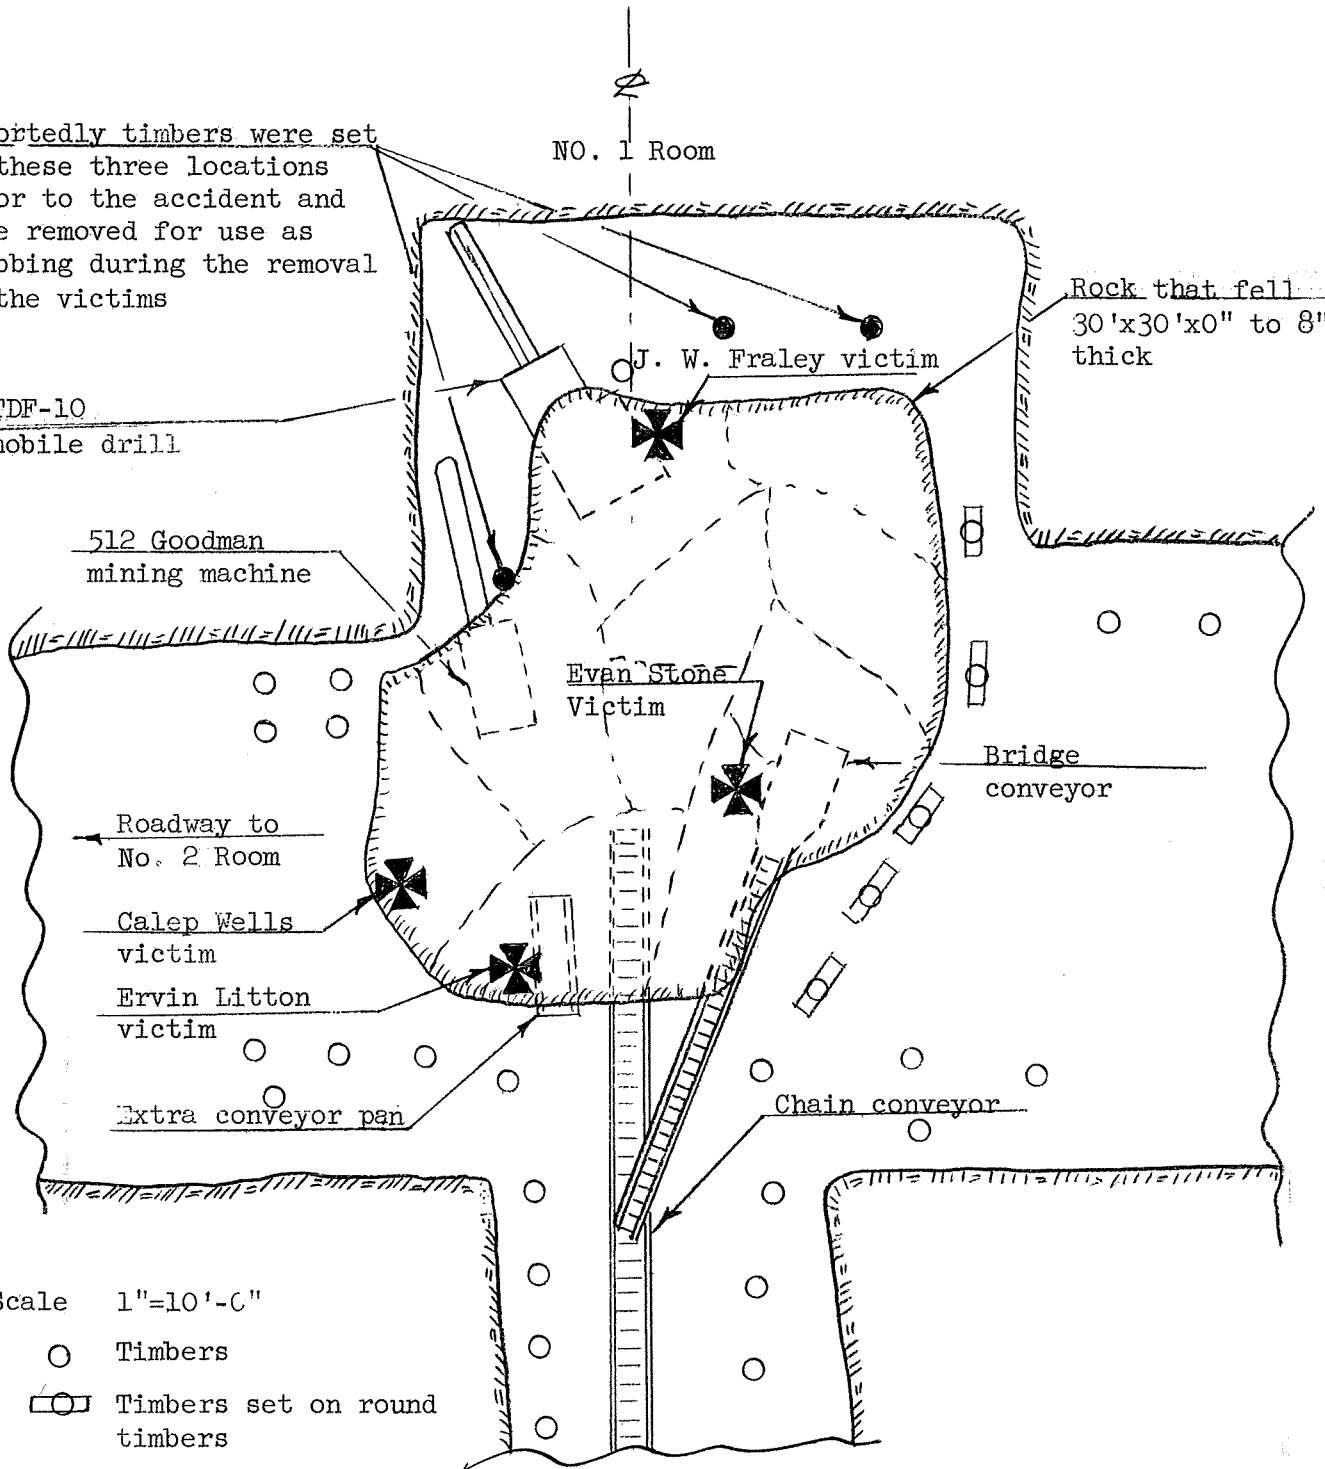
SKETCH NO. 2
 MULTIPLE FATAL ROOF-FALL ACCIDENT
 STEPHENS ELKHORN MINE
 STEPHENS ELKHORN FUEL CORPORATION
 MANTON, FLOYD COUNTY, KENTUCKY

Reportedly timbers were set at these three locations prior to the accident and were removed for use as cribbing during the removal of the victims

Calep Wells victim

Ervin Litton victim

J. W. Fraley victim

Rock that fell 30'x30'x0" to 8" thick

Evan Stone Victim
