REPORT OF FATAL COAL MINE ROOF-FALL ACCIDENT  
NEWFIELD MINE  
REPUBLIC STEEL CORPORATION  
NORTHERN COAL MINES DISTRICT  
NEWFIELD, ALLEGHENY COUNTY, PENNSYLVANIA  
(Post Office - Verona, Allegheny County, Pennsylvania)

August 26, 1968

J. W. Holcomb  
Federal Coal Mine Inspector

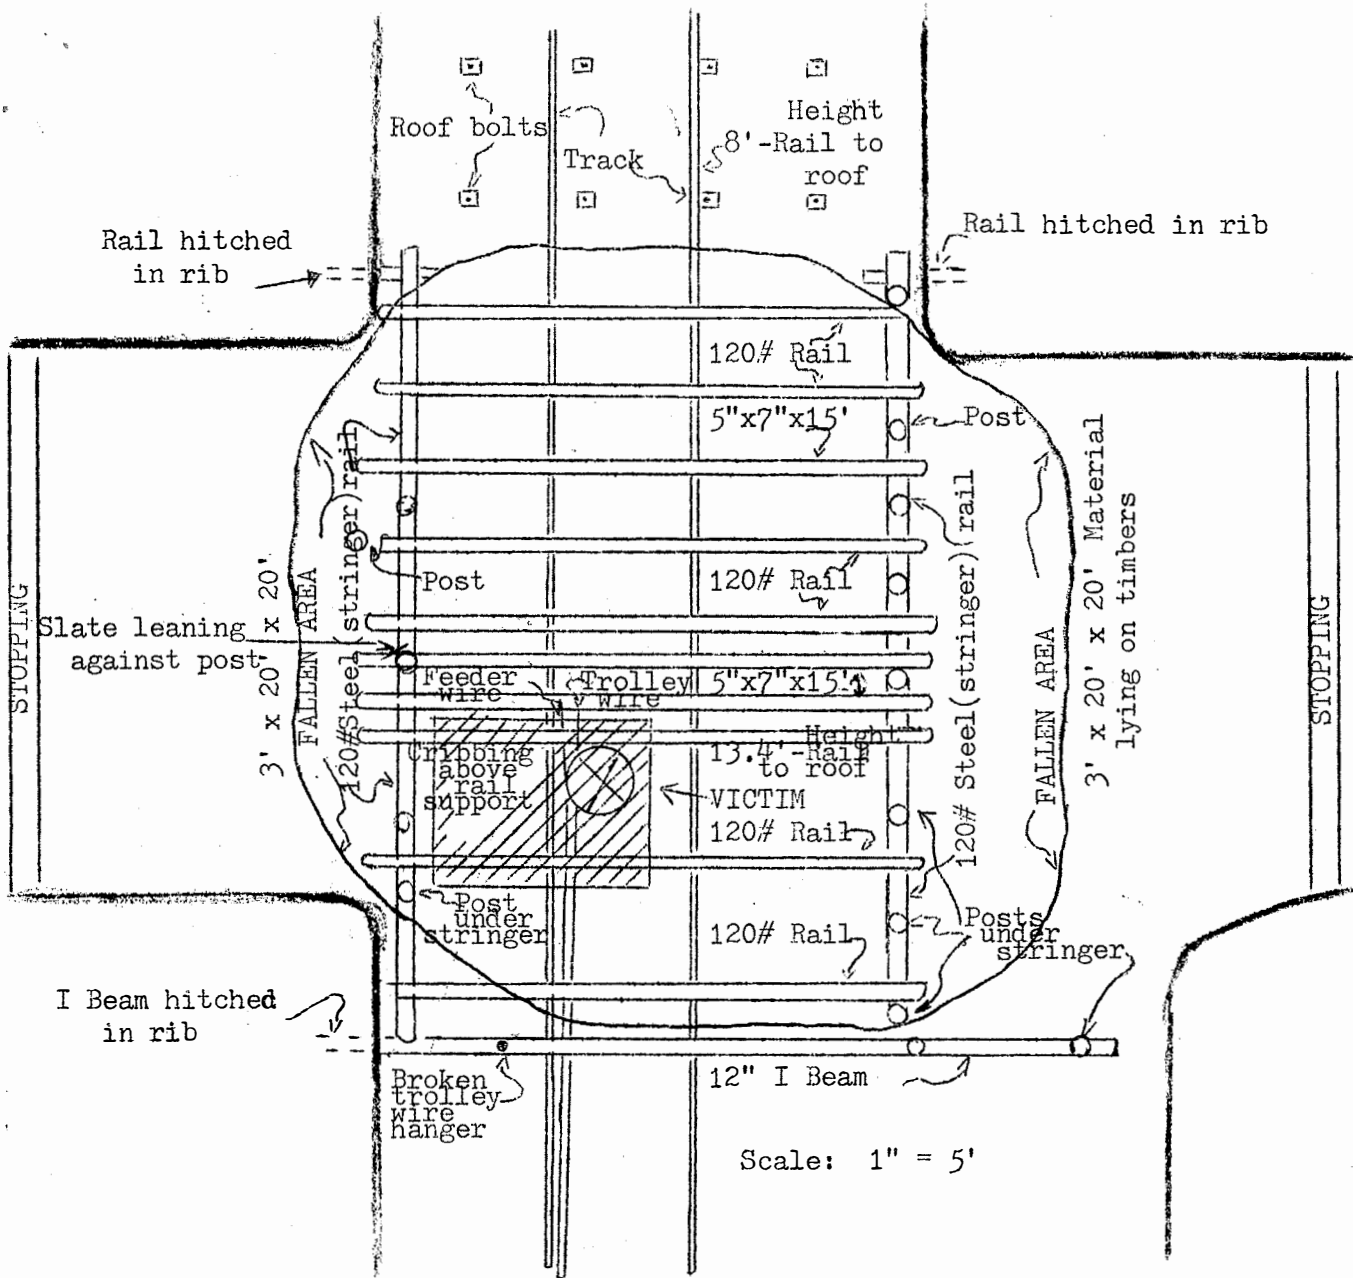
Sketch of Scene of Fatal Coal Mine Roof-Fall Accident.  
Newfield Mine

The wooden crossbars and the steel-rail crossbars were supported by steel stringer bars on either side of the entry. The steel stringer bars were supported by posts and pieces of steel rail hitched into the ribs (see attached sketch).

Gulish and Rugh prepared to install a crib on the trolley-wire side of the track. A piece of roof rock was wedged against a post under the stringer bar where the crib was to be installed. Gulish told Rugh to get in the clear while he broke the piece of rock. Rugh started walking along the track inby the intersection and when he was about 25 feet inby the intersection, he heard a sound like a hammer hitting a rock. Immediately thereafter he heard a loud crash and was engulfed in dust. He started to run, then he stopped and looked back and saw that the entire intersection had collapsed. He heard Gulish, under the fallen materials, yelling, "Turn off the power," at least four or five times.

Gulish was protected from the falling roof material by the crossbars and the lagging material. When sufficient material was removed to examine Gulish, no pulse or sign of life could be detected. His left arm was extended above his head and was in contact with the trolley and feeder wires. His left arm was burned severely.

This accident resulted because of the dislodgment of the trolley and feeder wires by a fall of timbers and roof material. The wires contacted the victim's (employee) body while he was trapped under the fall. Factors which could have contributed to the accident were: (1) Failure to guard or deenergize the power wires when working around or under such wires, (2) improper evaluation of a dangerous condition, and (3) failure to install temporary roof supports while retimbering doubtful roof.

1. When reinforcing heavily overburdened timbers, better evaluation should be made concerning the hazards relevant thereto.
2. Temporary safety supports, such as posts or safety jacks, should be installed when necessary for safety before other operations are begun and as needed thereafter.
3. Heavily overburdened timbers along haulage roads should be unloaded or taken down and the material loaded out.
4. Energized trolley and trolley feeder wires should be insulated adequately or deenergized when work such as timbering is done in the vicinage of such wires.
5. All persons working around uninsulated energized power wires should be familiar with such circuits, including the location of cutout and power-control switches for the circuits.
