# COAL FATAL

REPORT OF FATAL (MULTIPLE) ROOF-FALL ACCIDENT  
SOMERSET MINE  
UNITED STATES STEEL CORPORATION  
WESTERN DISTRICT-COAL  
SOMERSET, GUNNISON COUNTY, COLORADO

September 19, 1968

Originating Office - Bureau of Mines  
P. O. Box 15037, Denver, Colorado 80215  
E. W. Felegy, District Manager  
Health and Safety District E

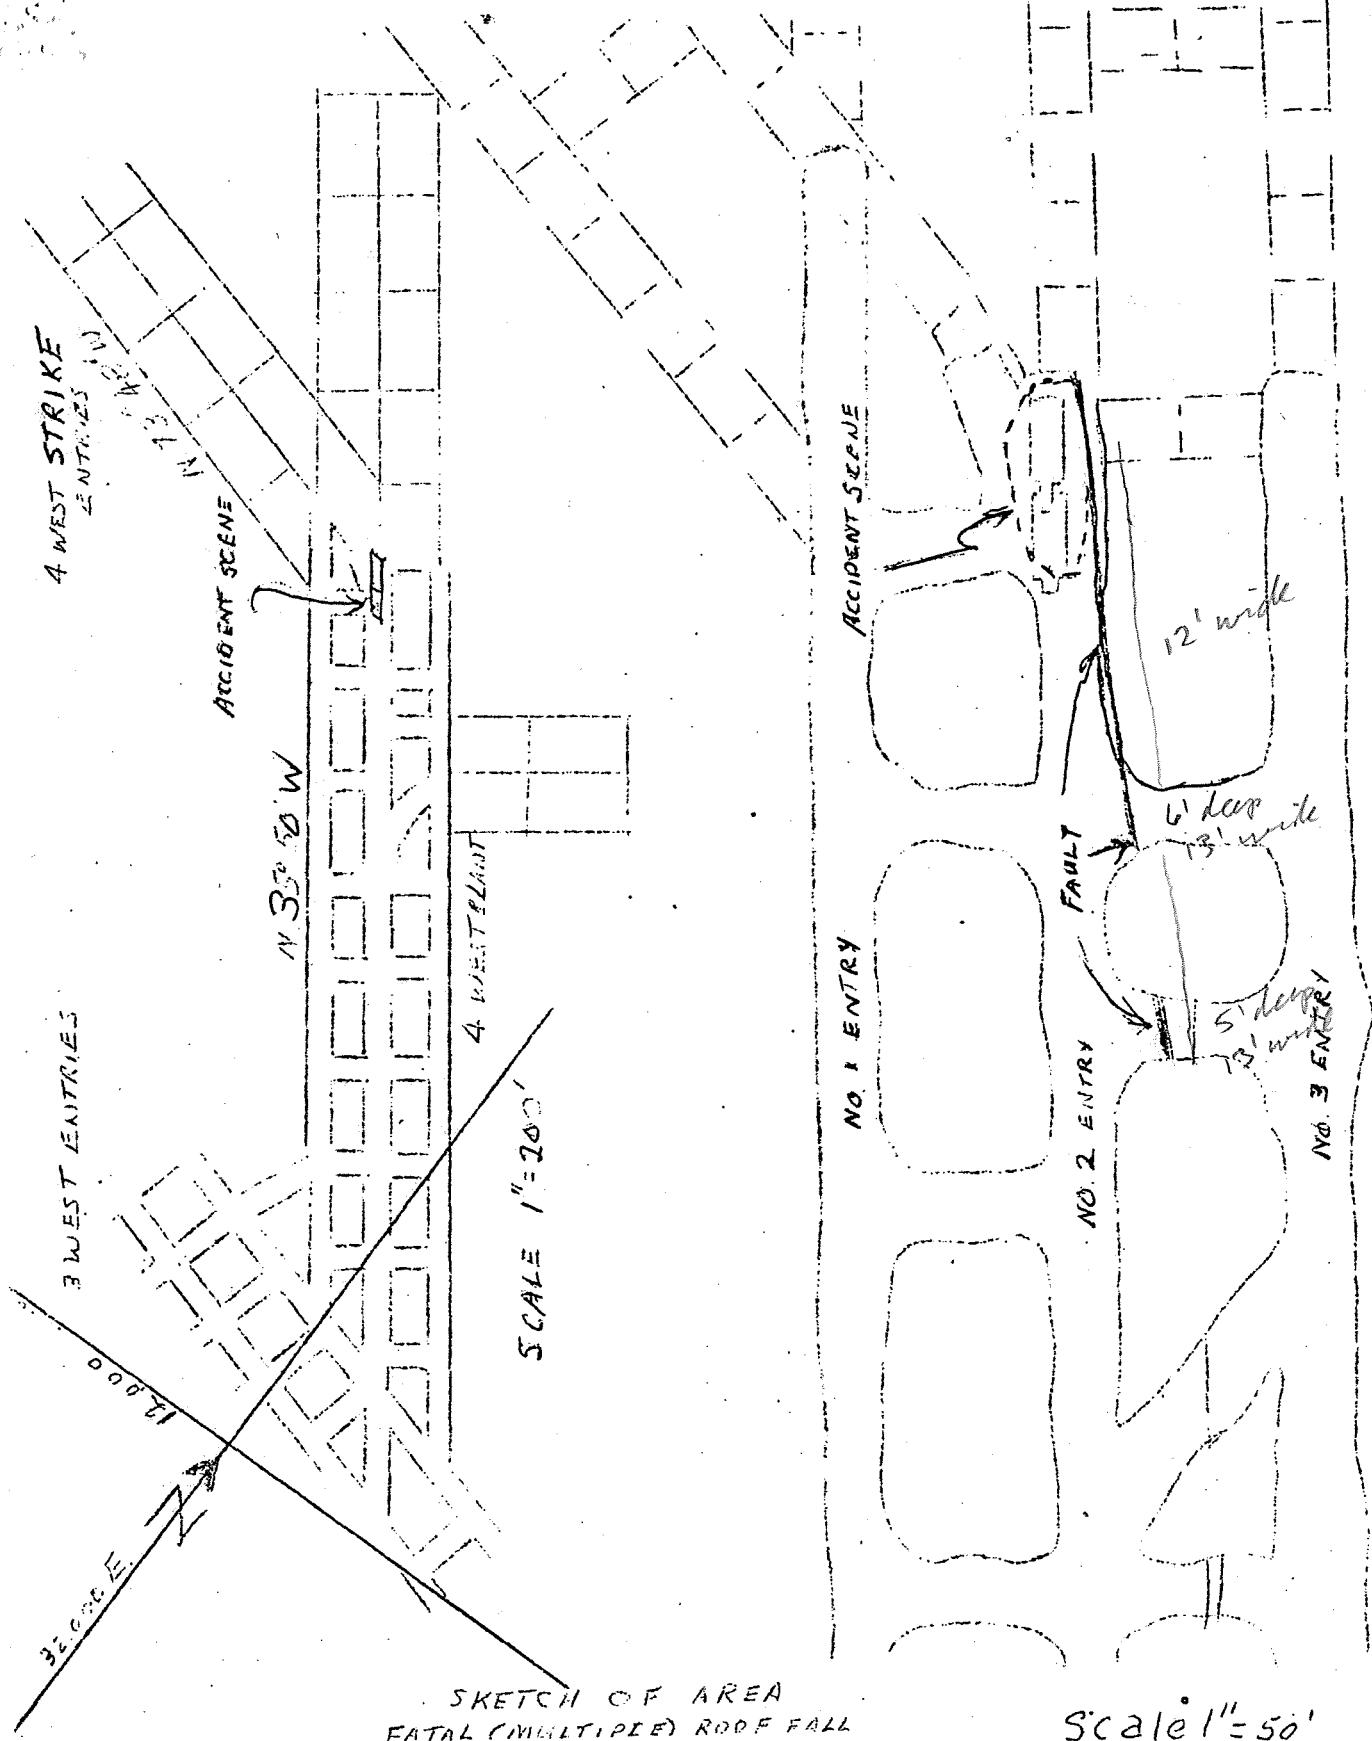
SKETCH OF AREA  
 FATAL (MULTIPLE) ROOF FALL  
 SOMERSET MINE - 4 WEST 'C' SEAM  
 U.S. STEEL CORPORATION  
 WESTERN DISTRICT - COAL  
 SOMERSET, GUNNISON COUNTY, COLORADO  
 SEPT. 19, 1968

The fall of roof was bounded on one side by a fault plane with slickensides, along the right rib of No. 2 entry. Transverse slips and bedding planes were also noted. This created an abnormal roof and rib condition where the accident occurred. The fault plane extended from the face of the entry outby for a distance of about 180 feet. The fireboss report of September 18, 1968, revealed that a "bad slip" along the right rib was supported; wide steel sheets in combination with bolts were installed

to within 4 feet of face, and timbers were set to support the slip in No. 2 entry where the fall occurred. The bolting plan was followed. The 4 west entries were developed by slanting three entries off 3 west entries, because of faults encountered in the main 3 dip entries. The 4 west entries would normally have been developed off the 3 dip entries. After advancing the slant entries far enough to turn 4 west at an angle for developing on the strike, a fault was encountered in No. 2 entry. Driving a crosscut between Nos. 1 and 2 slant entries, and then turning No. 2 entry to the strike at the intersection of the crosscut and No. 2 entry resulted in an excessive width, ranging up to 41 feet, where abnormal conditions existed. See sketches.

The rock that fell measured 48 feet long, 25 feet wide at the widest point at the roof line, and 15 feet wide at the top. It was 10 feet thick. There were slickensides along the right side and at the top.

The general superintendent stated that plans are to reduce the width of mine workings to 16 feet and to increase the distance between crosscuts in an effort to prevent a similar occurrence.

1. Where faults or other disturbances are encountered, engineering projection changes should be made.
2. Employees and officials should be extremely careful in faulted roof areas, as this mine roof is known to contain numerous hidden slips, pots, and slickensides.
3. Width of mine openings at intersections should be kept to a minimum to avoid abnormal stress of the mine roof.
4. When mining in the vicinity of faults or other abnormal areas, roof and rib conditions should be appraised carefully and proper precautions taken such as installing additional support.

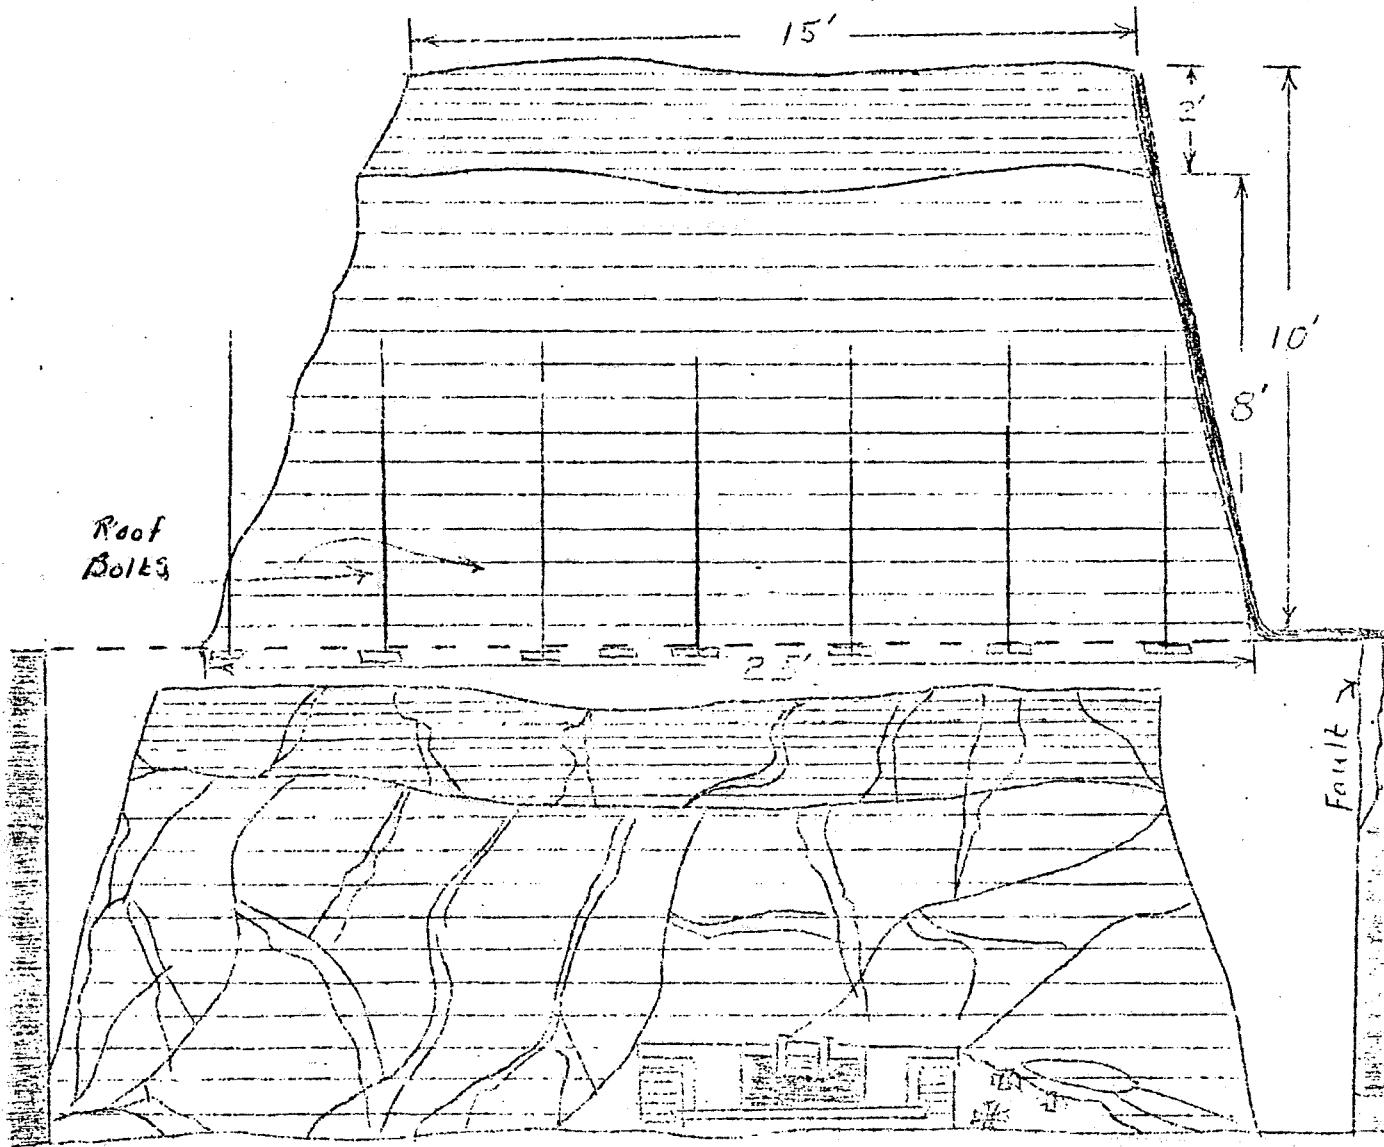
CROSS-SECTIONAL VIEW  
FATAL (MULTIPLE) ROOF FALL ACCIDENT  
SOMERSET MINE - 4 WEST "C" SEAM  
U.S. STEEL CORPORATION  
WESTERN DIVISION - COAL  
SOMERSET, GUNNISON COUNTY, COLORADO  
SEPT. 19, 1968      NOT TO SCALE

Roof overlying the "C" coalbed consists of 5 to 10 feet of strata grading from sandy shale to laminated sandstone and coal bearing shale. This roof contains slips, pots, and slickensides, which are hidden by the top coal, and tends to separate from overlying strata when exposed. Roof support in the "C" coalbed consisted of installing roof bolts in accordance with revised roof-bolting plan No. 4 approved by the Bureau of Mines June 29, 1962. Roof bolts were 3/4-inch diameter, 5 feet in length, anchored with expansion shells and bearing was afforded by 1/4-inch embossed steel plates. Bolts were spaced 4 feet apart or less, lengthwise and crosswise, where the accident occurred. Wide steel sheets (16 gage minimum) were used for continuous support between bolts, where deemed necessary. Torque tests, made of roof bolts in the vicinity of the accident area, revealed that bolts were tightened properly. Reportedly, roof at working faces was tested at frequent intervals by officials and workmen.
