REPORT OF FATAL COAL MINE (MACHINERY) ACCIDENT
BANNING NO. 4 MINE
REPUBLIC STEEL CORPORATION
NORTHERN COAL MINES DISTRICT
WEST NEWTON, WESTMORELAND COUNTY, PENNSYLVANIA

Injured: February 20, 1969 Died March 23, 1969

Walter J. Balitski Federal Coal Mine Inspection Supervisor

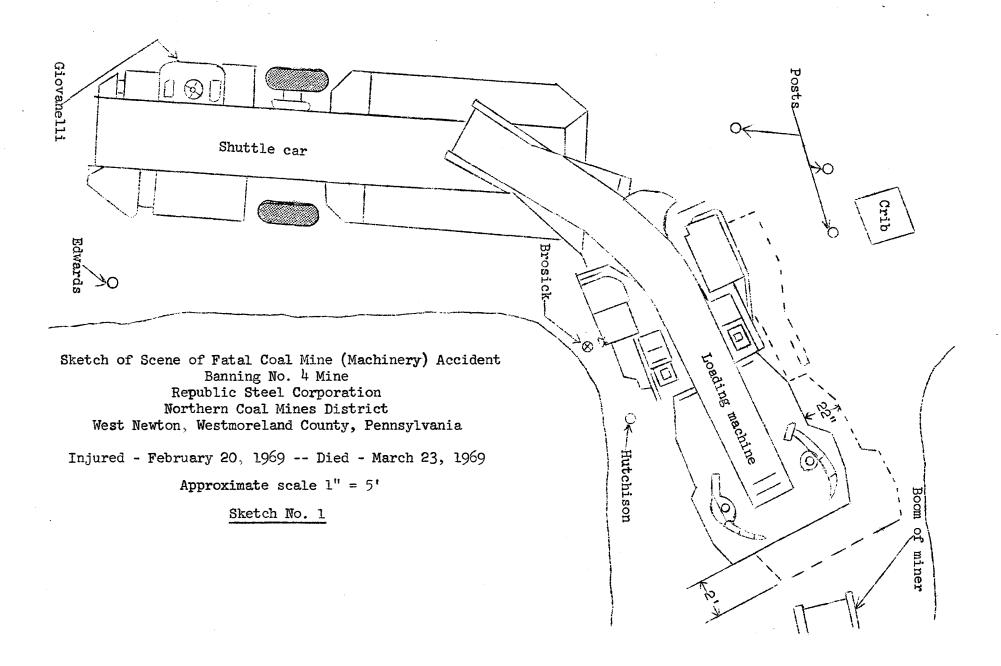
Sketch No. 2

The equipment involved was a Jeffrey 67-MT shuttle car and a Jeffrey 81-A loading machine which had been operated for about 10 years. Due to the design of the underside of the boom of the loading machine and an alteration to the sideboard of the shuttle car, a locking effect was created when the shuttle car started to tram. Management and employees stated that to their knowledge this was the first time that two pieces of equipment had locked. The simultaneous movement of the loading machine and shuttle car suddenly moved the loading machine 24 inches outward and 22 inches sideward. A flame safety lamp that hung near the resistance case may have also come in contact with Brosick's legs since it was damaged.

The cause of this accident was the moving under the stress of an emergency of the loading machine before the shuttle car was in the clear.

Shuttle car and loading machine caught together at this point

In an effort to prevent the possibility of similar accidents, management has had metal plates welded over the openings in the booms of all similar types of machines.
