REPORT OF FATAL COAL MINE ROOF-FALL ACCIDENT
NEWFIELD MINE
REPUBLIC STEEL CORPORATION
NORTHERN COAL MINES DISTRICT
NEWFIELD, ALLEGHENY COUNTY, PENNSYLVANIA
(Post Office - Verona, Allegheny County, Pennsylvania)

July 24, 1970

Everett Turner
Federal Coal Mine Inspection Supervisor

Willard A. Stiltner
Federal Coal Mine Inspector

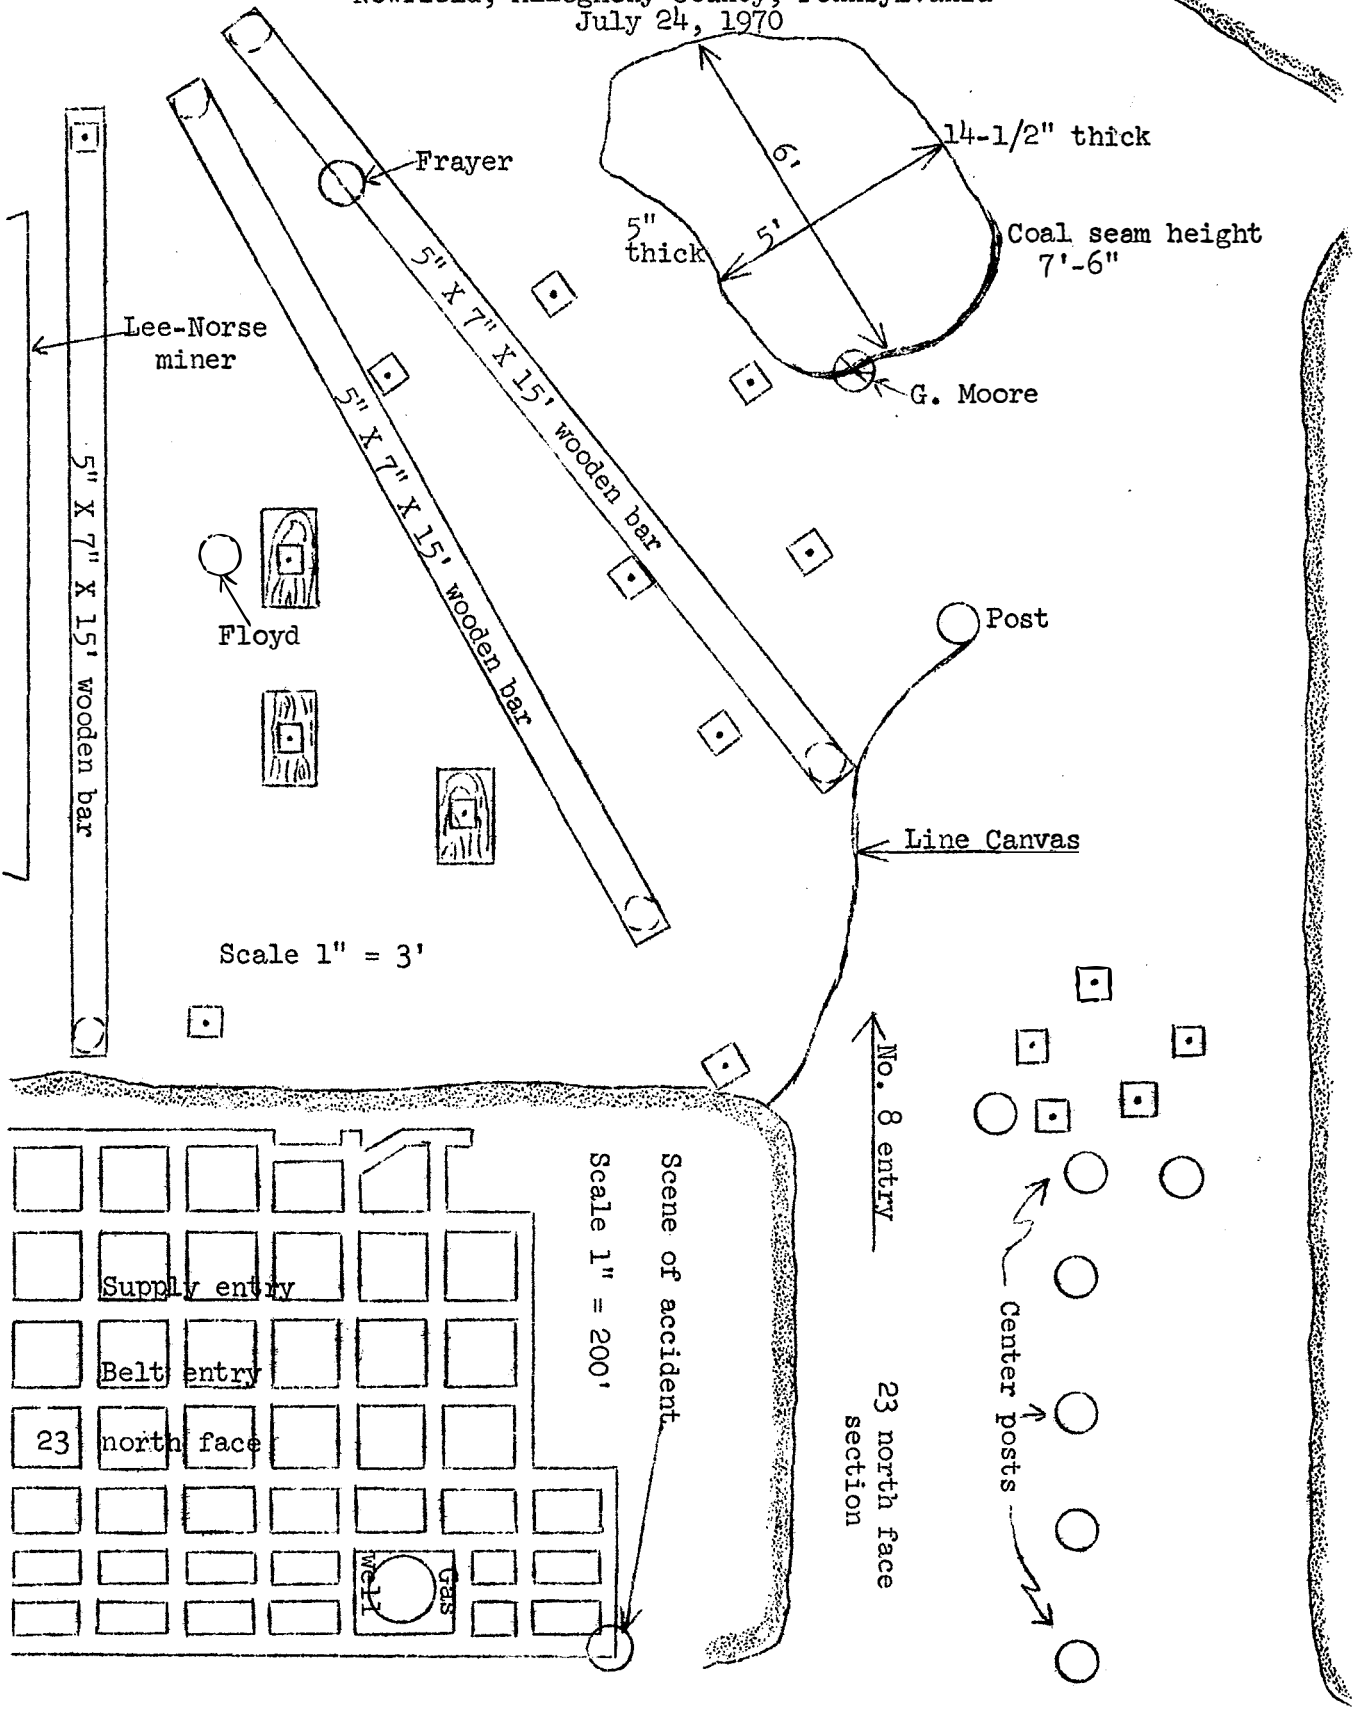
Sketch of Scene of Fatal Coal Mine Roof-Fall Accident
 Newfield Mine
 Republic Steel Corporation
 Northern Coal Mines District
 Newfield, Allegheny County, Pennsylvania
 July 24, 1970

After lunch Floyd, Frayer, and Moore went back to No. 8 entry working place while the other workmen were bringing in the crossbars and posts. Floyd entered the place, went up the left side, and examined the working place. Moore had picked up the slate bar and was standing under the inby roof bolt near the center of the place. He cautioned Floyd of the unsafe roof condition and Floyd left the face region and returned to where the roof was supported (see attached sketch).

about 10 feet outby Moore, he heard the roof material falling, turned around and saw the falling roof material striking Moore, Frayer was not looking at Moore when the roof fall occurred; however, it was apparent that Moore had stepped inby the roof bolt. Moore's legs were pinned under the fall. Floyd and Frayer were unable to lift the material off Moore and Frayer ran for help while Floyd installed a safety jack.

The roof rock that fell and struck Moore was 6 feet long, 5 feet wide, and varied from 5 inches to 14-1/2 inches in thickness. The height of the coal in the place where the accident occurred was 90 inches. The accident occurred about 8 feet from the face.

Management's failure to properly evaluate a dangerous condition and/or take necessary safety precautions, such as having temporary supports installed, and the employees working under unsupported roof, were the causes of this accident. A contributing factor could have been management's failure to provide a suitable tool to take down the roof in high places.

1. Where abnormal roof conditions are known to exist management shall assure that necessary safety precautions are taken, such as the installation of safety jacks or posts, to protect workmen before attempts are made to take down loose roof materials.
2. More thorough examinations and better evaluation should be made, especially of doubtful roof conditions.
3. Tools used to take down loose roof material shall be of a design that will enable workmen to perform their duties from a safe position without exposure to falling material.
4. The roof-control plans shall be complied with at all times.
