REPORT OF MULTIPLE FATAL HOISTING OF MATERIALS TYPE ACCIDENT

MAPLE MEADOW MINE (SLOPE) (ID NO. 46-03374)
MAPLE MEADOW MINING COMPANY

MONTY BROTHERS CONSTRUCTION COMPANY (ID NO. A97-410(A))
FAIRDALE, RALEIGH COUNTY, WEST VIRGINIA

October 2, 1974

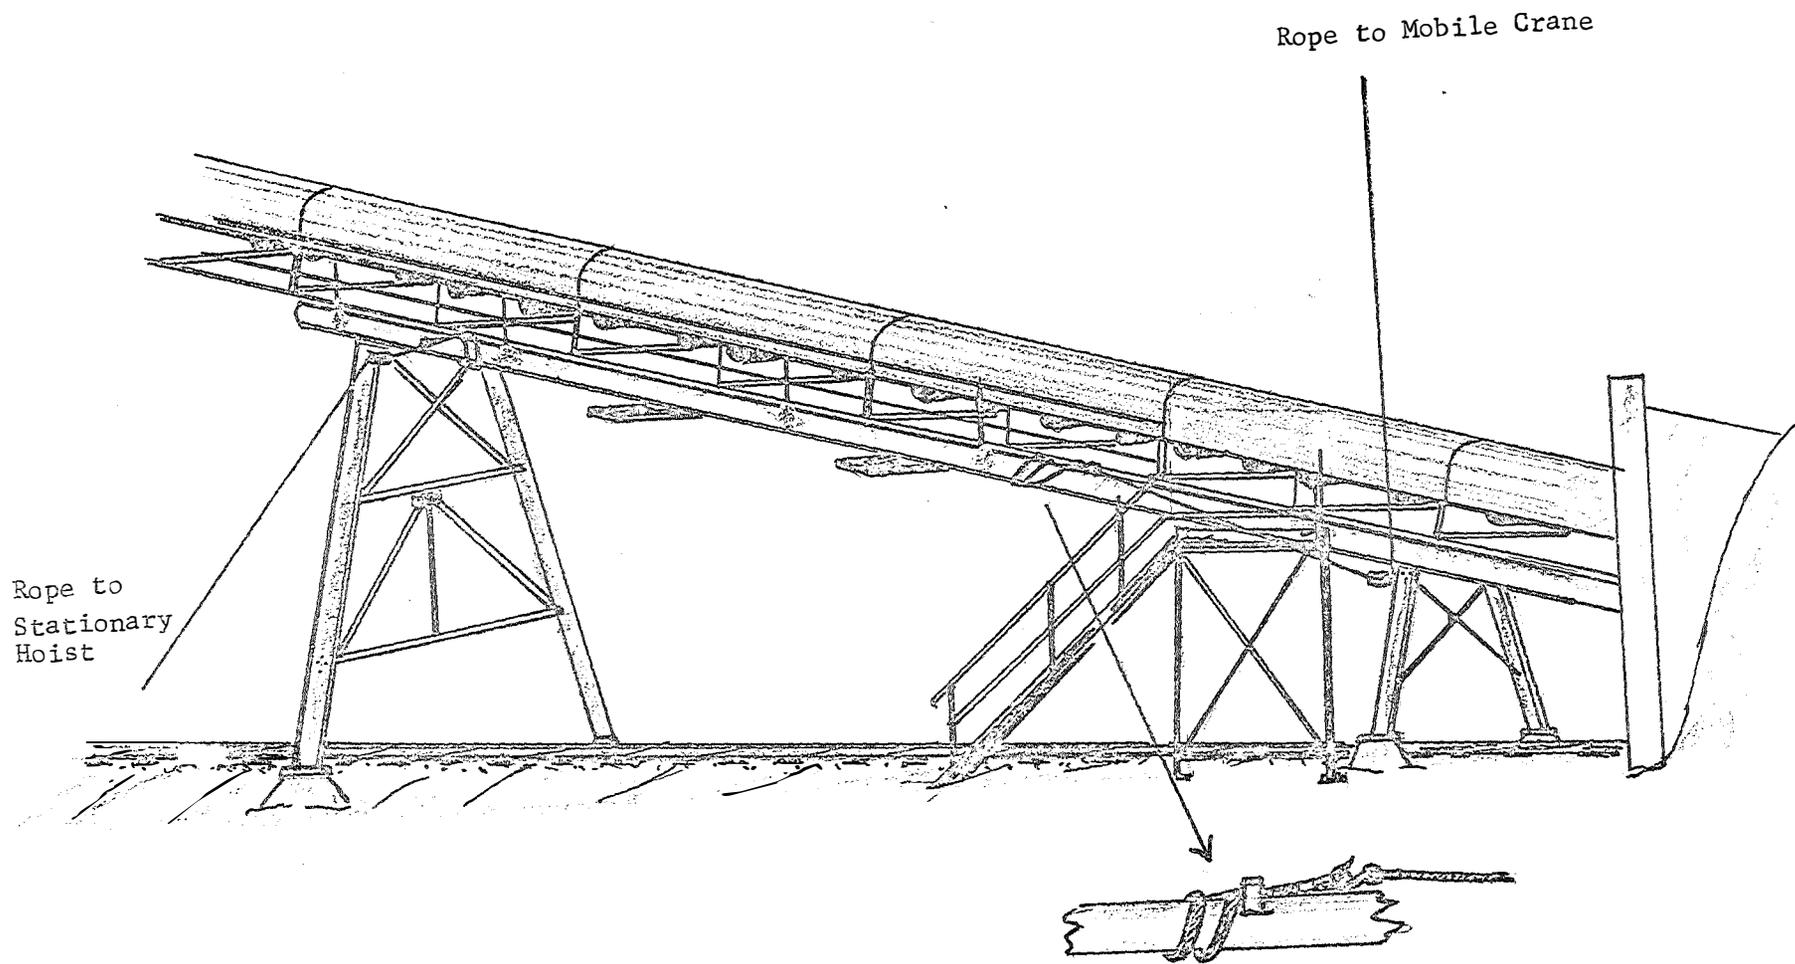
Not Drawn to Scale
Sketch No. 2

20. The 5/8-inch wire rope choker sling used around the pipe was permitted to rub the welded lug on the pipe. In addition, the choker sling had been permitted to rub the angle iron of the working platform as the pipe descended into the slope.

Choker Rope Arrangement

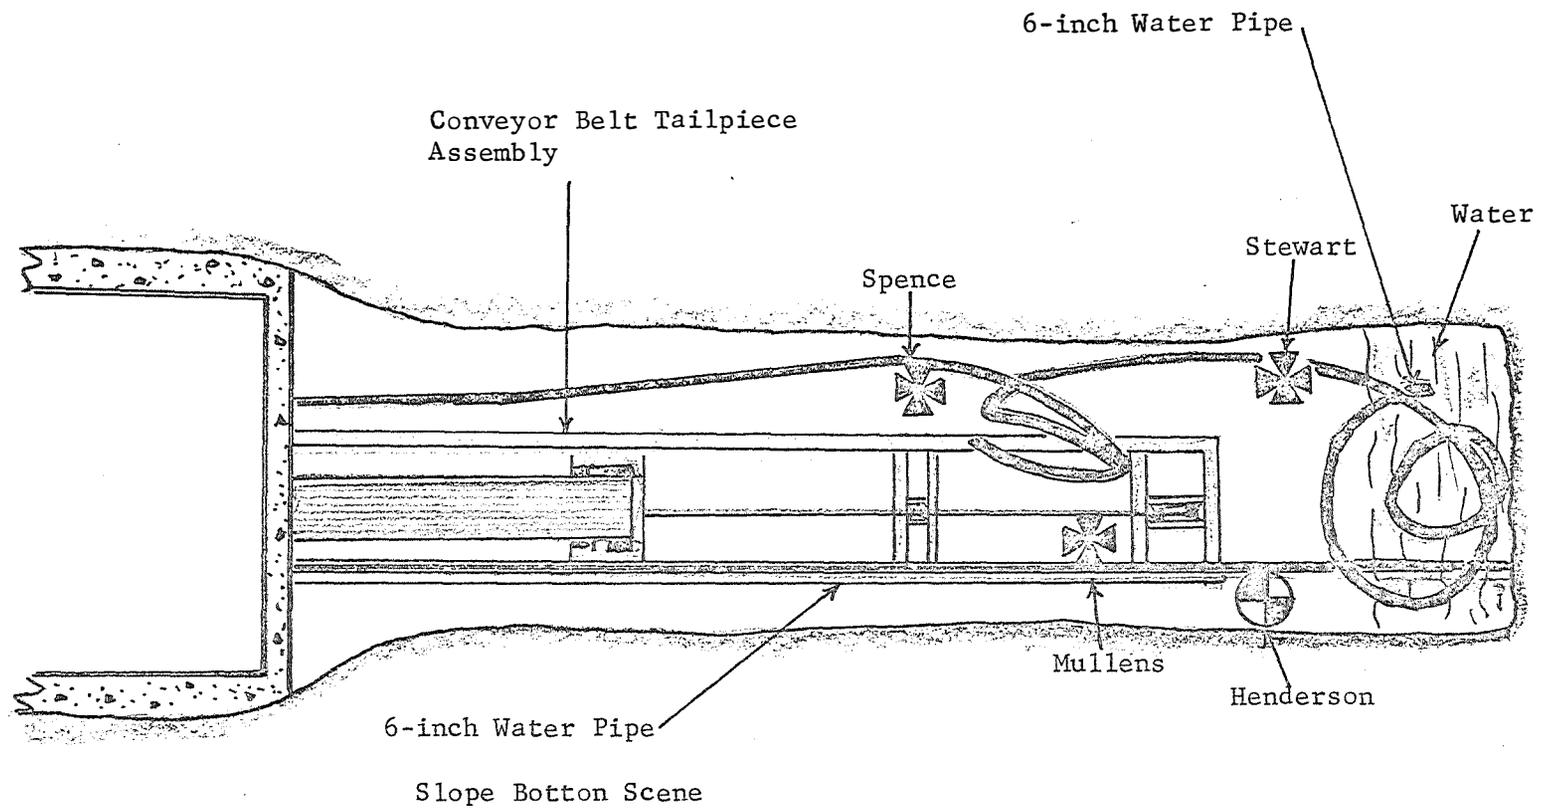
Not Drawn To Scale
Sketch No. 3

About 11:15 a.m., the time of the accident, a combined length of pipe was being lowered to a position in the slope to facilitate the connection of another section of pipe. Stewart stated that the pipe moved about 10 to 12 feet when the 5/8-inch wire rope choker sling broke. Approximately 700 feet of the 6-inch pipe, which weighed about 13,000 pounds, began to slide down the slope on the steel I-beams that were installed in the slope to support the belt structure. The pipe gained momentum as it slid down the 2,880-foot slope. Marks on the sandstone roof revealed that the pipe struck the roof at a distance of about 2,650 feet into the slope. The impacts with stationary objects near the bottom of the slope broke the 700-foot length of pipe into 6 separate sections. Some of the pipe sections crossed over and under the conveyor belt. Most of the pipe sections (after the initial impact near the 2,650-foot point in the slope) traveled to the left side of the slope and/or near the center of the slope. (See Sketch No. 3)
