## HEALTH AND SAFETY REPORT

REPORT OF MULTIPLE FATAL HYDROGEN SULFIDE GAS POISONINGS  
BONNIE LAKE MINE AND MILL  
W. R. GRACE AND COMPANY  
BARTOW, POLK COUNTY, FLORIDA

June 4, 1975

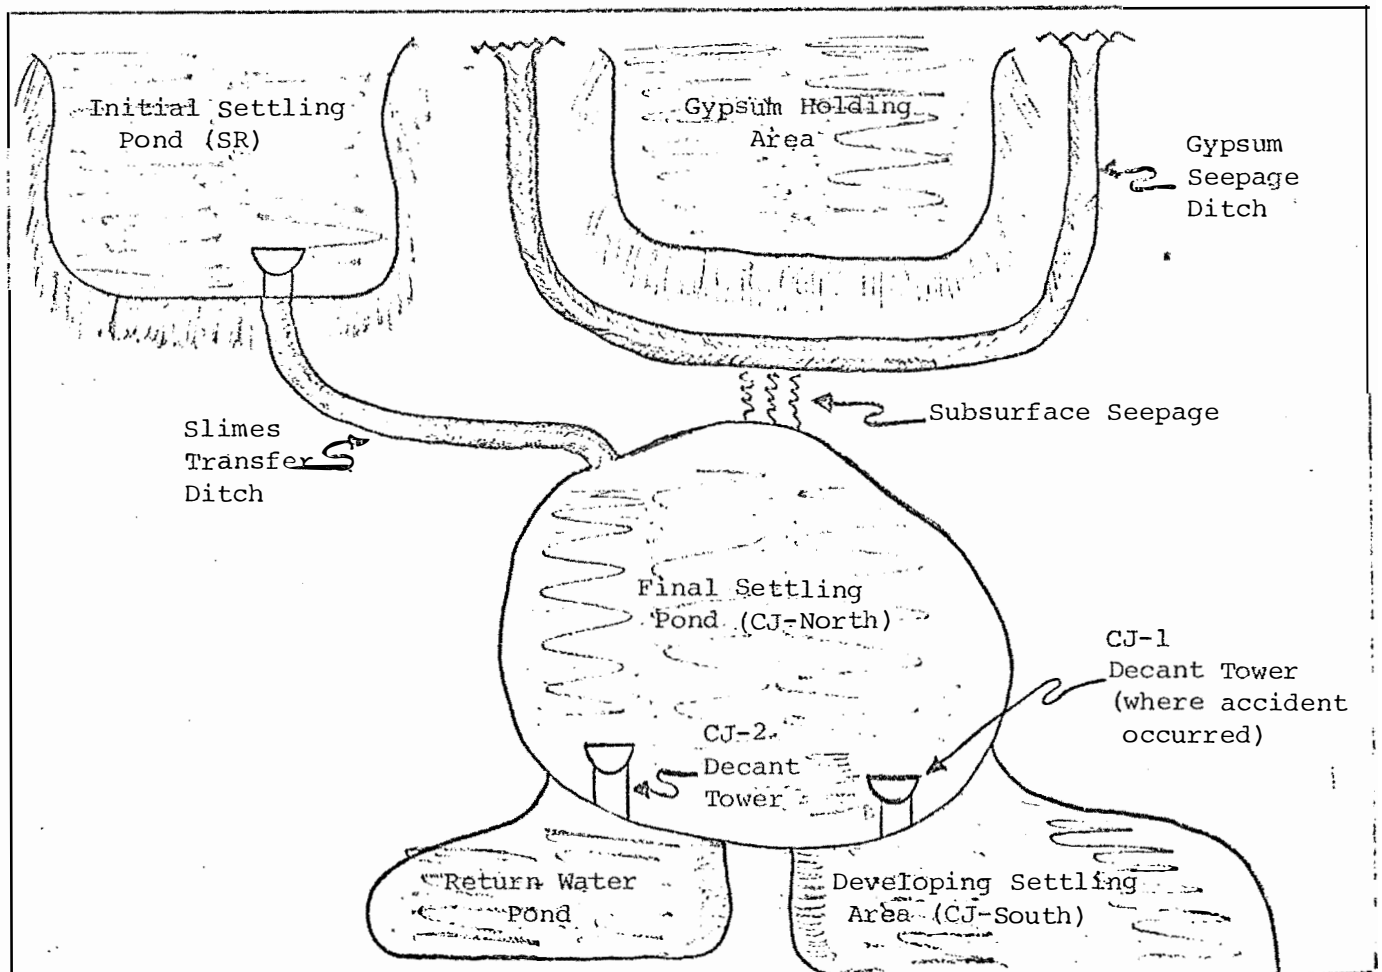
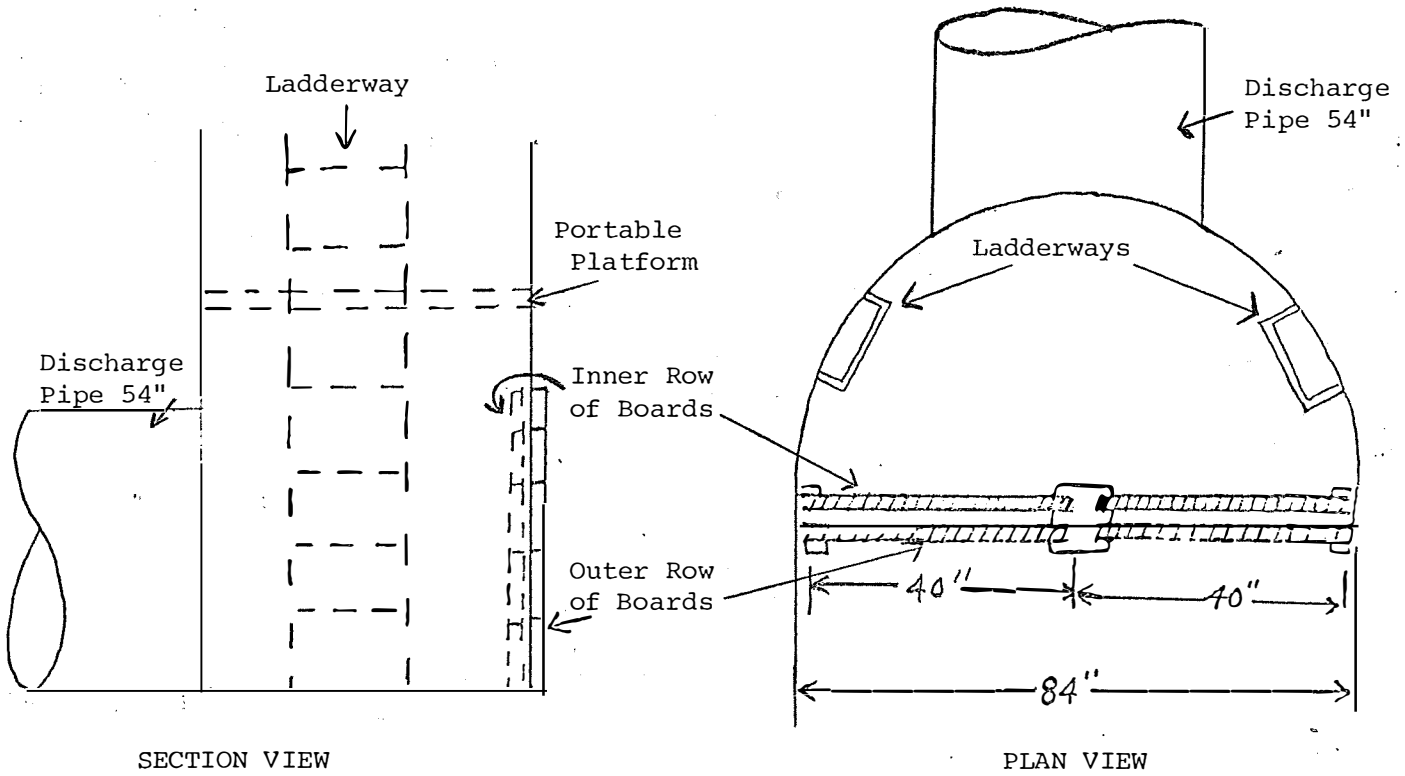
SECTION AND PLAN VIEW  
 OF  
 BOTTOM OF DECANT TOWER

The retaining dam at the accident site was approximately 20 feet high. An expanded-metal walkway extended from the top of the dam to the top of the decant tower. The tower was of steel construction, 20 feet high, semi-circular in cross section and 84 inches across the diameter. The water level in the pond was raised by inserting flashboards across the diameter of the riser. Two boards, 8 inches by 2 inches by 40 inches, fitted end-to-end into channel-iron slots would raise the water level 8 inches. Two sets of these flashboards were frequently used. The second, or back-up, set provided additional strength when the water reached greater depths of 12 to 14 feet and pressure against the outer set of boards increased. Two fixed ladders were attached on opposite sides inside the tower and extended to the metal bottom. A portable, expanded-metal platform installed through the rungs of both ladders was used to stand on while placing or removing boards. Water from the tower was discharged by means of a 54-inch diameter tube extending from near the bottom of the tower, through the dam and into the pond on the other side. At the time of this investigation, approximately 5 feet of water was in the CJ-North pond at this location.
