REPORT OF MULTIPLE-FATAL COAL-MINE ROOF-FALL ACCIDENT
DEER CREEK MINE (I.D. NO. 42-00121)
PEABODY COAL COMPANY
HUNTINGTON, EMERY COUNTY, UTAH

May 12, 1975

Tony Gabossi
Coal Mine Inspection Supervisor

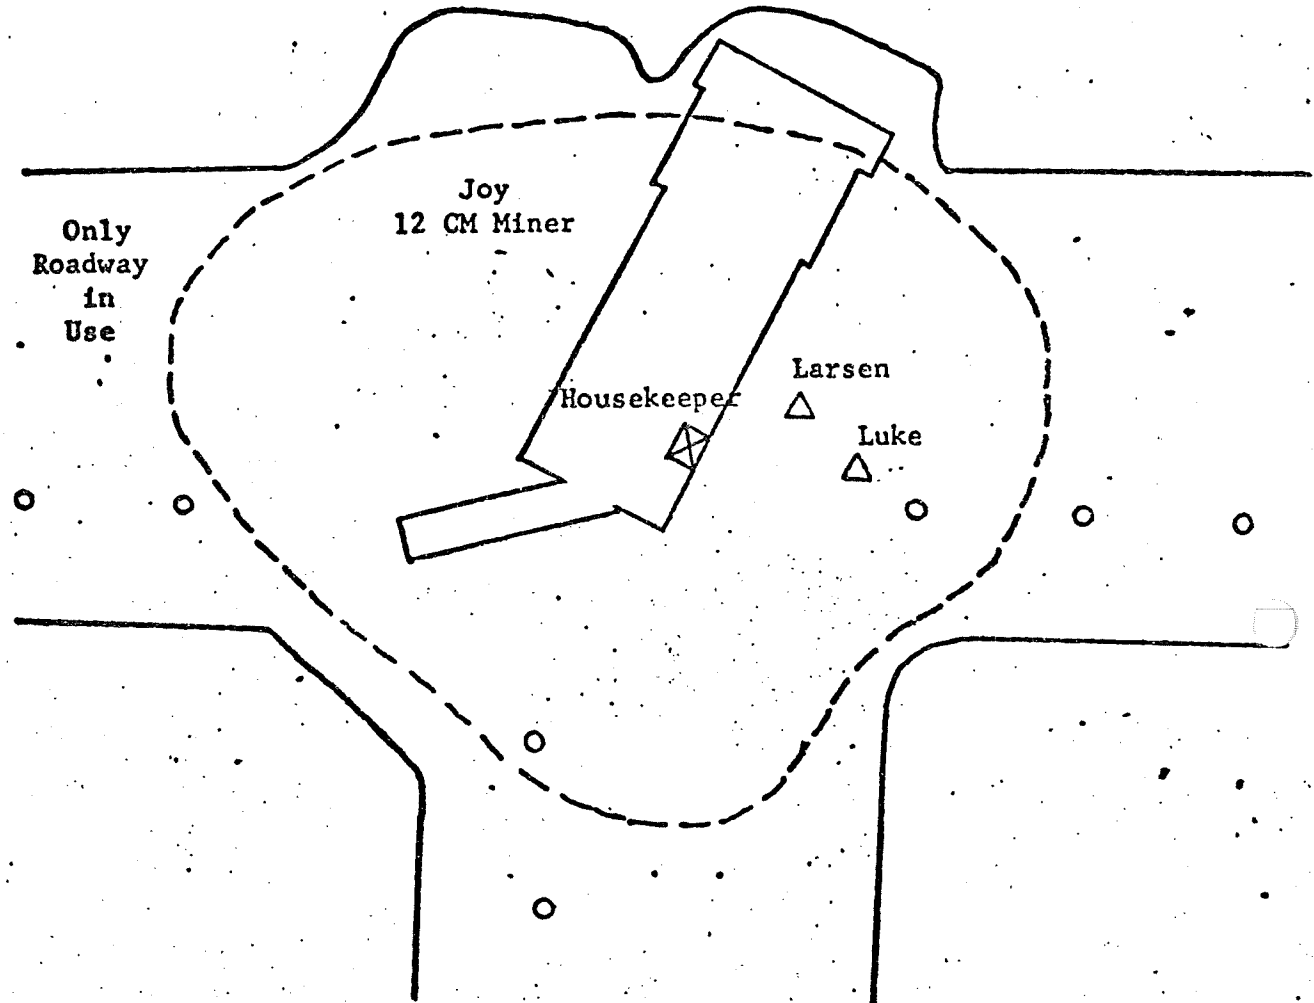
INITIAL FALL

Recovery of the remaining two victims proceeded without incident. Luke was recovered at 1:55 p.m., and Larsen at 11:25 p.m. Both victims were pronounced dead upon arrival at the surface by Dr. O. B. Spencer. The roof fall was approximately 41 feet long, 32 feet wide and varied in thickness from 16 to 48 inches.

Failure of management and workmen to recognize and evaluate the hazardous roof condition that existed in the area and to install adequate roof supports before the crosscut was started at the three-way intersection was the cause of the initial accident.

1. The roof was not adequately supported at the three-way intersection in the main entry (belt entry) in 1 south section, where No. 87 crosscut was being started to the left; a violation of Section 75.200.
2. The approved roof-control plan was not being complied with, in that the opening to the crosscuts between entries had been driven excessively wide in the 1 south section (crosscut opening widths ranged from 22 to 29 feet), which was a result of poor mining practices; a violation of Section 75.200.
3. The roof-control plan was not being complied with, in that the plan for recovery work was not posted in the area following the initial roof-fall; a violation of Section 75.200.
4. The recovery crew installed inadequate temporary supports on loose material after the initial fall.

1. The roof-control plan shall be revised to require full roof bolting throughout the mine and temporary supports shall be installed immediately after each mining cycle is complete. When loose roof, water, or fractures are encountered, additional supports shall be installed.
2. Where falls have occurred management shall devise and have in writing, at the scene of the fall, a plan incorporating the procedures for recovery.
3. During recovery operations work shall be performed under the direct and constant supervision of a company official, and loose overhanging roof shall be taken down or adequately supported before workmen are permitted to work in the area.
4. All underground employees shall be retrained and thoroughly instructed in the requirements of the new roof-control plan for safe and proper bolting procedures.

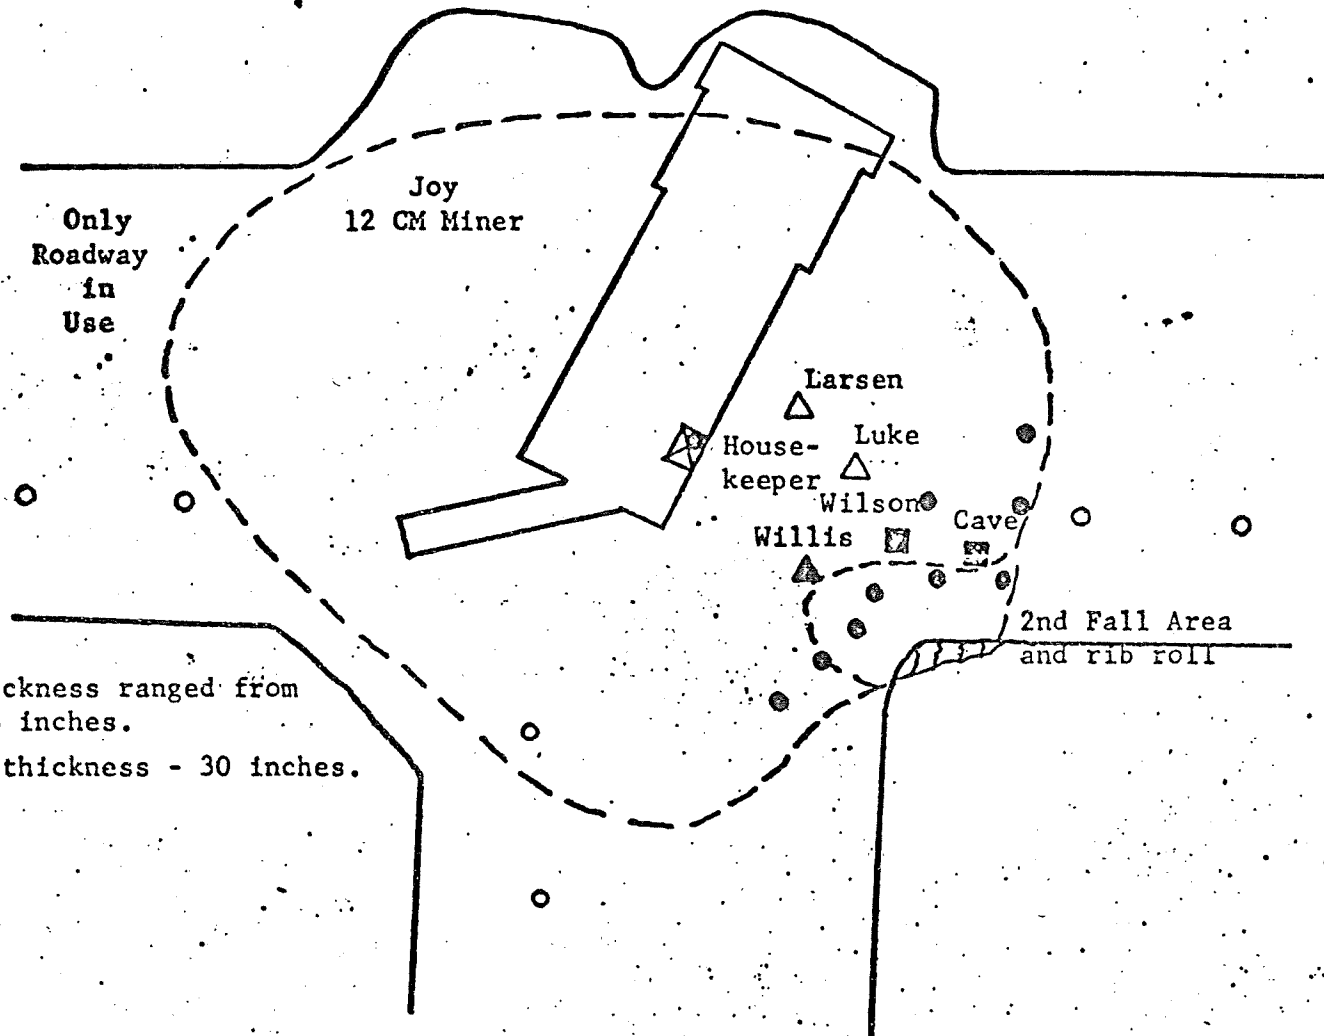
FALL DURING RESCUE ATTEMPT

During recovery operations the safety posts which were installed (approximately eight or nine) were not adequate to support the loose overhanging roof and rib. A second fall occurred, striking Dave Cave, Vernon Wilson and Alfred Willis, victim. Noyes, with the help of others, immediately removed Wilson and Cave from the fall area. The men were examined for injuries and determined through discussion and observations that Wilson sustained pelvis injuries. It was determined that Cave was not

Cause of the second accident was management's failure to properly supervise rescue operations.

5. A second fall occurred during recovery operations, which resulted in the death of one employee and injuries to two employees.
6. Horizontal fractures and vertical slips in the roof were evident in the cavity left by the fall.
7. Coal which had been left on the roof for support purposes could have affected the examination and detection of the roof condition.
8. Water was observed dripping from the roof in the fall area.
9. Employees stated the roof had been tested (visual and sound methods) several times by Noyes, section foreman, and Housekeeper, continuous-mining machine operator.
10. The cab on the continuous-mining machine prevented injury to the continuous-miner operator.

Fall thickness ranged from
16 to 48 inches.
Average thickness - 30 inches.
