REPORT OF TRIPLE FATAL MACHINERY (FRONT-END LOADER) ACCIDENT  
EL PASO QUARRY  
EL PASO ROCK QUARRIES, INC.  
EL PASO, EL PASO COUNTY, TEXAS

February 15, 1975

FATAL MACHINERY ACCIDENT (FRONT-END LOADER)  
EL PASO QUARRY  
EL PASO ROCK QUARRIES, INC.  
EL PASO, EL PASO COUNTY, TEXAS

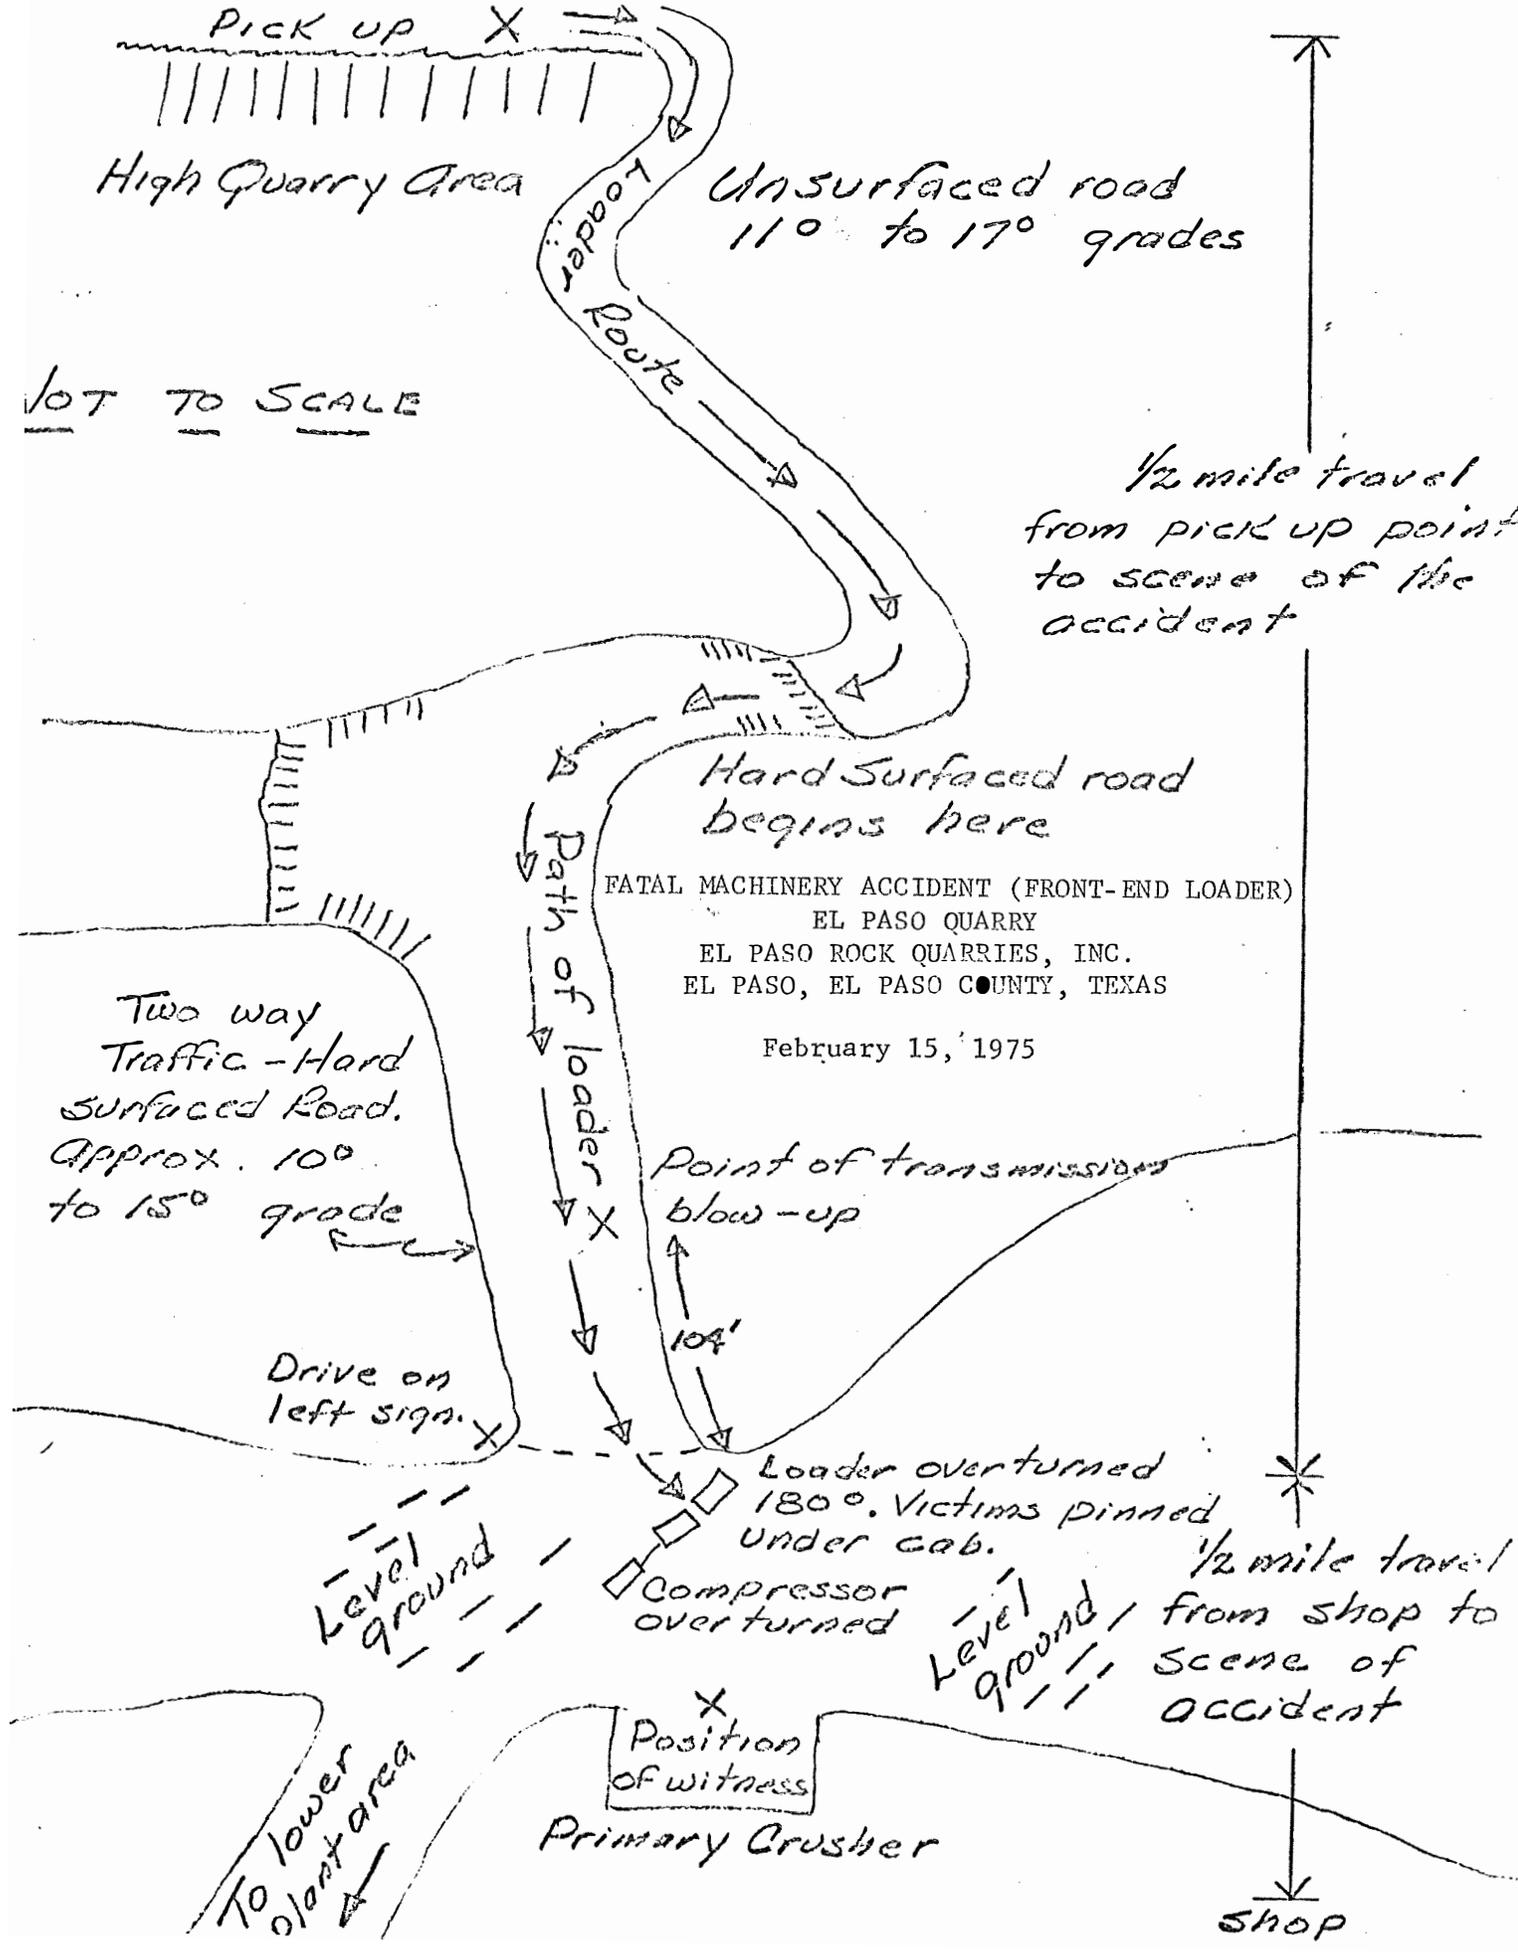
Point of transmission  
blow-up

Loader overturned  
180°. Victims pinned  
under cab.

Compressor  
overturned

Prior to the accident, Mr. Sosa, who was an experienced loader operator, drove the front-end loader from the lower shop area to the upper quarry area. After the compressor was attached to the loader, the approximate one-mile trip to the shop was started. The loader, with the three men in the cab and with the compressor in tow, was driven down the unsurfaced portion of the roadway without incident. It then began the descent down the surfaced portion of the roadway (see sketch).

This investigation determined that the transmission of the loader disintegrated approximately 104 feet up the inclined roadway. At this point, tire skid marks were observed and from this point down to the overturned loader various parts from the transmission, transmission oil, and hydraulic fluid were in evidence on the roadway. It is assumed that the loader operator, in an attempt to slow the loader, changed the travel position from forward to reverse; thereby, causing the transmission to disintegrate. Some time during the accident, the ring-type attachment on the drawbar broke; however, the safety chains remained attached. An examination of the loader revealed the two front brake lines had been severed, possibly by flying metal; however, the power steering and bucket cylinder mechanisms were still operable. The brake linings were intact and were neither scorched nor glazed.
