REPORT OF TRIPLE FATAL COAL MINE RIB-FALL ACCIDENT

HARRIS NO. 2 MINE (ID NO. 46-01270)
EASTERN ASSOCIATED COAL CORP.
BALD KNOB, BOONE COUNTY, WEST VIRGINIA

JUNE 5, 1975

PAUL E. MARGOCEE
FEDERAL COAL MINE INSPECTOR

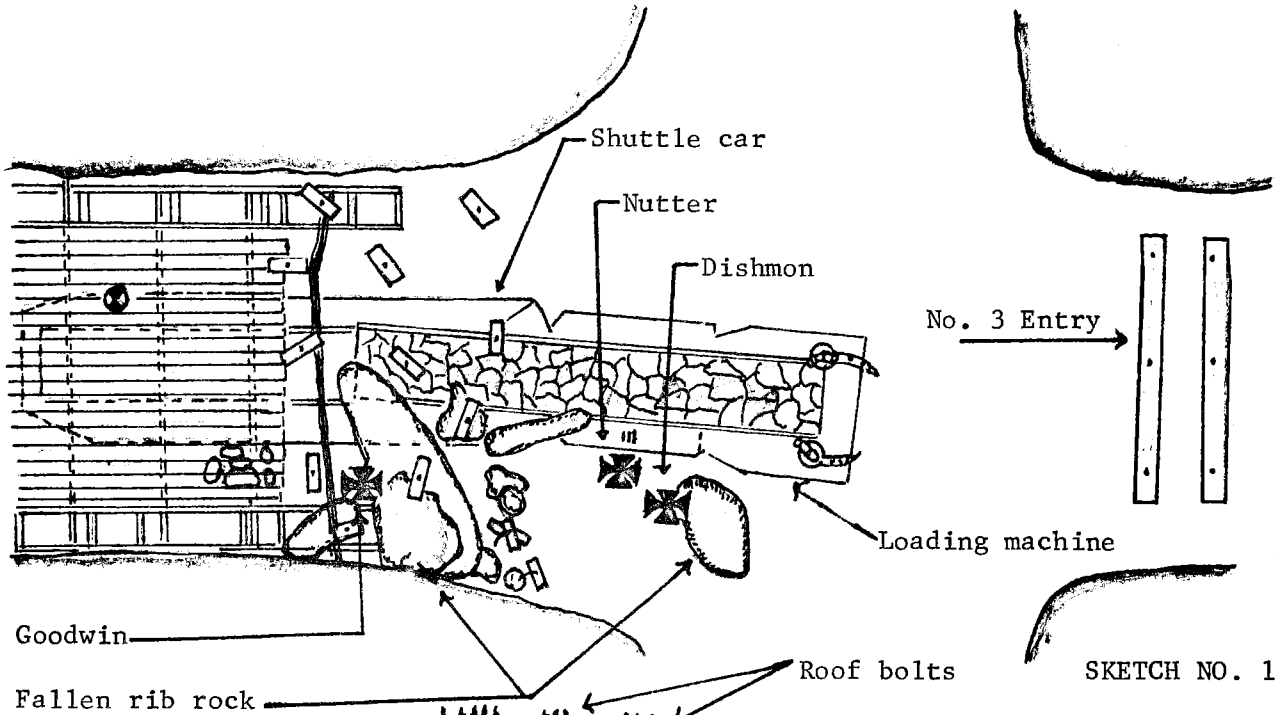
According to Wilson, suddenly the rib materials began falling on the opposite side of the shuttle car and Goodwin, who was standing near Dishmon and Nutter (See sketch No. 1) began shouting warnings to Dishmon and Nutter. Wilson stated that after the accident, he immediately ran to the locations of Dishmon, Nutter and Goodwin, and it was obvious, because of the size of the fallen rib materials, that he was going to need assistance to free the three men. Therefore, he notified the other crew members of the occurrence and then he ran to the telephone to call for help.

Further observations in the accident area revealed the rib area that fell during the accident extended from a height of about 10 feet above the mine floor to a height of about 40 feet above the mine floor. The rib materials was 3 to 4 feet in thickness and extended 6 to 10 feet in width. The material broke into several pieces during the fall and the subsequent impact. By the positions of the victims after the accident, it could be readily recognized that they had been, prior to the accident, working alongside the dangerous rib.

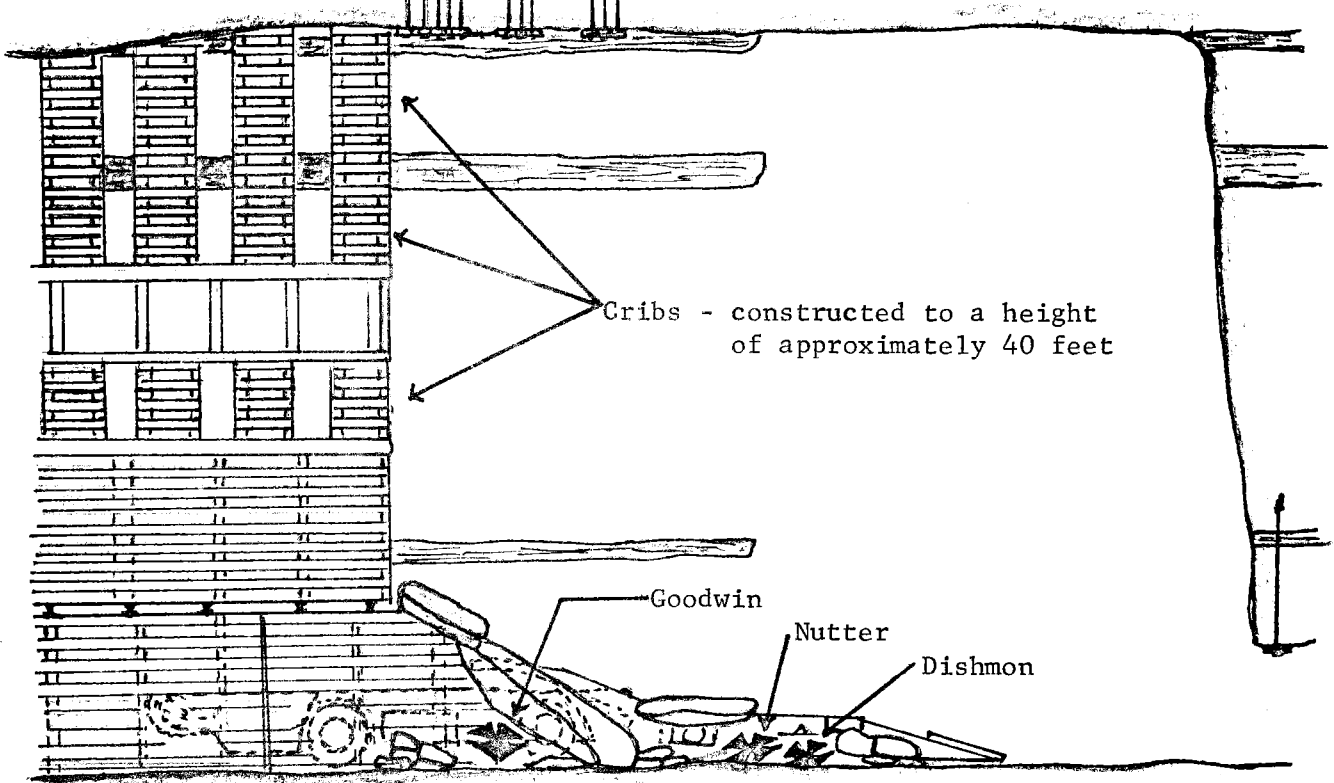
Prior to commencing removal of the fallen roof materials, persons would install temporary roof supports and follow up with permanent roof and rib supports, beginning at the edge of the fall and progressing across the fall. The fallen materials were then drilled and blasted, and thereafter loaded into shuttle cars with a 14BU10 Joy loading machine. The material was then dumped into mine cars and removed from the mine. As the upper levels of the fall decreased, exposing the ribs, rib supports were installed. In February 1975, the construction of wooden cribs for roof and rib support was started in the No. 3 entry area (See sketch No. 2).
