HEALTH AND SAFETY REPORT

REPORT OF MULTIPLE FATAL-GAS EXPLOSION  
STERLING "B" SHAFT  
INTERNATIONAL SALT COMPANY  
RETSOF, LIVINGSTON, NEW YORK

April 18-19, 1975

### REPORT OF MULTIPLE-FATAL GAS EXPLOSION

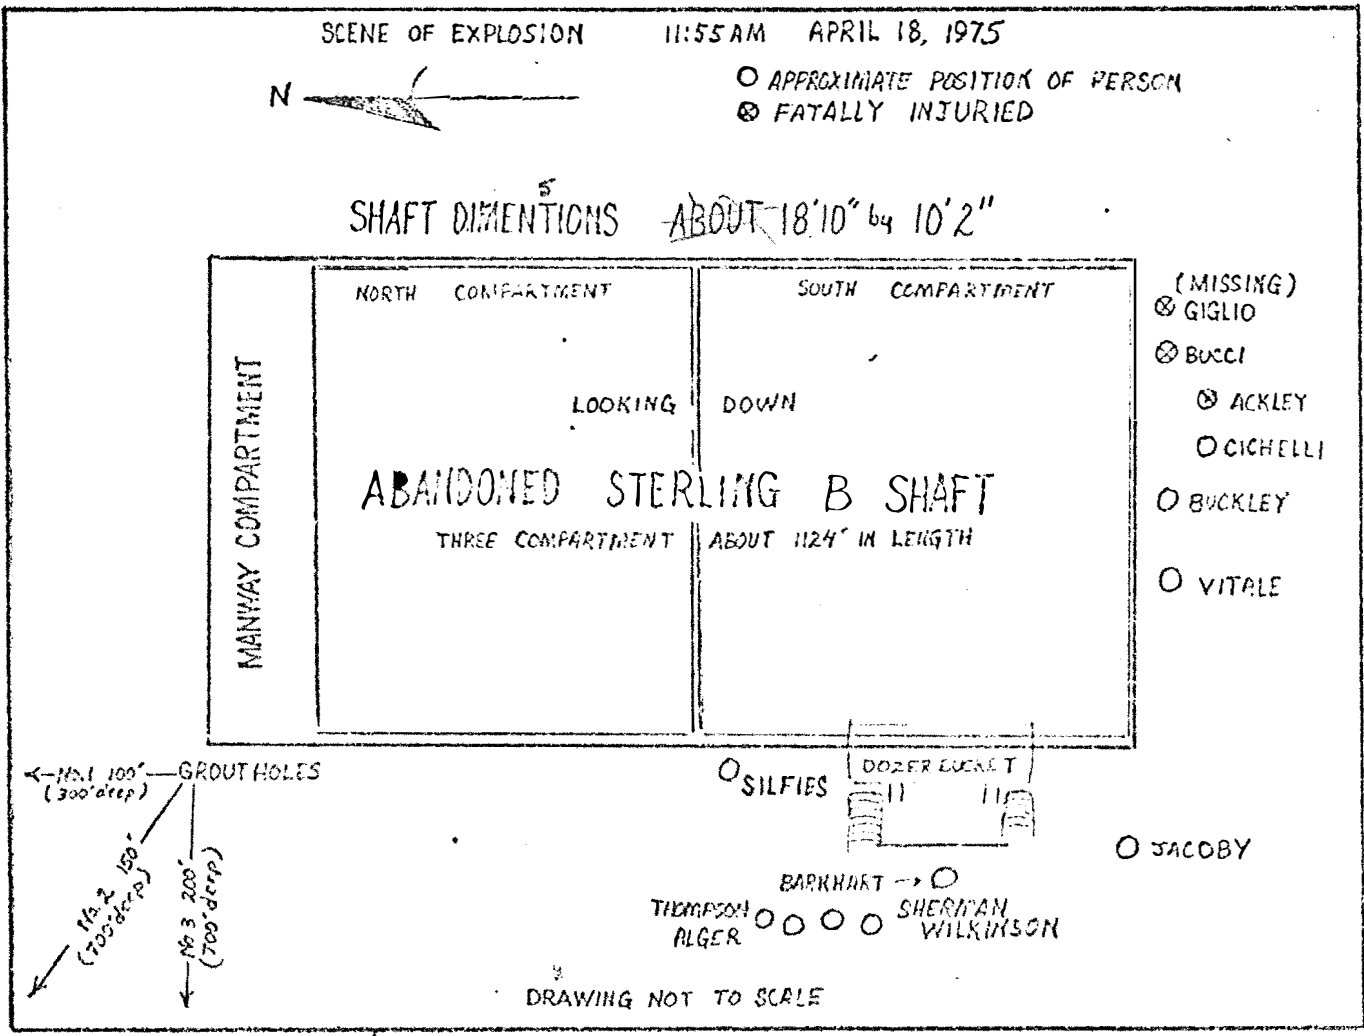
# Sketch 2

On the day of the explosion, two flood lamps were lowered to the upper blockage; an odor of petroleum was intermittently evident at the collar but no one suspected that the mixtures would be explosive. The gas-emitting strata was below the 380-foot blockage; however, the interlaced timber plug and subsequent large boulders would not have been a sufficient seal to contain the flammable gases. Methane, the light gas constituent probably rose to the surface as it was emitted; the heavier hydrocarbons gradually built to the collar in the unventilated shaft. A large rock, approximately 6 tons, was dropped down the shaft from the bucket of a tractor-mounted, front-end loader without incident but did not penetrate the upper blockage. About 11:58 am, a second boulder was dropped and the explosion occurred. At the time, the subsequent victims were standing along the south side of the shaft; Mr. Giglio was in a prone position peering down at the blockage through binoculars; safety belts and lines to various substantial anchorage points were worn by each man at the collar. Mr. Giglio, the missing man, reportedly, had tied himself in this manner; however, immediately before the rock was dropped, he released himself to perform some chore. It could not be determined with certainty that the safety belt had been refastened. See Sketch 2.

Timber probably was thrown upward by the force of the explosion but was contained within the shaft to some degree by two or three timber sets, which remained more or less intact immediately below the collar. Later, television observations of the shaft wall showed that the timber largely had been stripped and was piled on the blockage; the top level of the blockage had been altered by blast debris from a 380-foot to a 347-foot elevation below the collar. In the immediate shaft area, concrete panels in the building for 40 to 50 feet above ground level were blown out. Slabs of concrete and timber from the upper interior of the building appeared to have caused most of the injuries to personnel. Reportedly, Mr. Bucci and Mr. Ackley, both deceased, were close to one another and were buried under lighter material; others in the area received minor injuries from flying objects. See Sketch 2.

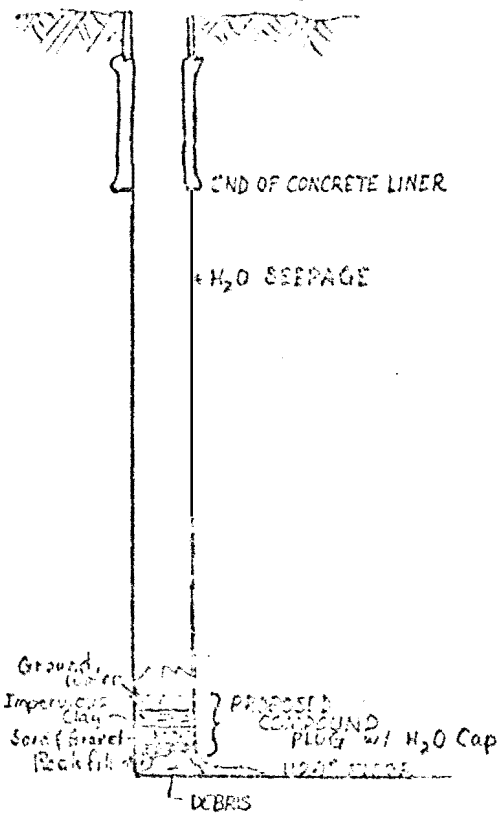
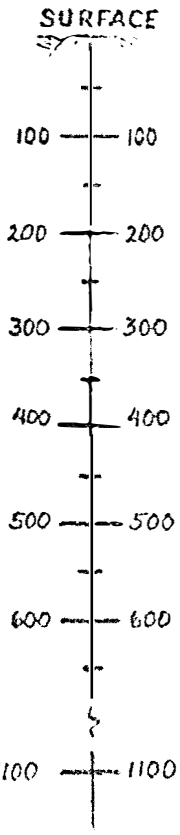
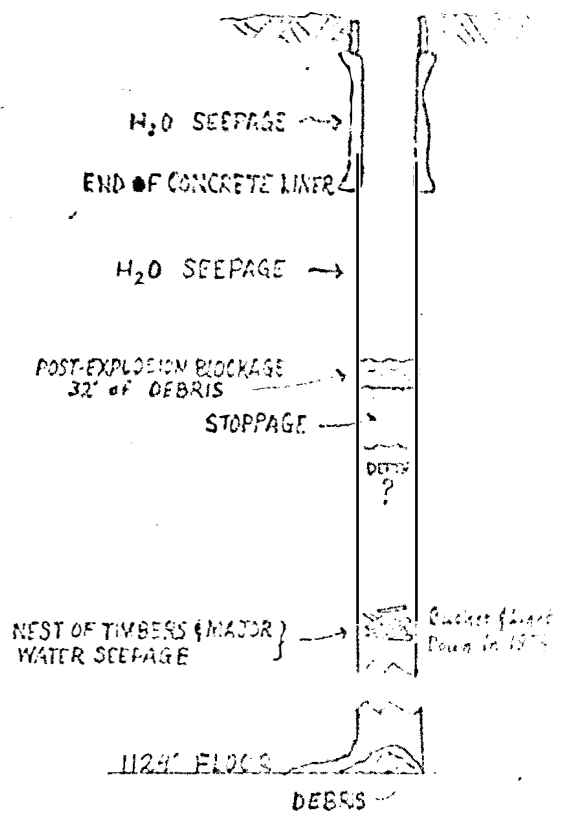
# Sketch 1

In 1965 to 1966, the Cementation Company of America, Inc., Ontario, Canada, constructed a 3-foot-thick, concrete water seal from a point 24 feet below the collar to 174 feet below. Because the shaft was abandoned and there was no foreseeable reason to reenter, timber, approximately 12-inch by 14-inch by 20-foot, and other waste, was thrown down the shaft; this material lodged somewhere between the 600 and 750 level. See Sketch 1.
