**REPORT OF INVESTIGATION  
(UNDERGROUND COAL MINE)**

**MULTIPLE FATAL ROOF FALL ACCIDENT**

**Beatrice Mine (I.D. No. 44-00238)  
Beatrice Pocahontas Company  
Keen Mountain, Buchanan County, Virginia**

**April 13, 1978**

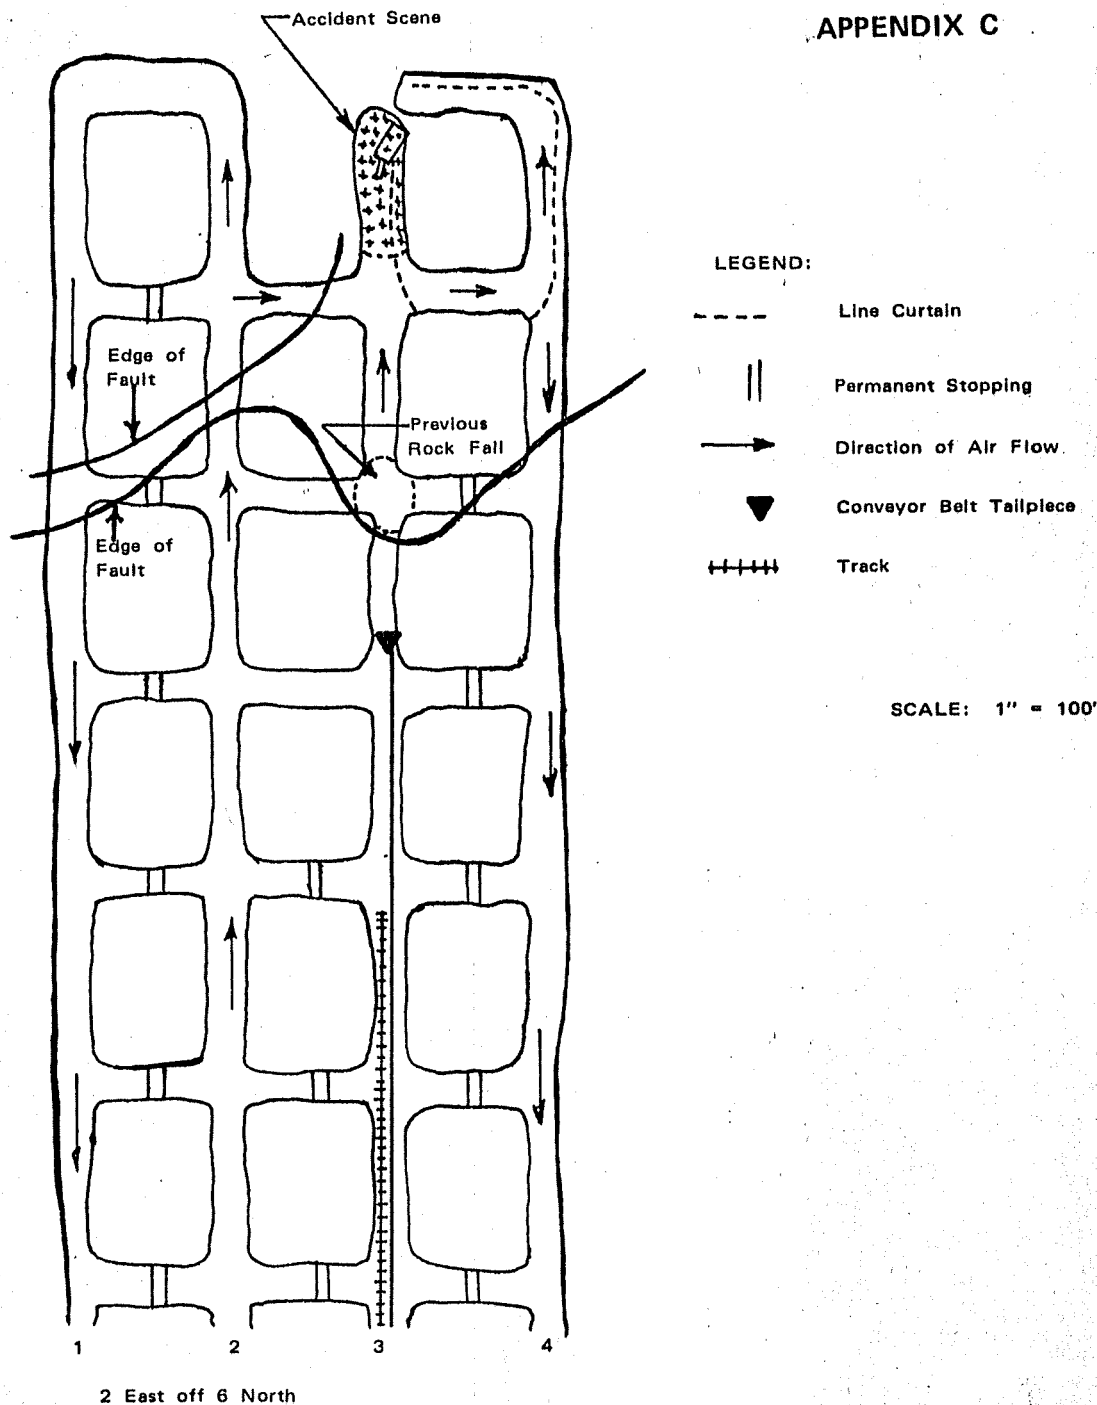
## SKETCH OF MULTIPLE FATAL ROOF FALL ACCIDENT

12. It is relevant to note that a large roof fall had occurred in the No. 3 entry about 125 feet outby the accident area and at the beginning of the fault (See Appendix C).
