Report of Mine Inundation
Jefferson Island Mine
Diamond Crystal Salt Company

INTRODUCTION

This is an investigative report of a mine inundation that occurred November 20, 1980, at Jefferson Island Mine, Diamond Crystal Salt Company, New Iberia, Louisiana, MSHA I.D. No. 16-00508. The investigation was made pursuant to the provisions of the Federal Mine Safety and Health Act of 1977, Public Law 91-173, as amended by Public Law 95-164 (30 USC 801 et. seq.).

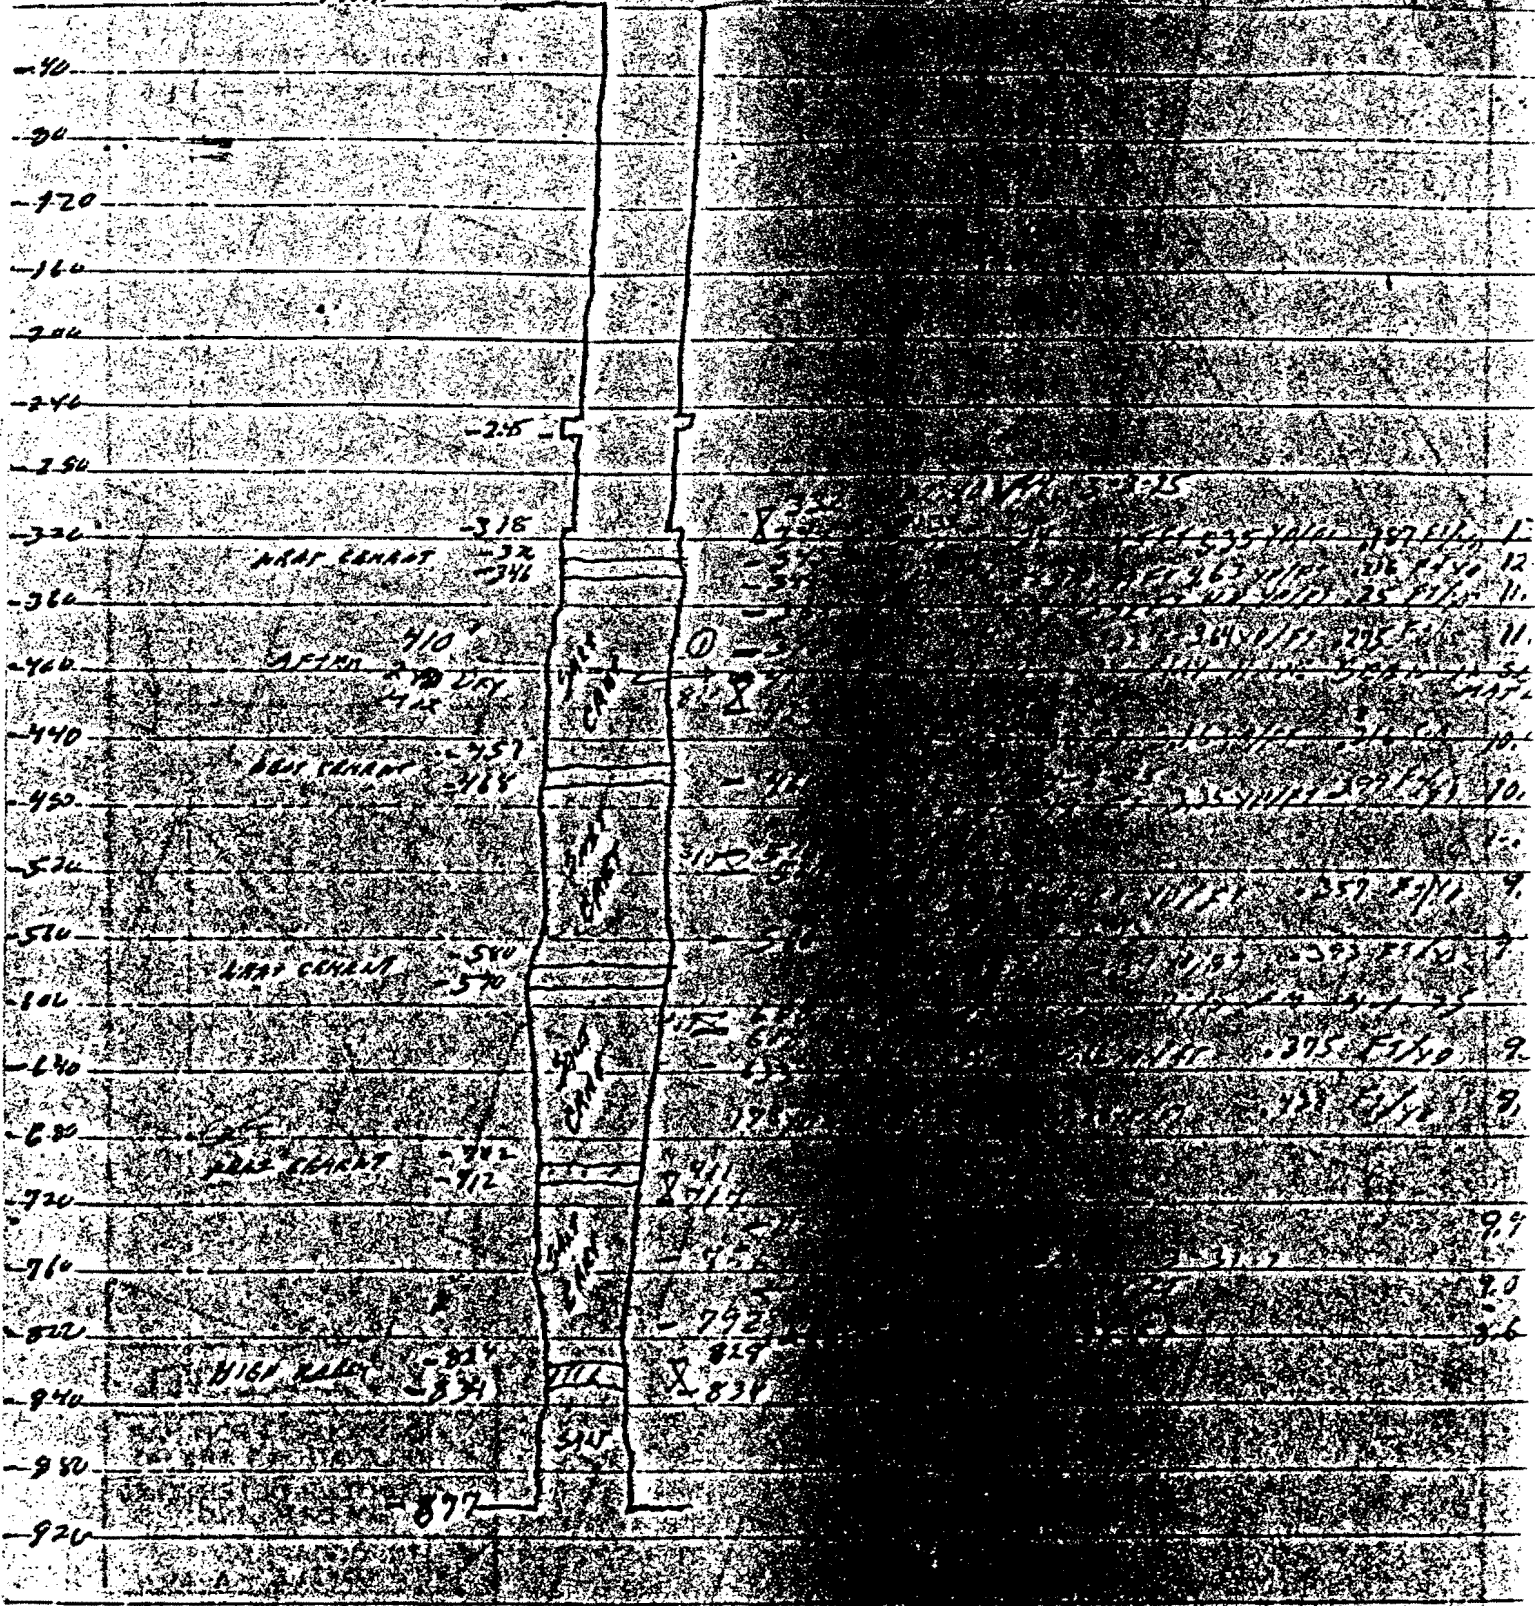
APPENDIX H: Old Air Shaft Seal (from Diamond Crystal Plan)

In March 1975, water leaks developed in the shaft liners of the old air shaft. On the advice of a consultant, the shaft was sealed from the 1,000-foot level to the surface with layers of saltcrete and concrete (Appendix H). The sealing was completed on March 30, 1975. No leakage from the old air shaft was reported after sealing. Diamond Crystal reported that the area on the 1,000-foot level was checked visually on November 20, 1980, during the evacuation and no leakage was observed.

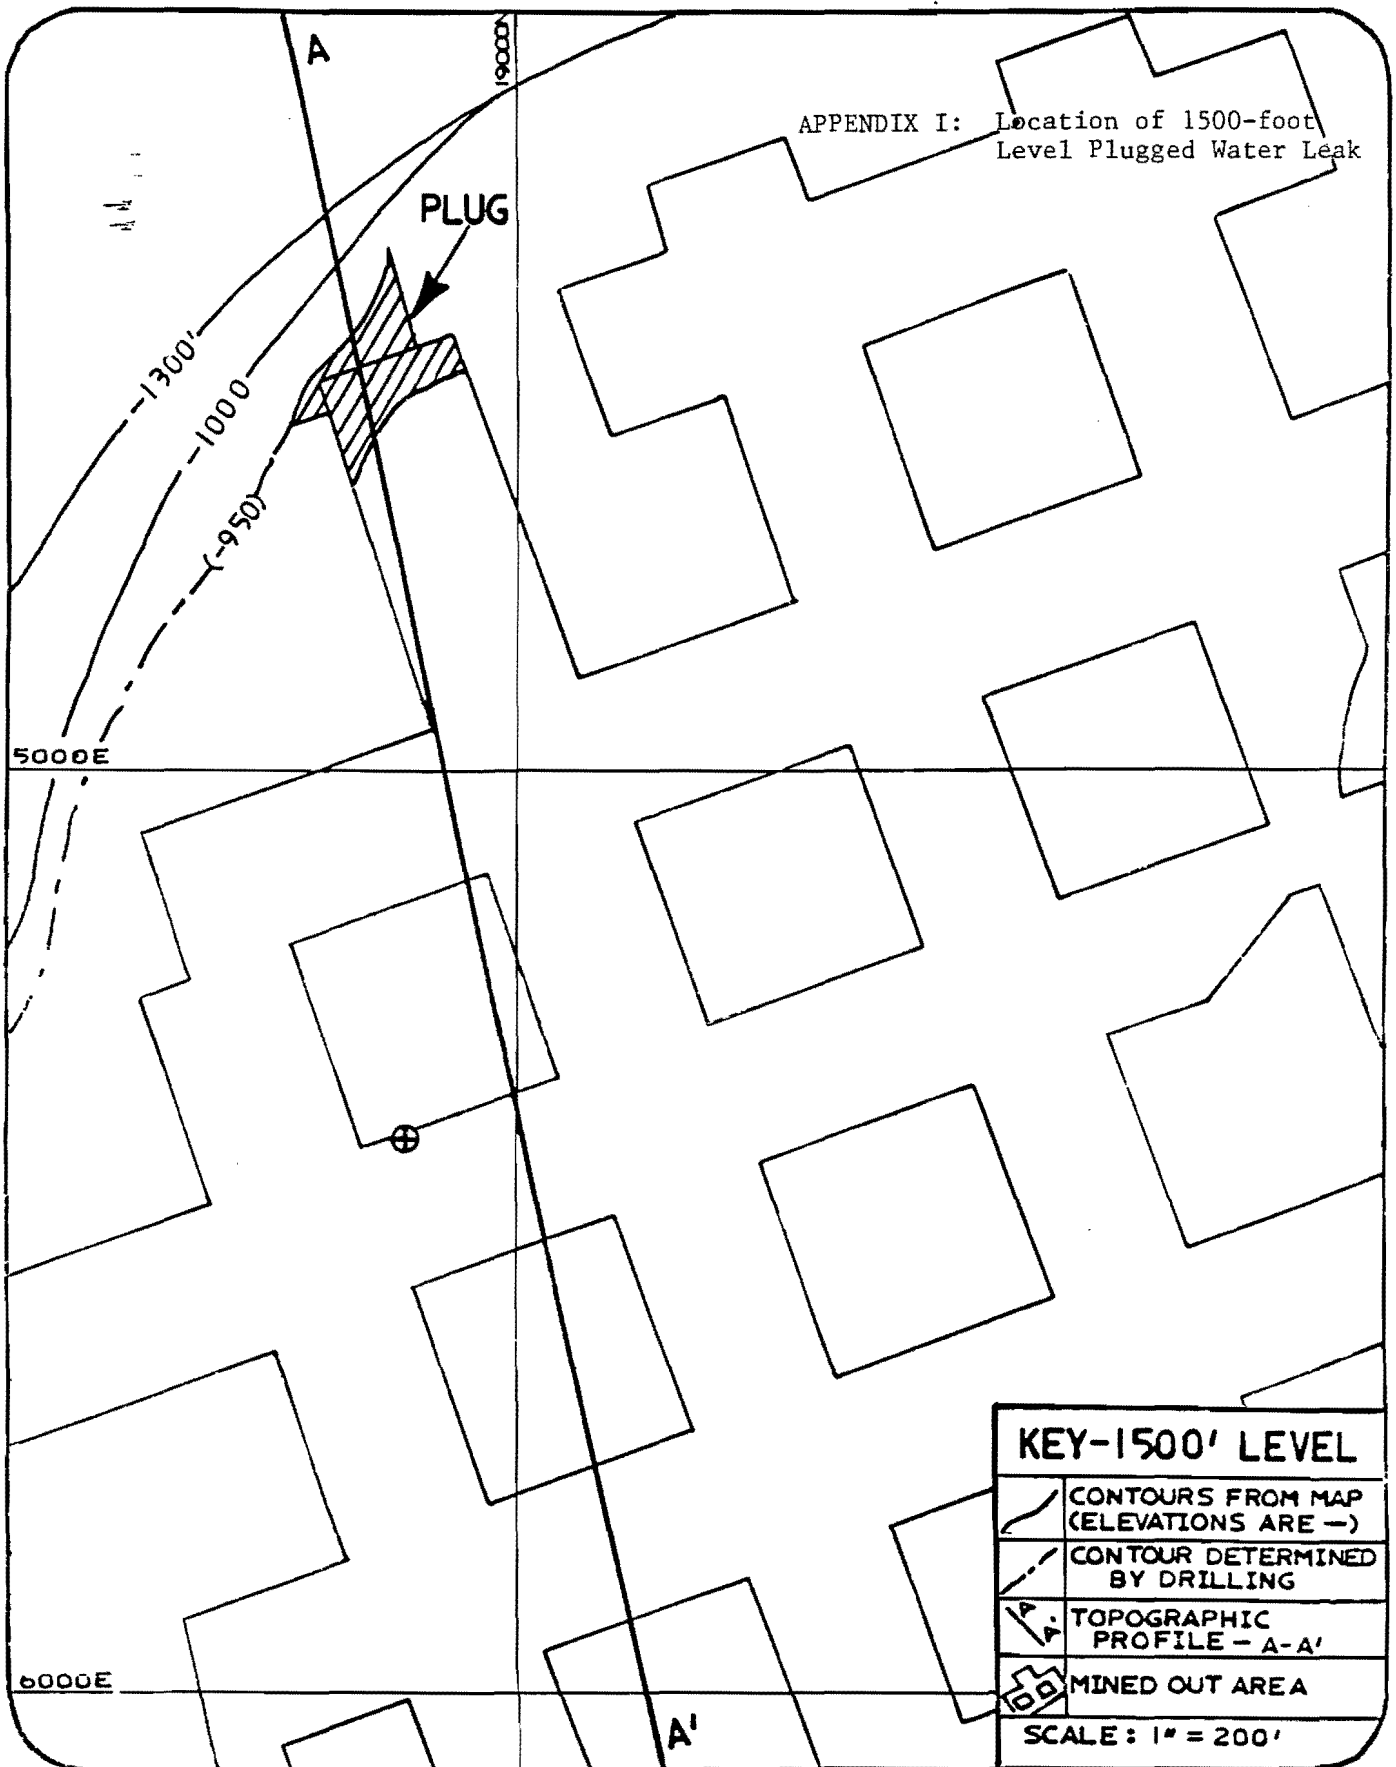
APPENDIX I: Location of 1500-foot Level Plugged Water Leak

On November 9, 1976, at heading H right, in the 1,500-foot level, a water leak occurred at the face (Appendix I). To restrict the flow of water, the room was backfilled with broken salt, then stabilized by grouting. The resulting plug reduced the undetermined flow rate to a seepage of approximately five to seven gallons per hour. In salt mine operations any water leakage without remedial action could result in serious consequences.

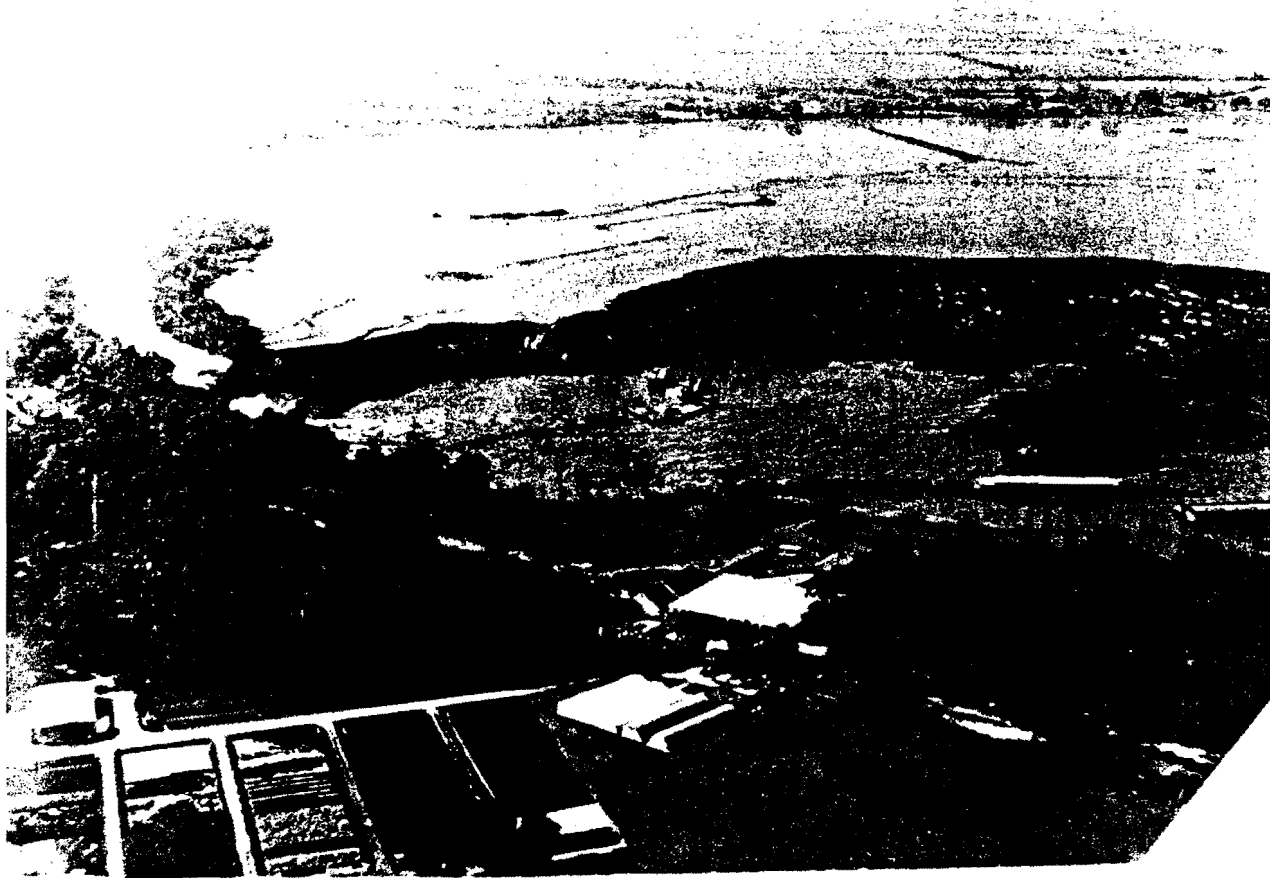
Early stage of crater development. (Barges in crater were between 120 - 200 feet in length.)

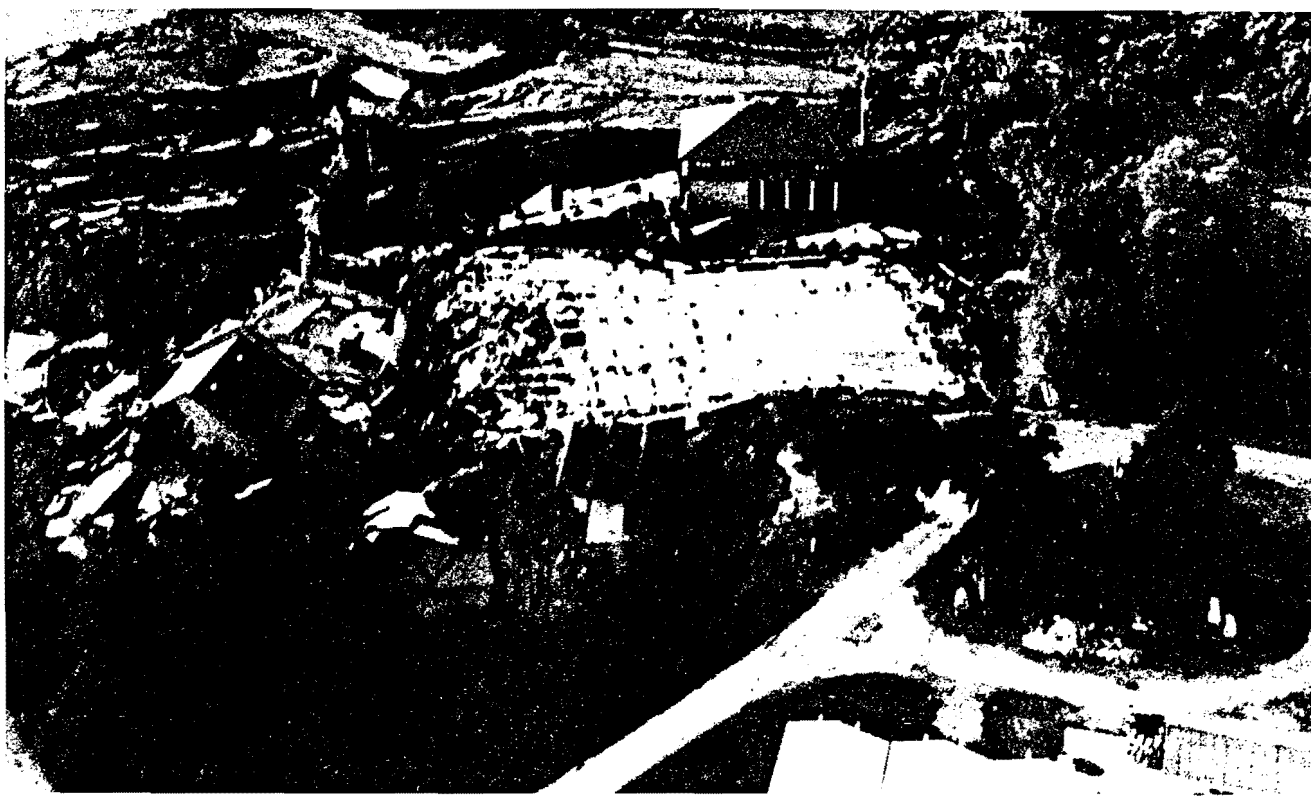
Bayless residence and greenhouses.

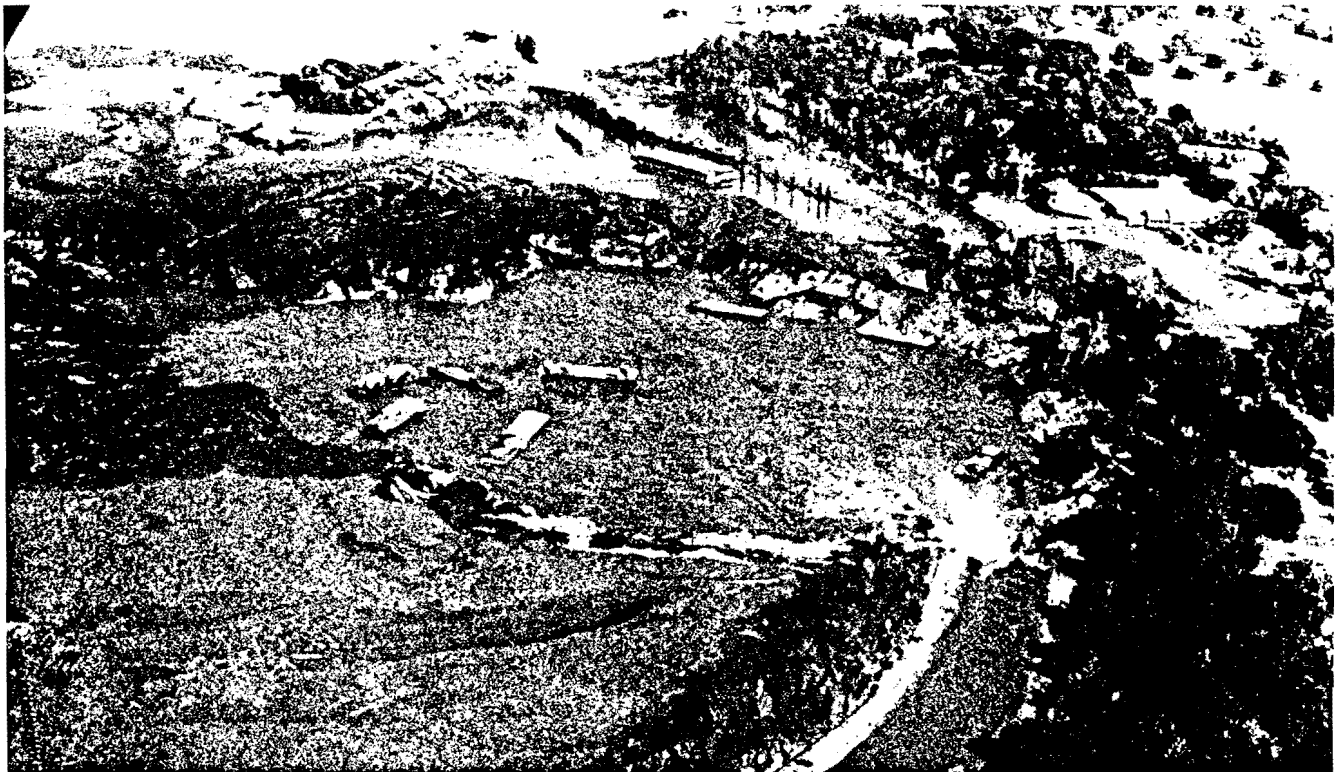
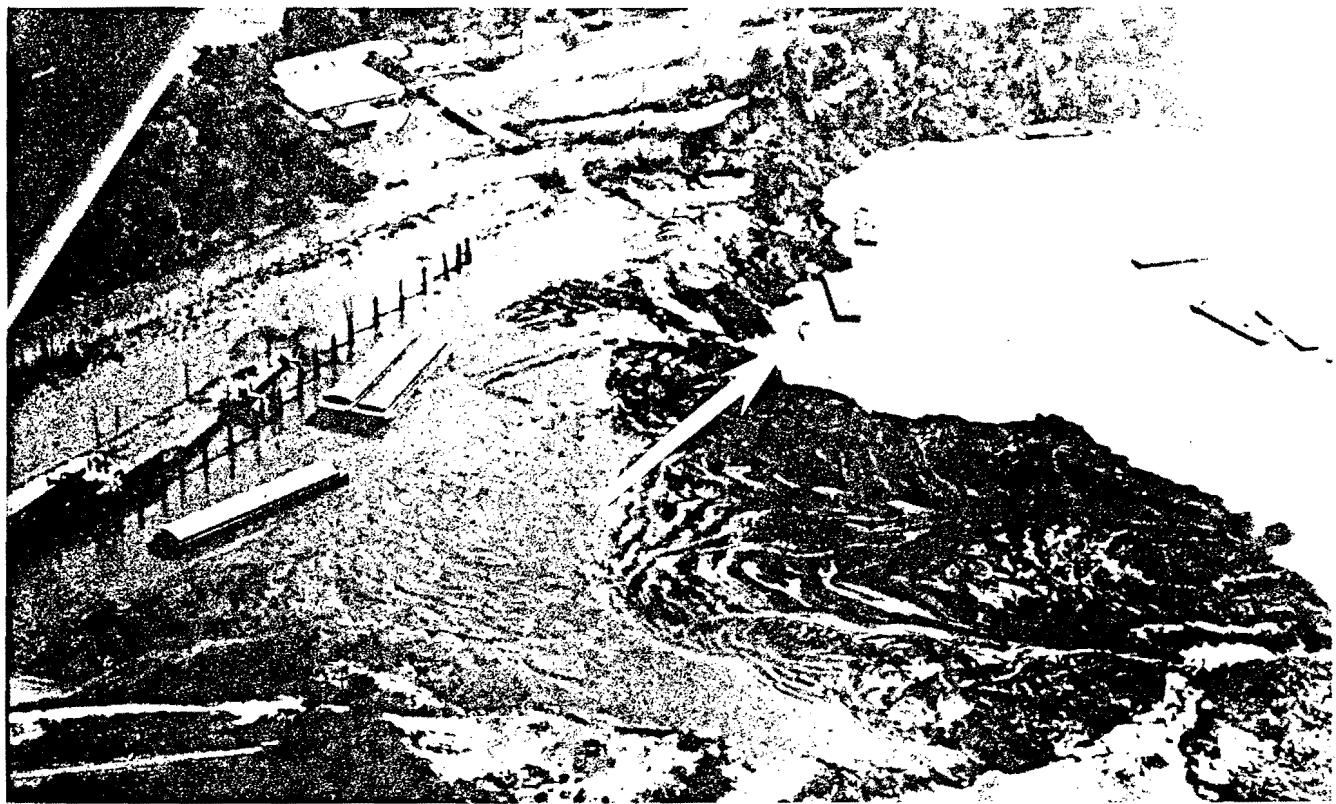
As the Delcambre Canal flowed into the lake, three barges temporarily remained at the loading dock. Small fishing boat (arrow) was in crater.

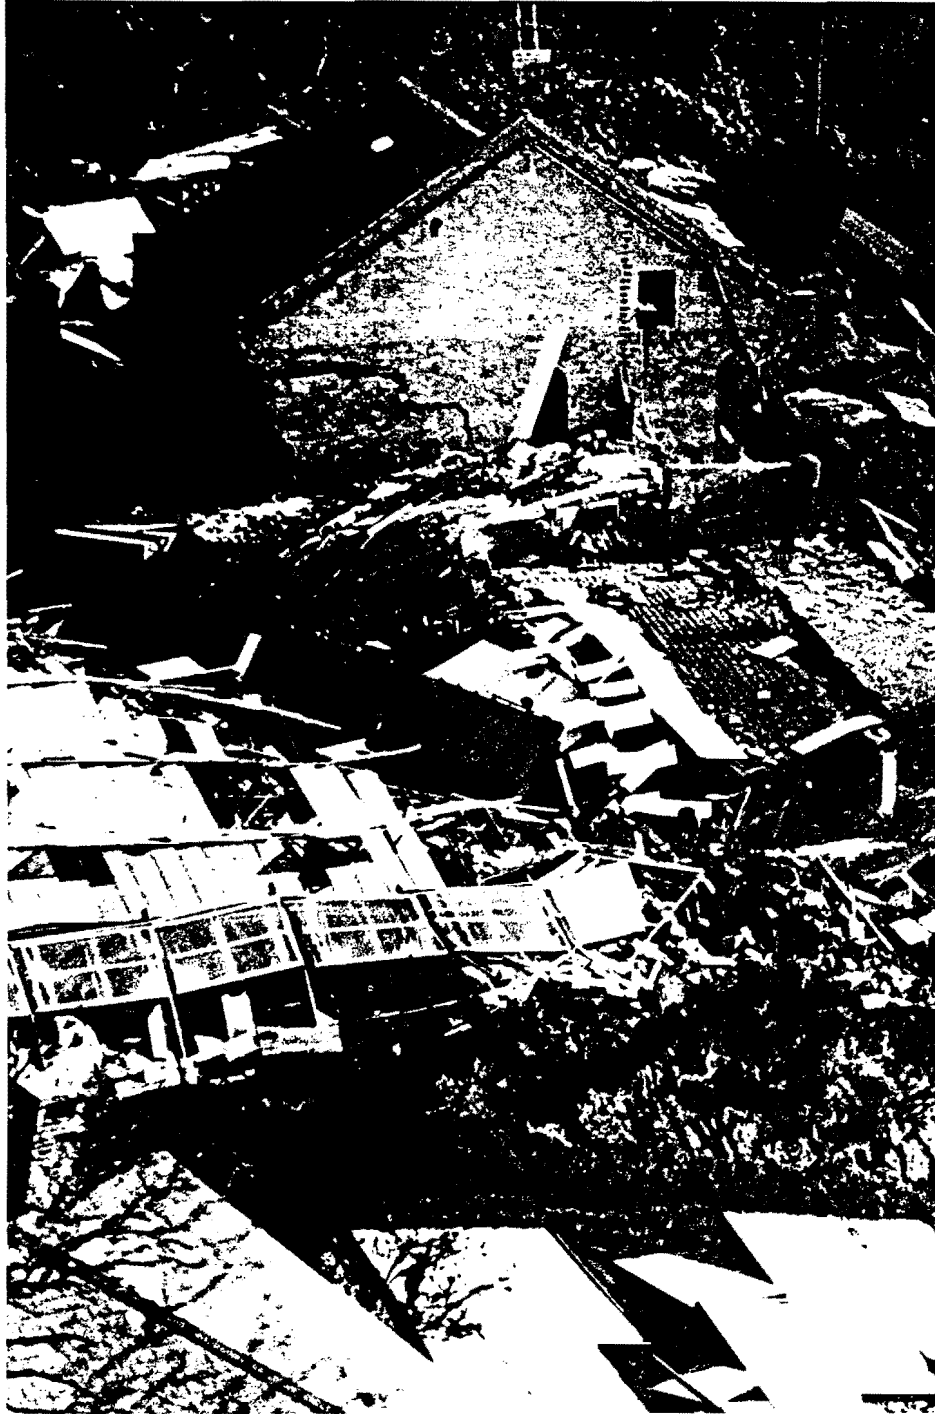
Bayless guesthouse and greenhouses.

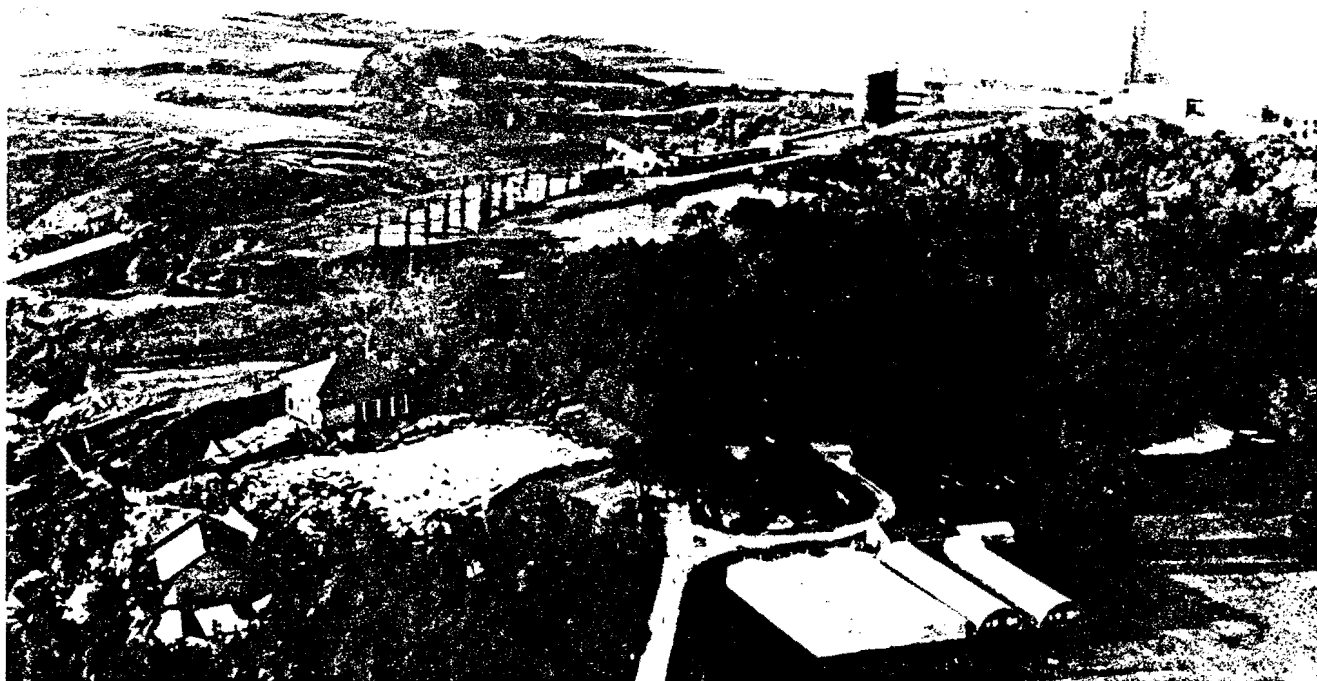
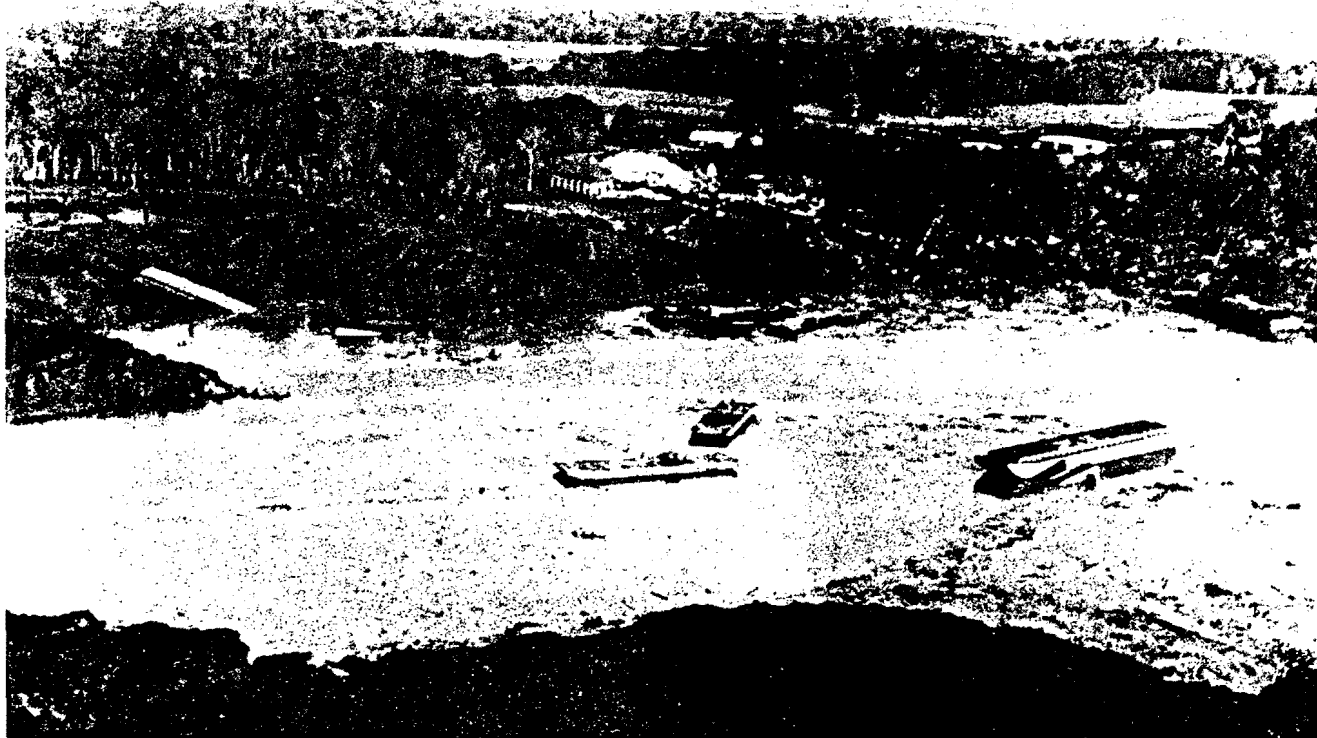
Conditions in the late afternoon,
November 20, 1981.

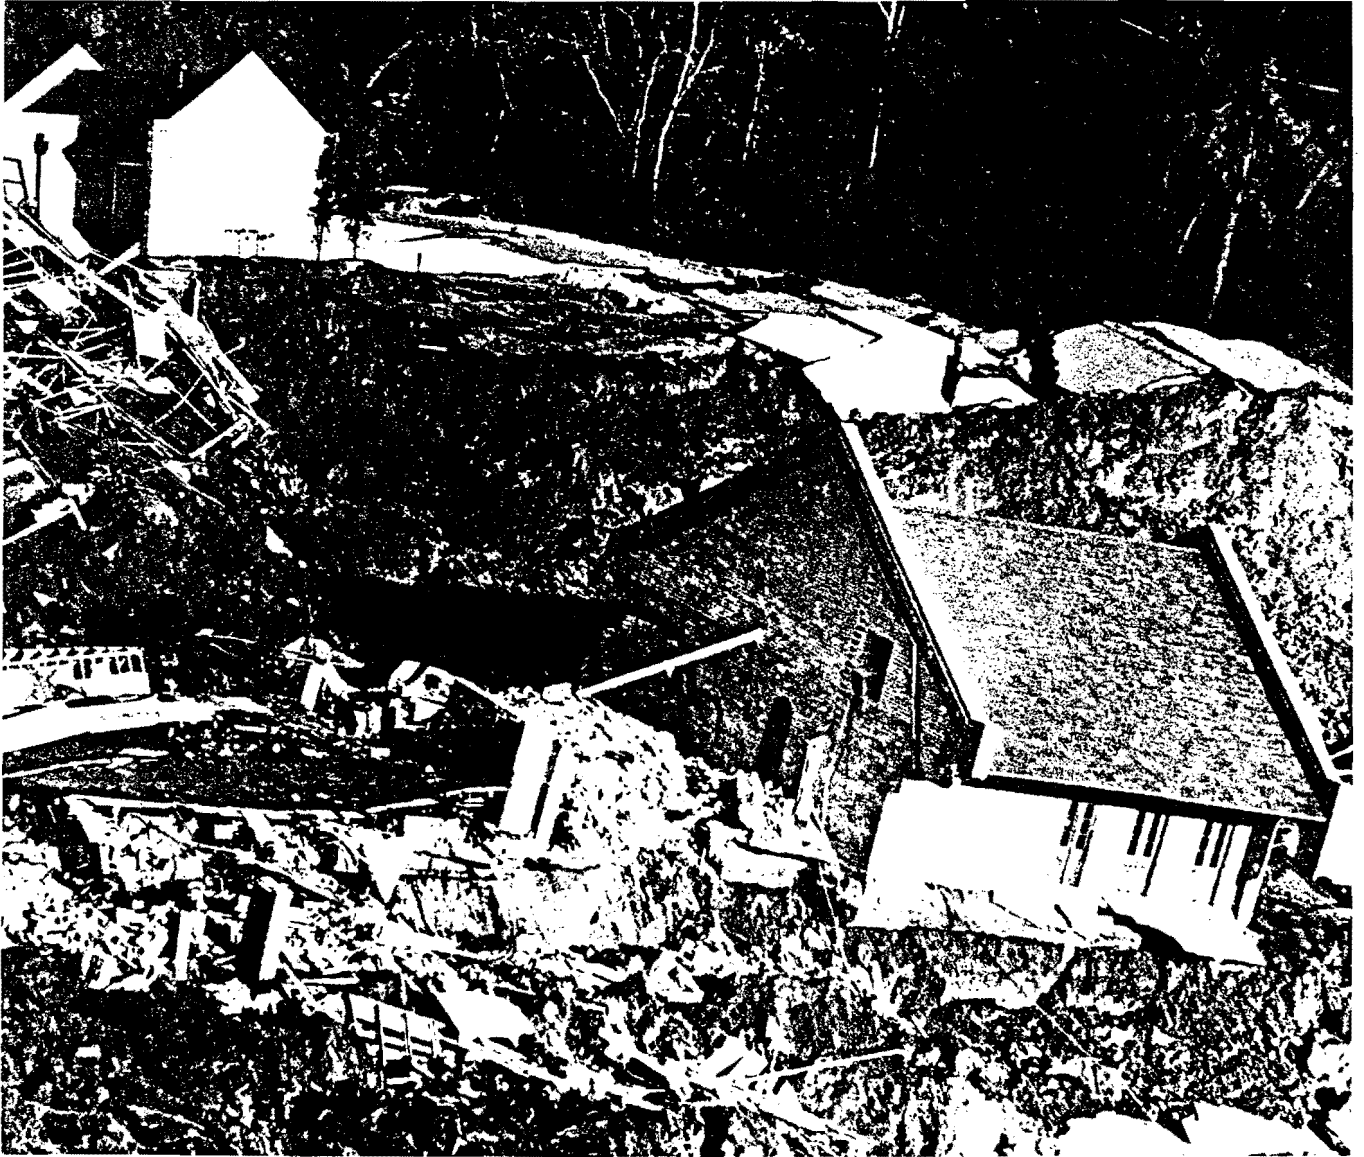
Bayless guesthouse.

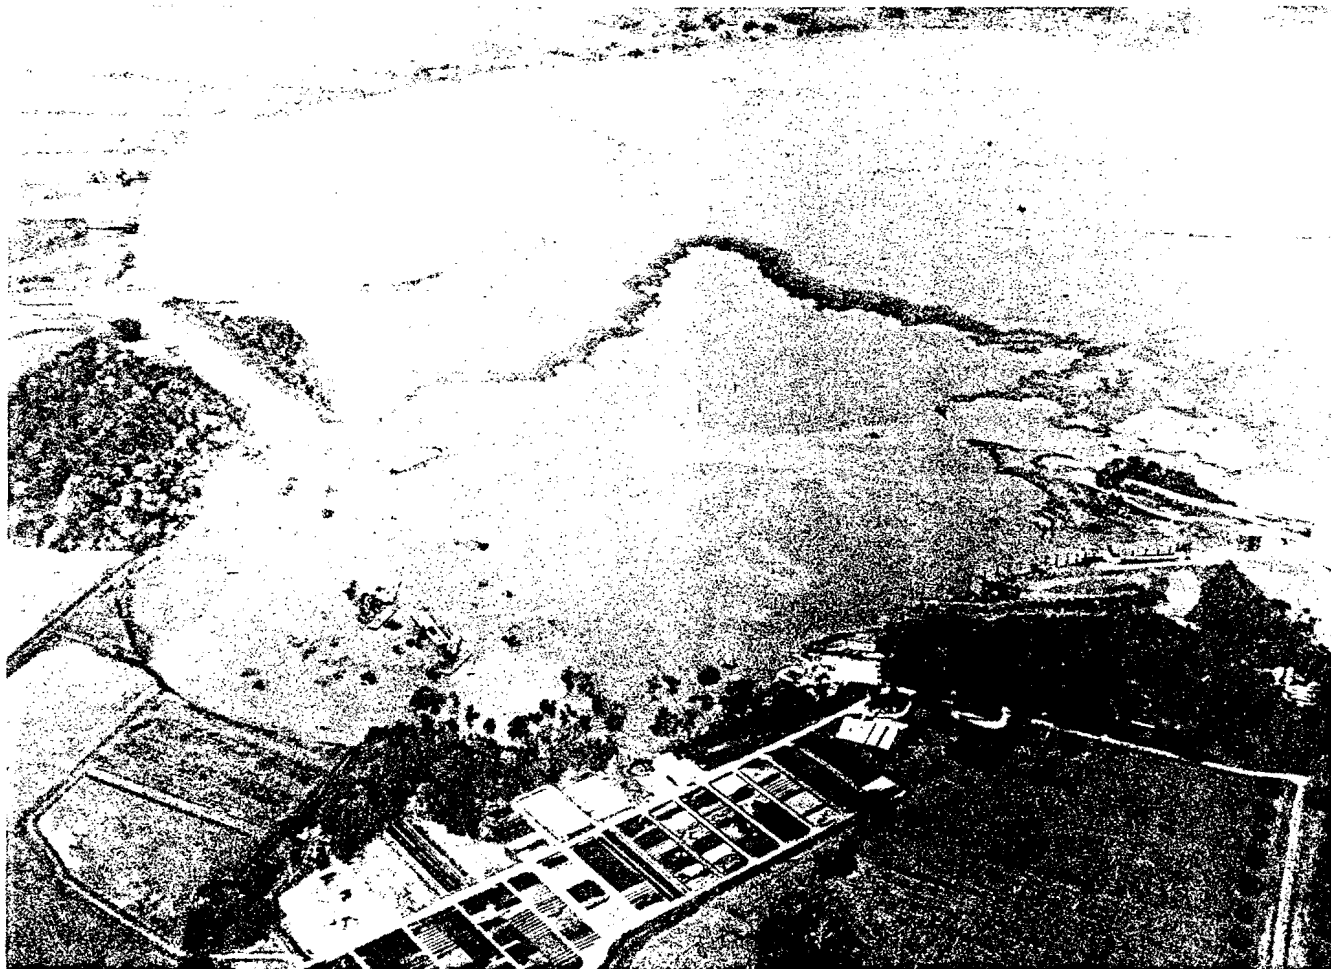
Texaco's Number 8 producing gas well had been located on the southeast shore of the lake. The ground movement caused by the inundation had damaged the casing of the well below the water level. The gas had become ignited--possibly by friction as the casing sheared--and a fire burned in about a 50-foot radius on the surface of the lake. There was agitation in the water from the escaping gas, but the lake was otherwise calm.

Texaco No. 8 gas well fire and
resurfaced barges.

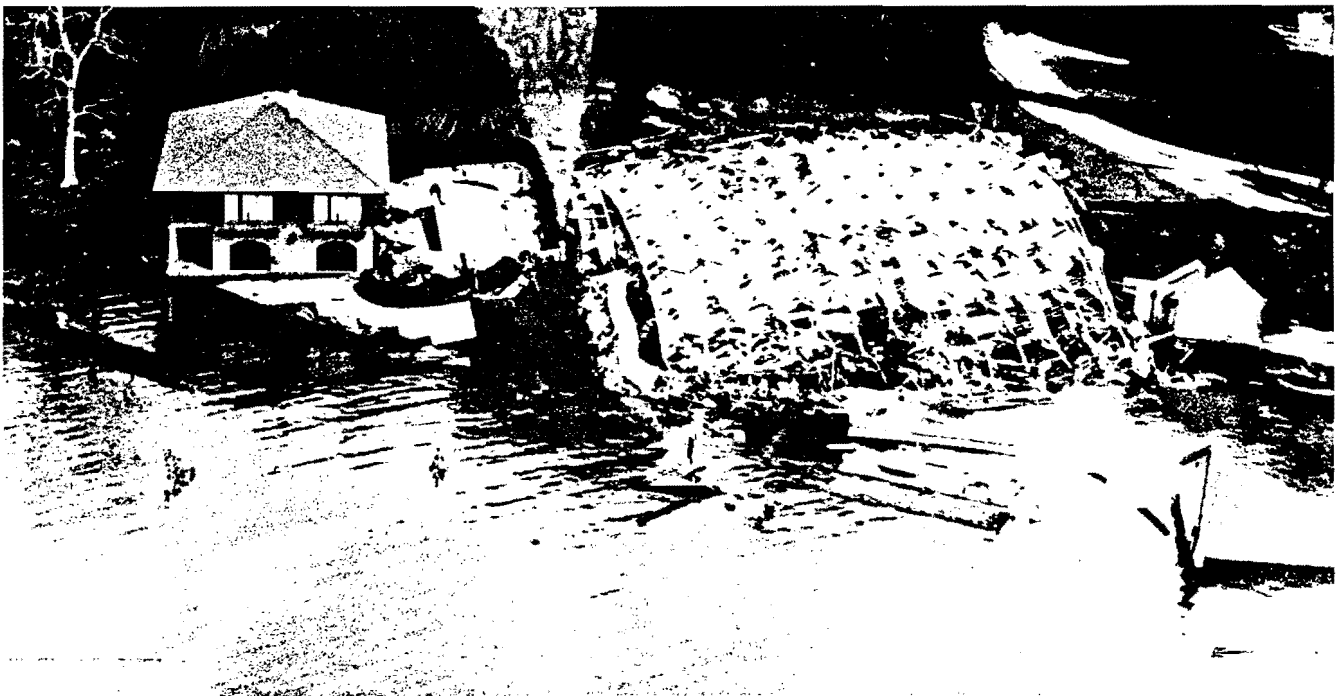
Subsidence damage at Bayless property.

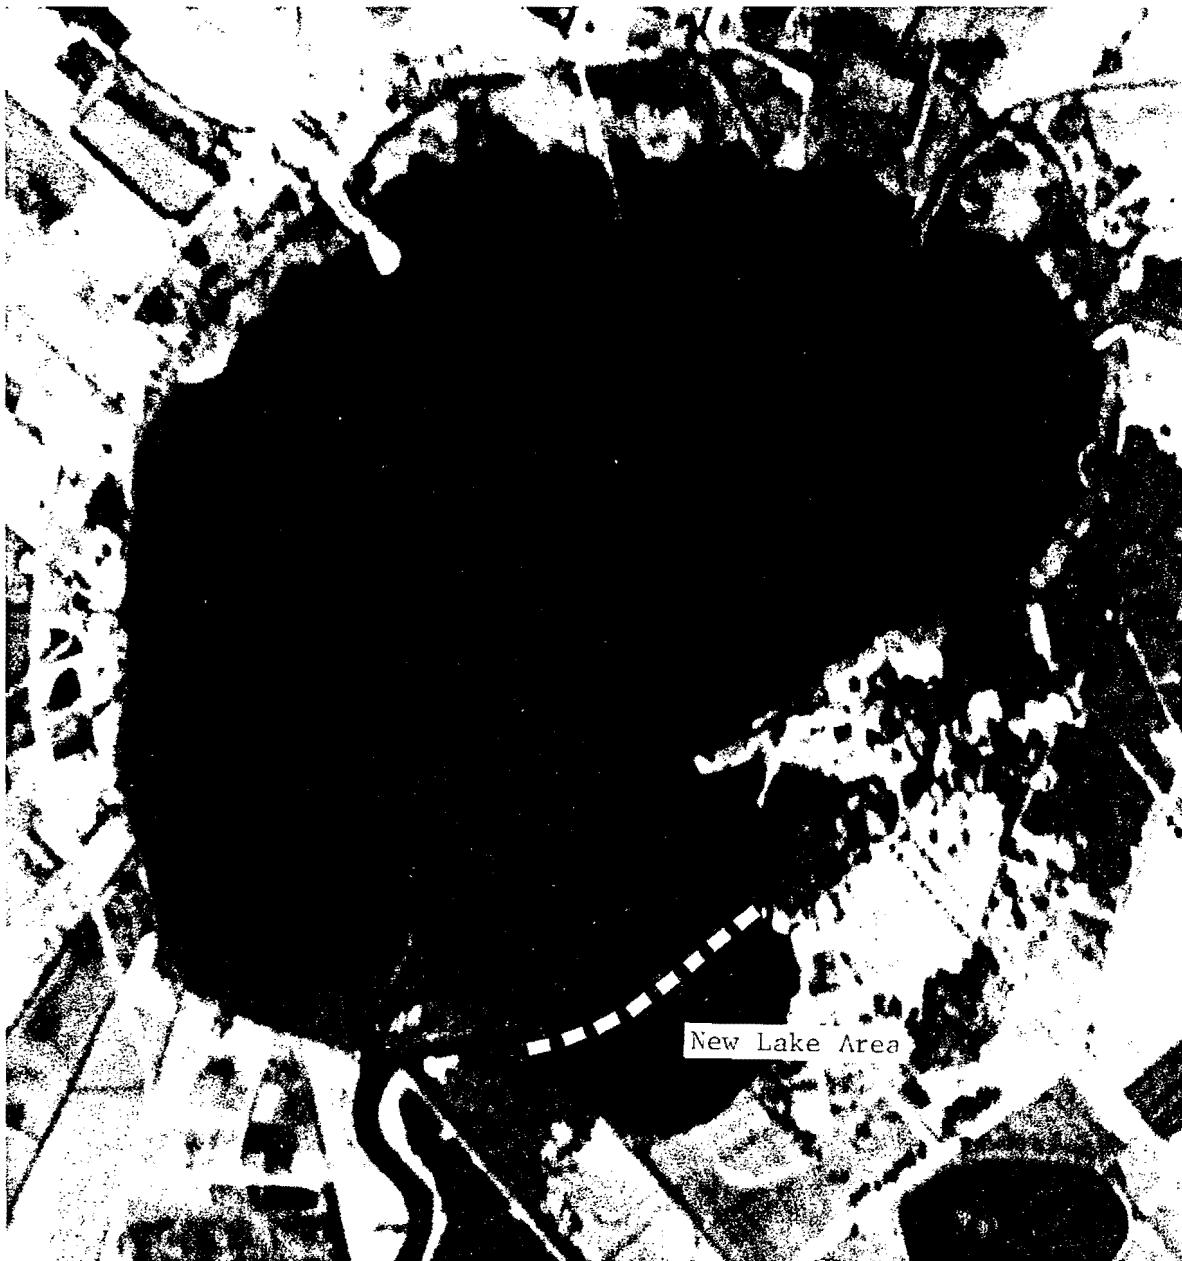
Post-inundation photograph of Lake Peigneur, February 1981.
New lake area caused by subsidence.

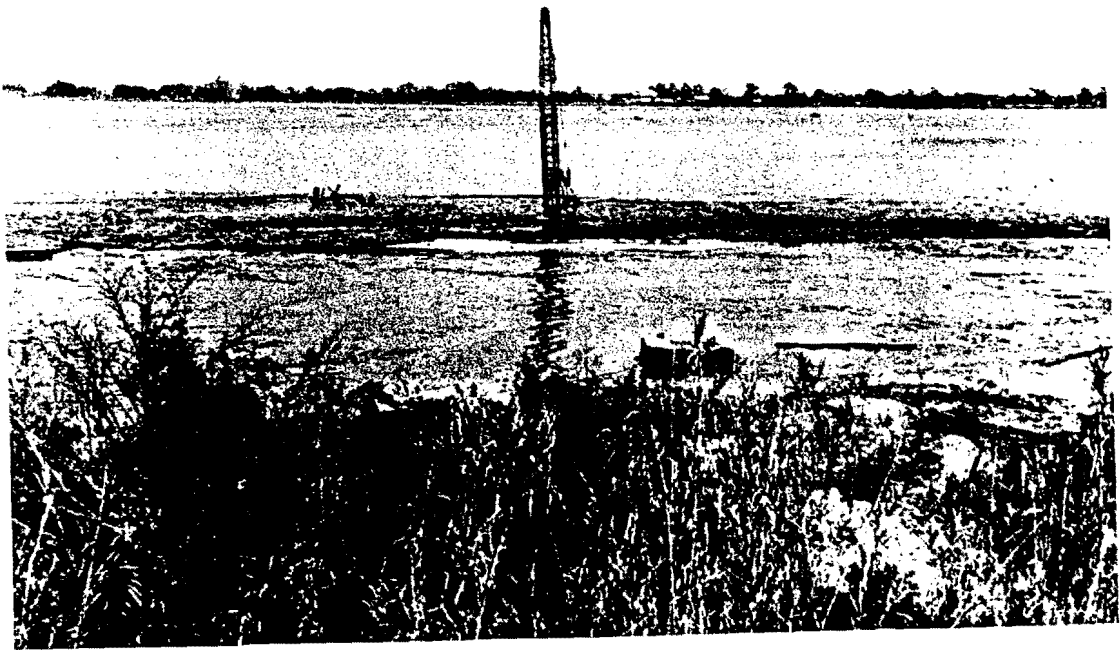
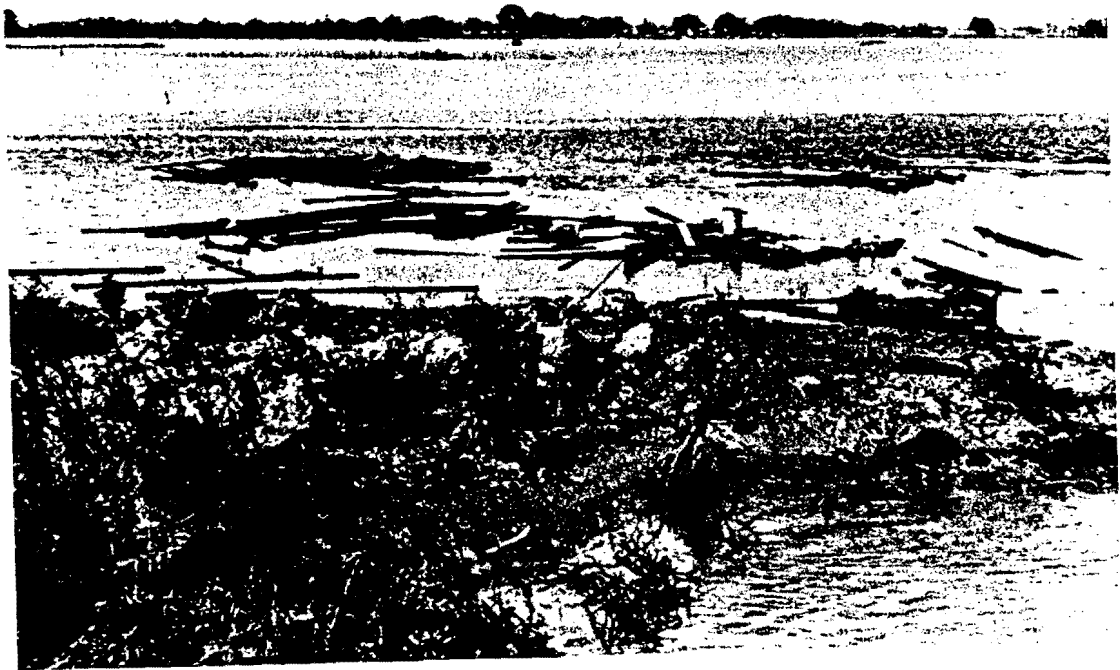
P-20 servicing equipment disappearing into lake.
