REPORT OF INVESTIGATION
(UNDERGROUND COAL MINE)

FATAL POWERED HAULAGE ACCIDENT

Banning (ID No. 36 00973)
Republic Steel Corporation
West Newton, Westmoreland County, Pennsylvania

March 5, 1981

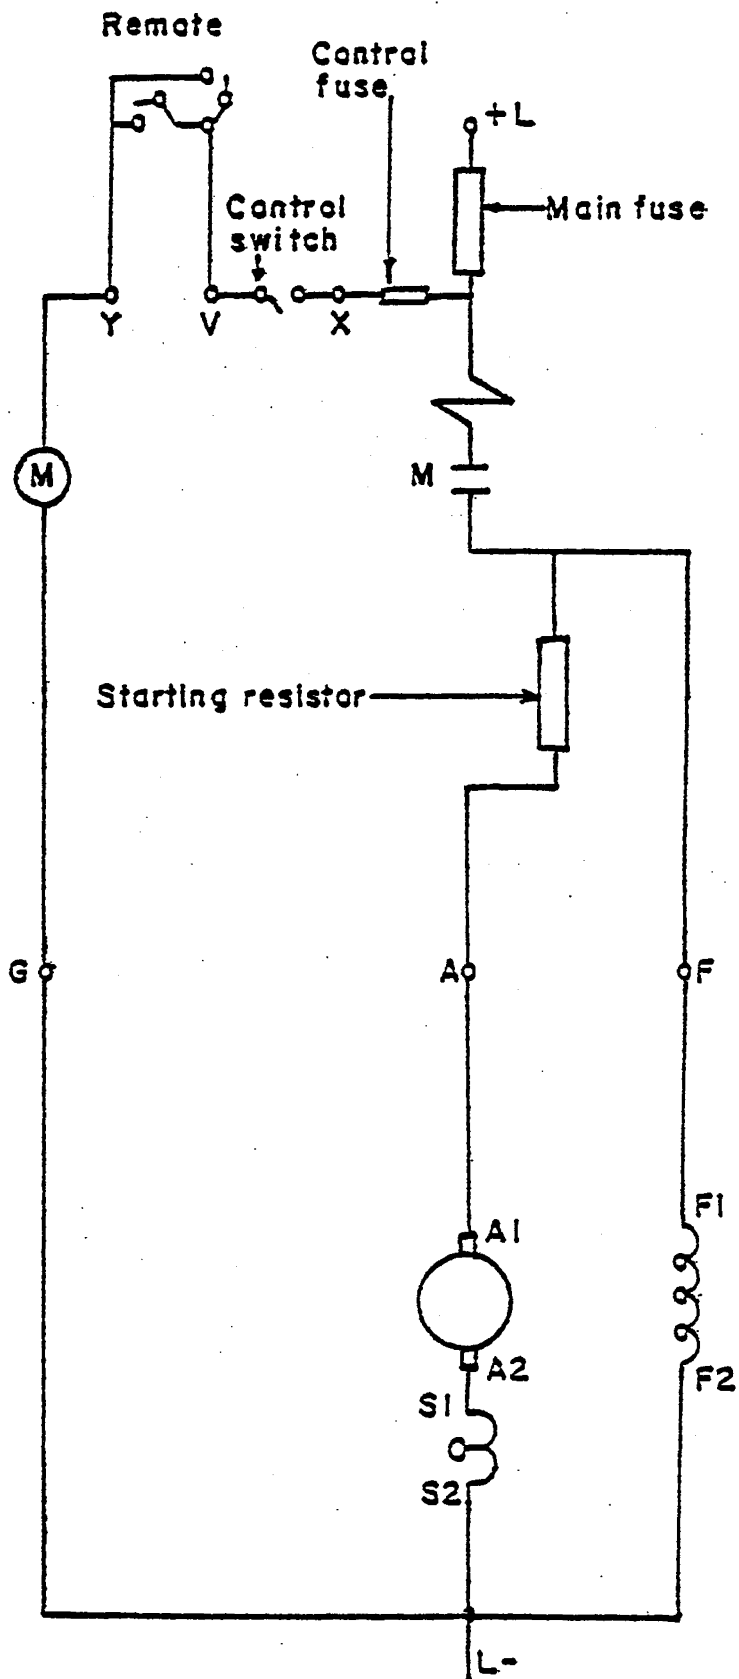
Wiring diagram of C-3 type AF motor starter for car spotter

3. On at least 3 occasions, the mine car spotter continued to move the mine cars after the pull-type car spotter switch had been released. Two separate means of deenergizing or deactivating the mine car spotter, one of which will deenergize the main power circuit leading to the car spotter shall be provided on each side of the loading ramp. A Notice to Provide Safeguard Section 75.1403.

Stamler car spotter, Model No. 6SH-20-18, Serial No. 1392, 550 volts direct current. Diagram of wiring circuit attached.
