CA1-2001-19

REPORT OF INVESTIGATION

Fatal Powered Haulage
September 17, 2001

Cardinal
Warrior Coal, LLC
Madisonville, Hopkins County, Kentucky
ID No. 15-17216

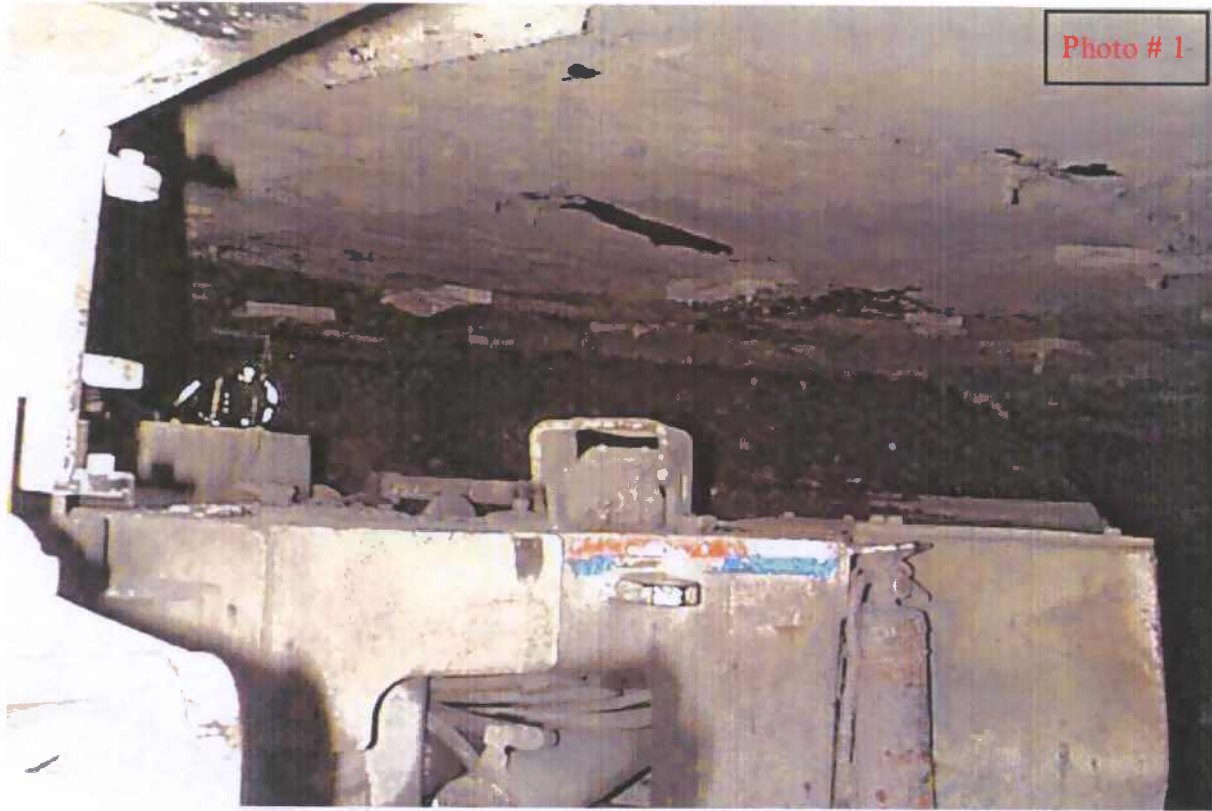
Except for the Eimco scoop, there was no other mining equipment operating on the No. 1 Unit to prevent miners from hearing the diesel scoop approaching the area. The floor of the No. 4 entry was clean from the last open crosscut inby to the working face. The scoop operator could not see past the end of his bucket in the elevated position with it loaded. With the full load of coal in the bucket at the time of the accident, visibility to the front of the machine would have been limited to along the right side of the bucket.

View from the operator's cab

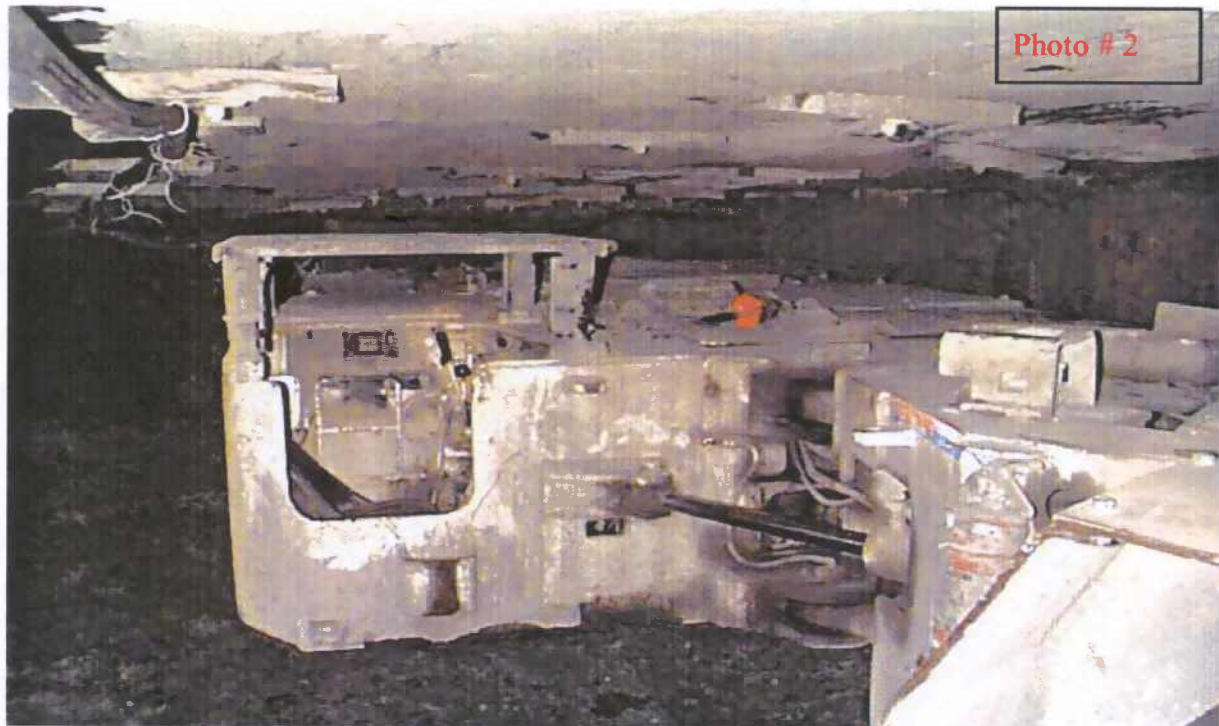
The operator's compartment was positioned perpendicular to the center line of the machine (See Photo #2). It was located on the right side of the machine (from the point of view of the operator using the bucket end of the machine as the front) just behind the articulation joint and on the engine half of the machine (opposite end from the bucket). A distance of 11 inches between the frame and the underside of the canopy provided the operator's vertical field of view. The canopy posts did not significantly obstruct the view from the operator's compartment. (See Photo #2)

View of the operator's cab

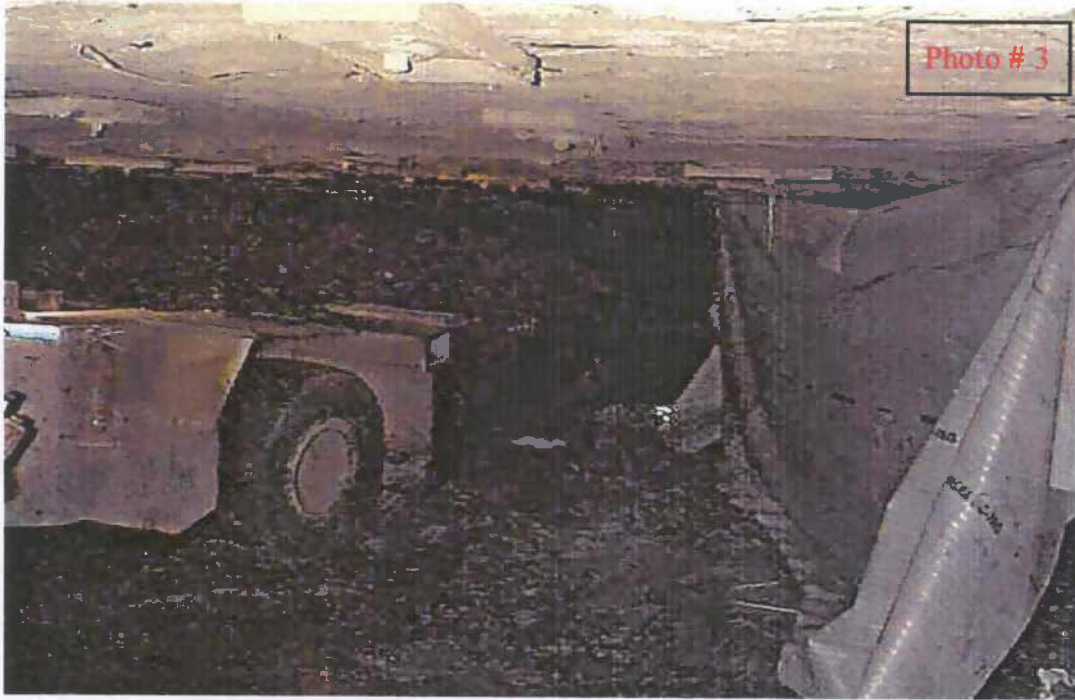
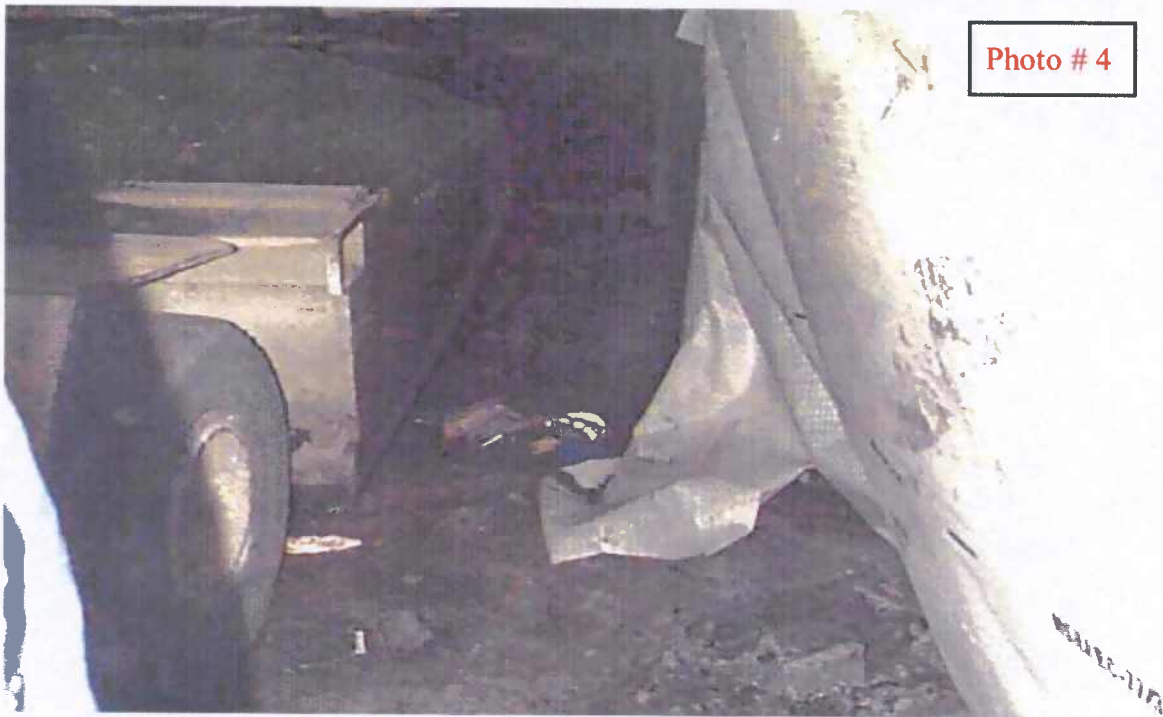
The working face of the No. 4 entry was 20 feet wide and located approximately 53 feet from the inby rib of the last open crosscut. The victim's body was located approximately twelve feet inby the right hand rib of the last open crosscut near the ventilation curtain that was installed along the right side of the entry. The height of the roof in the area where the accident occurred was 60 inches. A white ventilation line curtain approximately 2 feet and 9 inches from the right hand rib was installed from the last row of roof bolts in the intersection inby to the third roof bolt outby the face next to the pile of coal Vaughn had previously placed in the entry. (See Photo #4)

Face of #4 room
